September 6, 2018

Megan Pohanka,
Director of Market Development
UBC PROPERTIES TRUST

Root Exploration at Lot 11

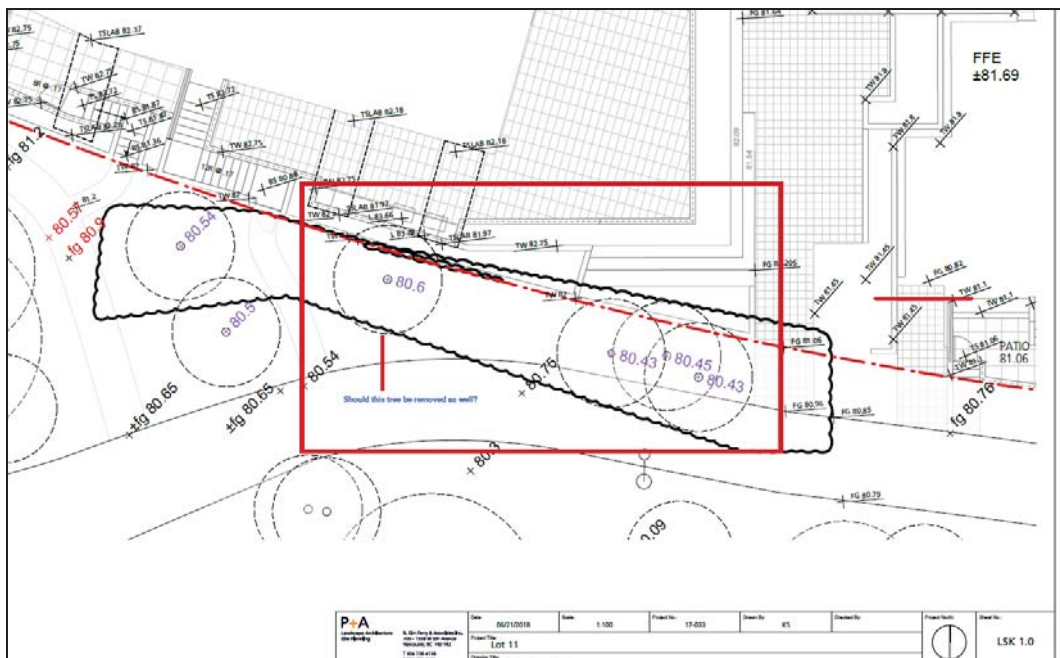
Figure 1 shows the tree locations in relation to the proposed building design. The TPZ of these trees will be impacted by the excavation and construction required for this development. The tree tags are shown in figure 2, and the tree attributes are shown in table 2. These trees are generally on the smaller side, with moderate to poor condition based upon their overall health, species characteristics and structure.

Figure 1 Location of the four trees that conflict with the proposed design (drawing from Perry and Associates).

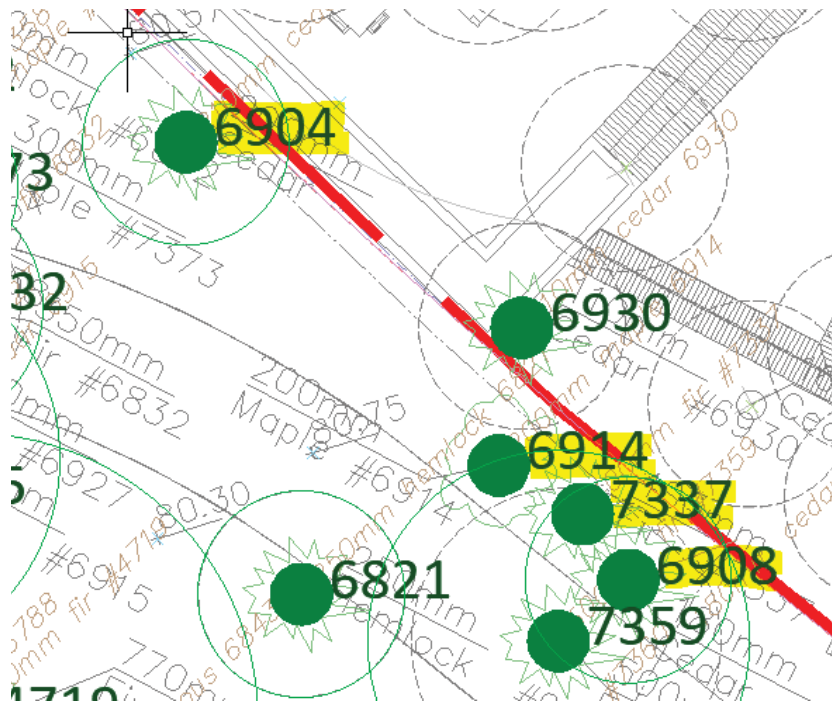
Figure 2 Highlighted trees from the DHC tree retention and removal map showing their tag numbers.

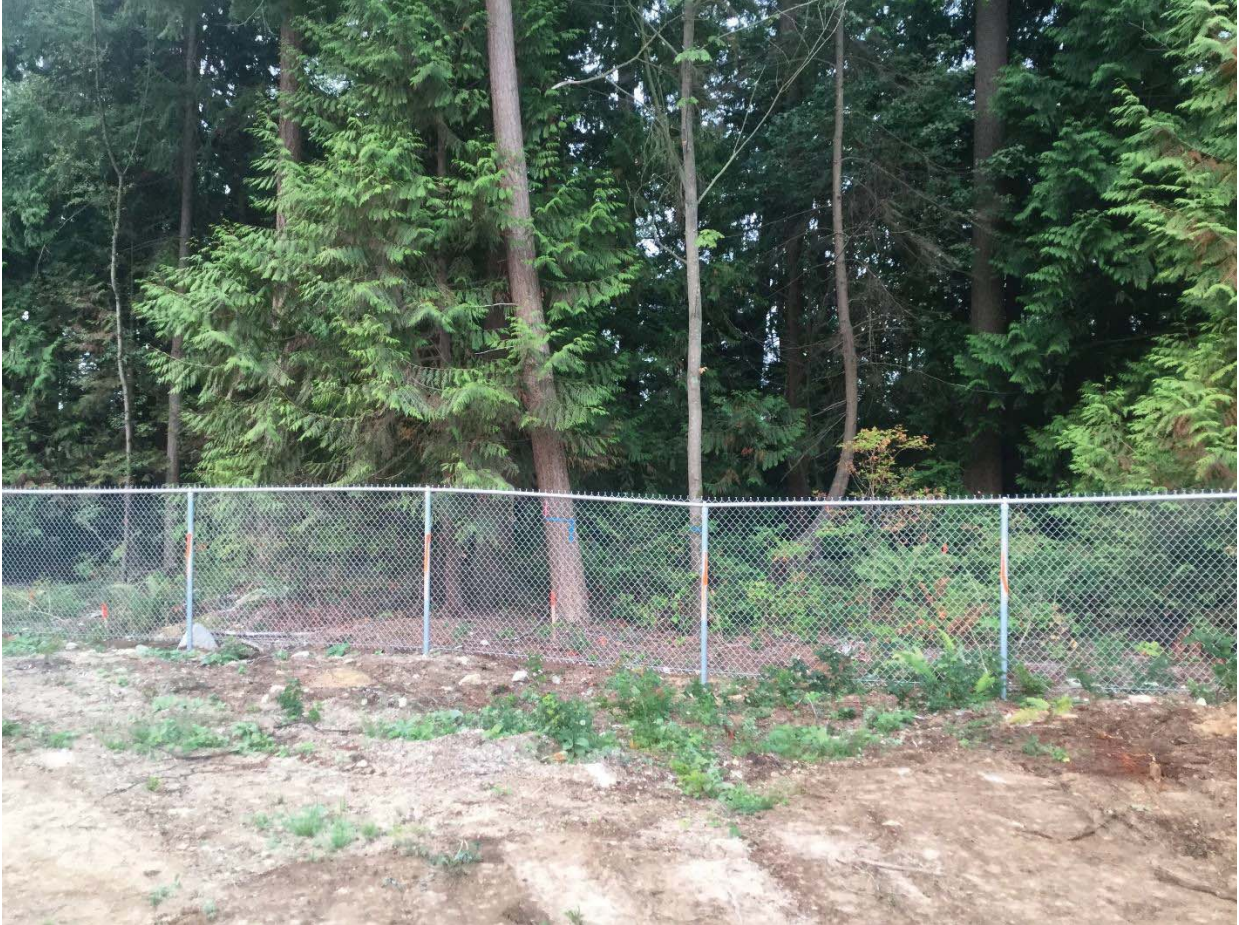
Photo 1. The assessed trees: #7337 in the center, with #6914 directly right and #6908 slightly obscured to the left. The crown foliage of #6904 is visible on the far left of this photo. Visible at the base of #7337 is a survey stake, which was used to identify the limits of excavation for the proposed development.

The root exploration revealed root conflicts with the proposed excavation in the form of dense feeder roots and medium sized lateral roots. The impacts of excavation for the building foundation (severing all these roots) will have significant health and structural impacts to all four trees, resulting in health decline and destabilization. With a new target being placed directly adjacent to these trees the overall risk rating will be high. It is recommended that these trees be removed due to the rooting conflicts with the proposed development.

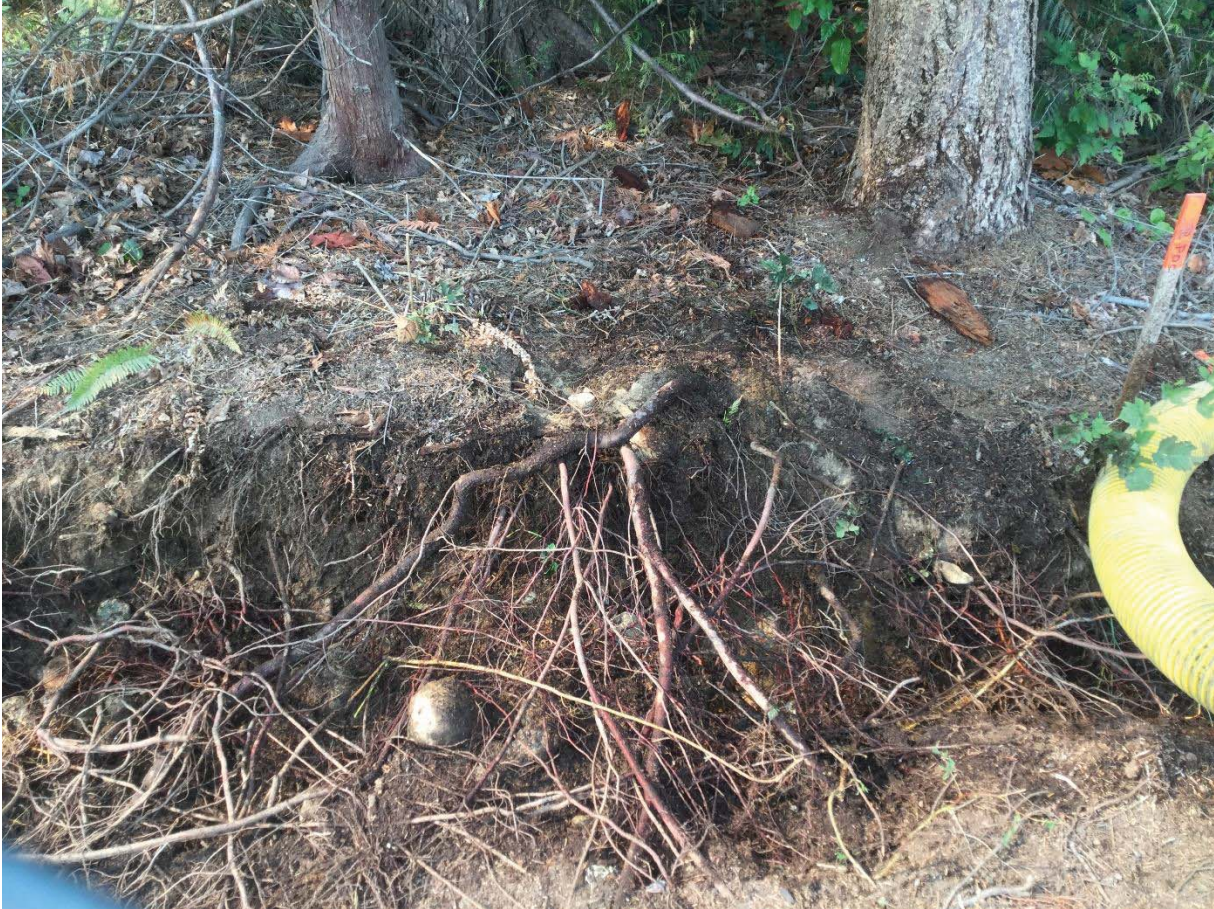
Roots were exposed to a depth of 12-18 inches for the root zones of the identified trees. The root exploration identified a dense mat of feeder roots and several medium sized lateral roots inside the assessed area. There are likely large structural roots below these at a significant depth, which were not exposed during the hydrovac root exploration. However, excavation damage to the visible roots would be enough to cause significant damage and destabilization to the trees. This would also eliminate a significant amount of the rooting area for all of the assessed trees.

Photo 2. Exposed roots from the Hydrovac adjacent to #7337. Dense mat of feeder roots with medium sized lateral roots. The cut to occur within less than a meter from tree 7337 would de-stabilize the tree.

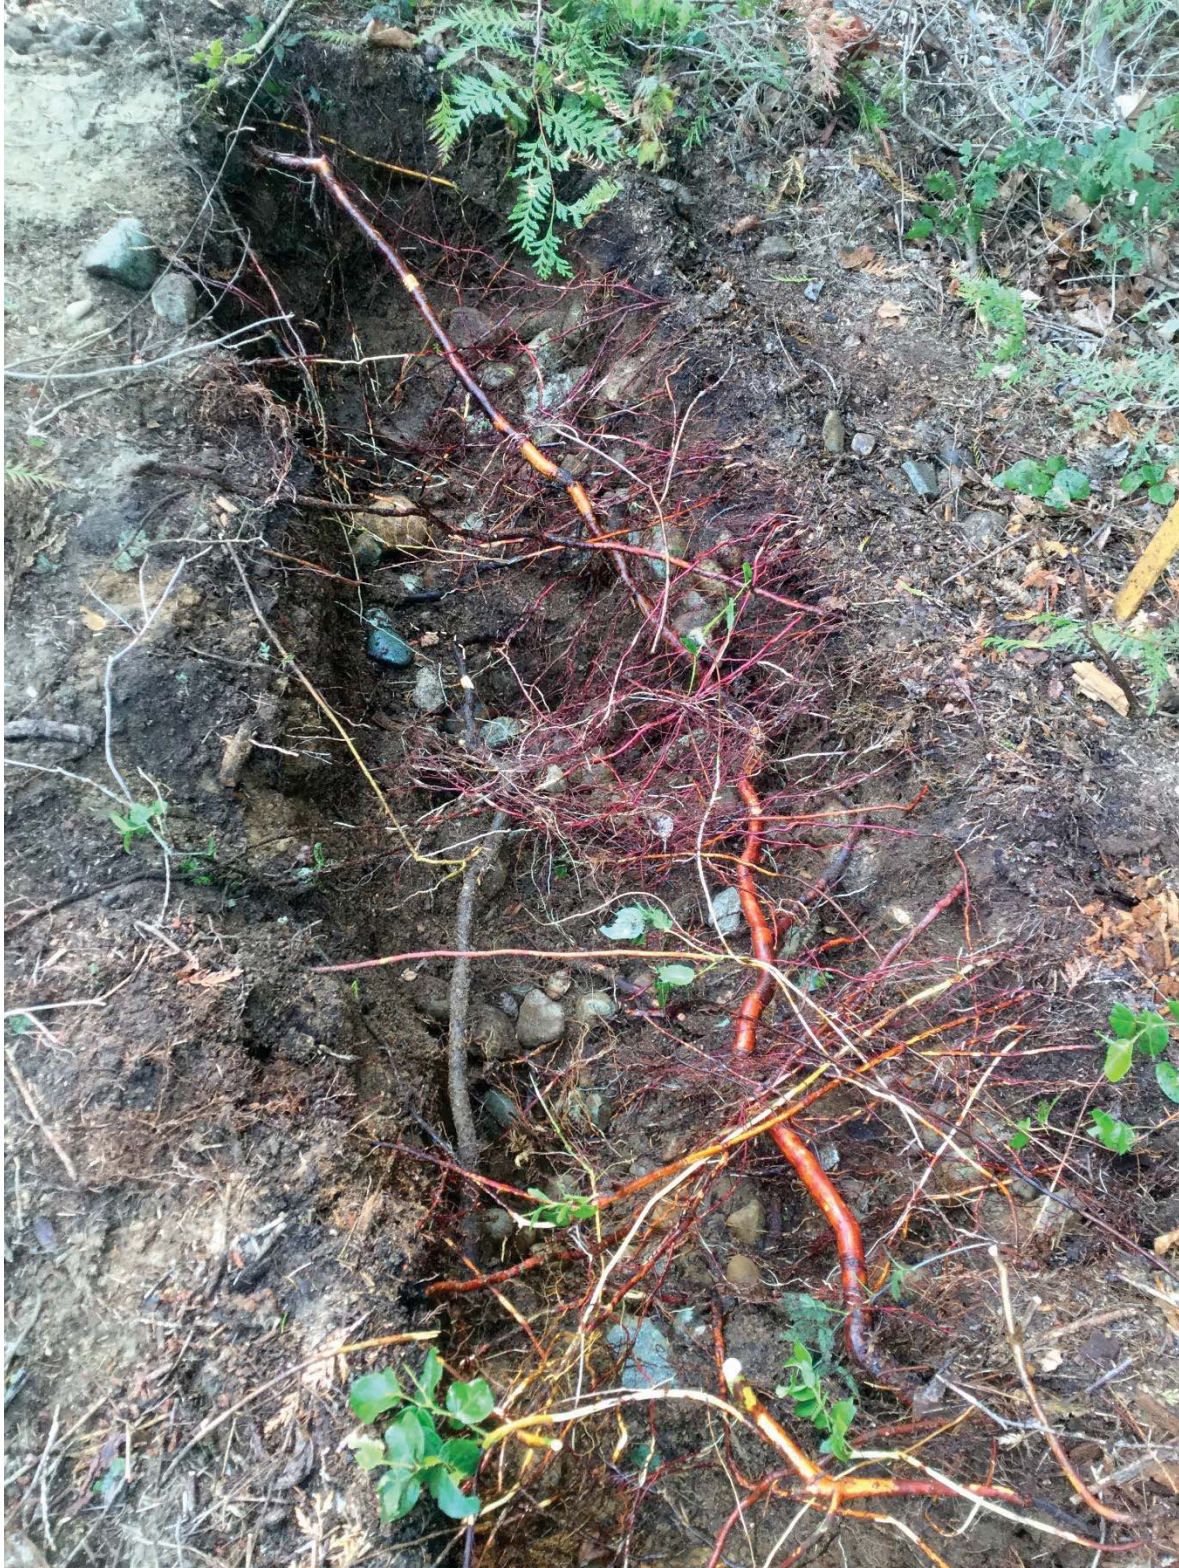
Photo 3. Example of the exposed roots from the Hydrovac adjacent to #6904. Dense mat of feeder roots with medium sized lateral roots.
