Arboricultural Inventory and Report

For:
Wall Financial Corporation

Site Location:
Lot 8 UBC South Campus

Date: December 18, 2017; revised March 7, 2018

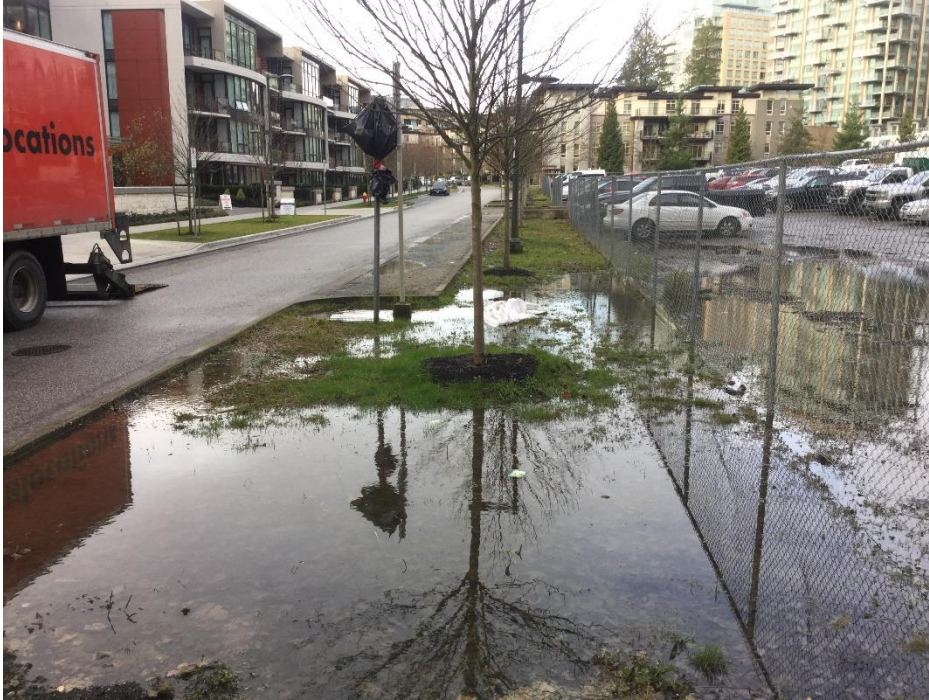
Photo 3. Tree 462 is a red maple street tree. Note standing water in boulevard indicating very compacted soil and poor drainage.

The red maples on Birney are currently planted poorly, with topsoil either missing entirely or covering only the root ball. Construction of the sidewalk and boulevard improvements presents an opportunity to improve the growing conditions for these trees. Decompacting the ground within the boulevard and replacing it with a quality top-soil to a depth >30cm would improve the long-term success of these trees. Soil replacement should be supervised by the project arborist. If boulevard improvements are planned to be implemented after construction of the building, the red maples on Birney should be protected with a layer of mulch over their root zones and fitted with a tree-gator or similar watering device to reduce drought stress during the summer months.
