Diamond Head Consulting Ltd. Arborist Report

Lot 8

Nobel Residences at UBC

September 26, 2017

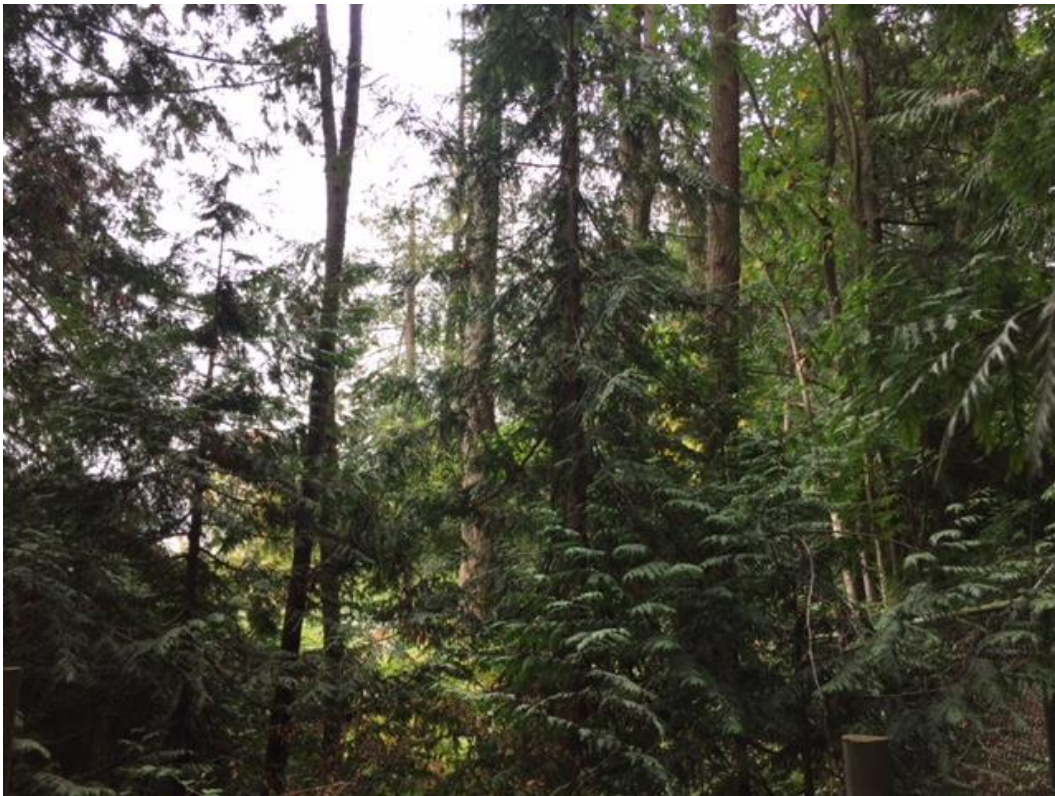
Photo 1. View of the northern edge in the middle of the lot. Note the number of young cedar trees growing in the understory.

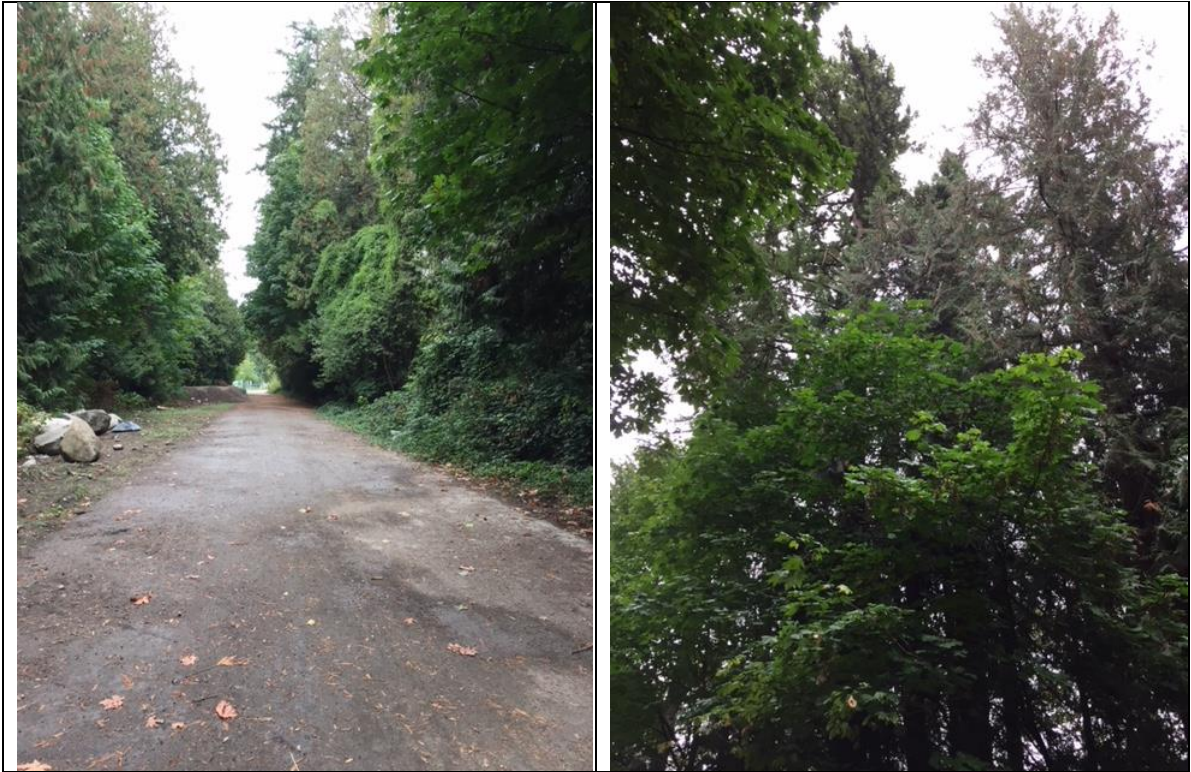
Photo 2 and 3. The pathway at the south end of the site. Note that there are very large trees along this edge. A number of trees on the left side of photo 2 will need to be removed as their root plates will be cut to accommodate the parking garage. With the removal of many of these edge trees there will be a need to remove a number of smaller intermediate trees in behind them as they have very high height to diameter ratios and or leans toward the future development site.

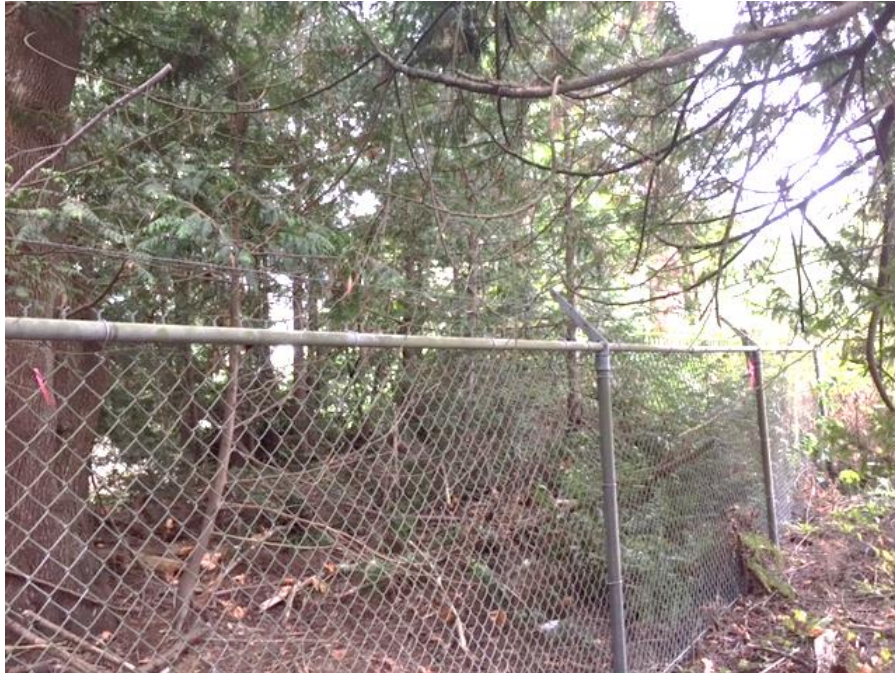
Photo 3. At the west end of the site there are many young western redcedar trees growing below the large Douglas-fir trees.

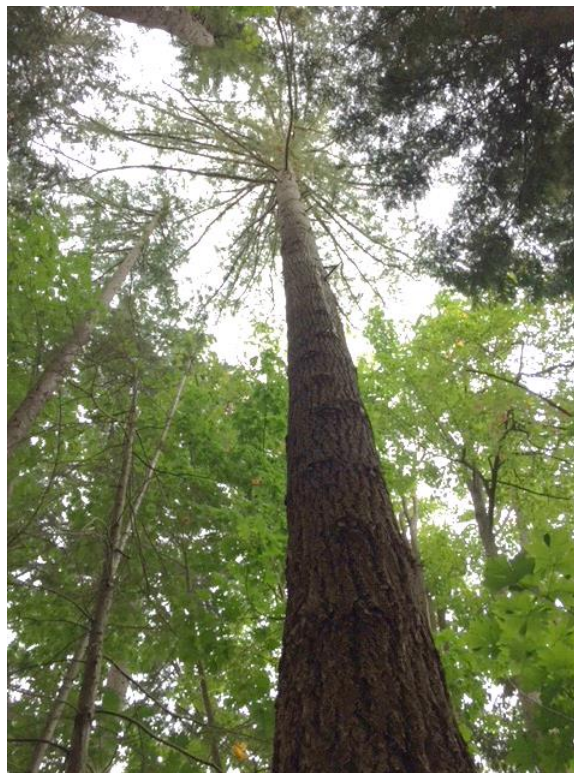
Photo 4. Some of the dominant Douglas-fir trees are over 35m tall. This tree is in decline due to a root pathogen.
