Diamond Head Consulting Ltd. Arborist Report

Lot 11 at UBC South Campus
Vancouver, BC
October 2, 2017

To be submitted with Tree Retention Plan
Dated: October 3, 2017

UBC Properties Trust
200 – 3313 Shrum Lane
Vancouver BC V6S 0C8

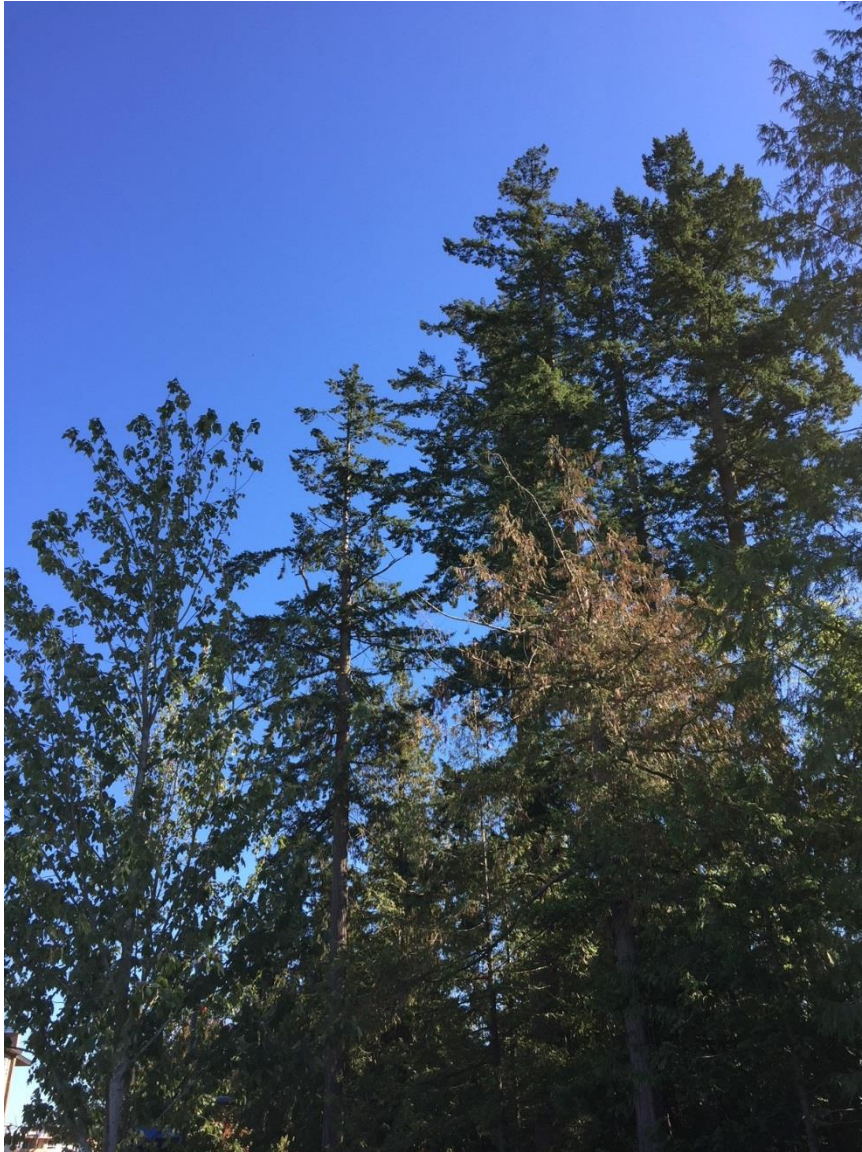
Photo 1. View of the east edge of Lot 11 and just east of it. The large firs are to be retained.

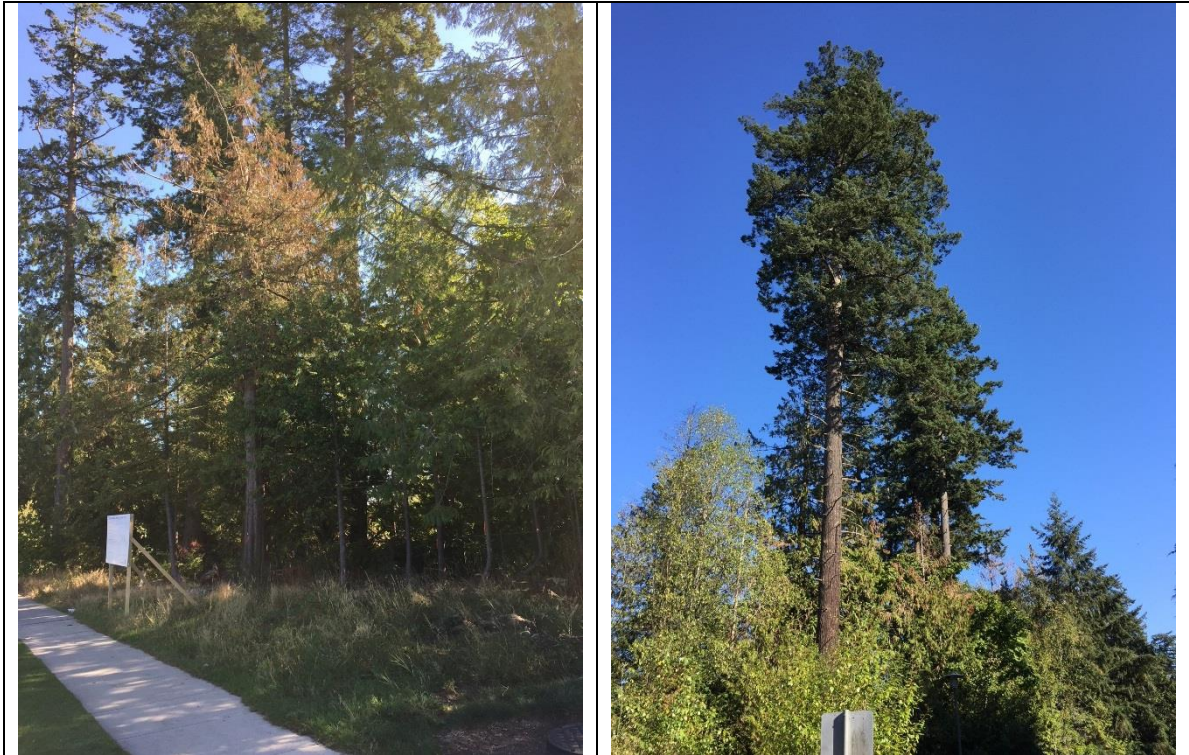
Photo 2 and 3. Note that many of the trees along the northern edge of the area to be retained have been impacted by grade changes and the new sidewalk construction. Some of these trees are to be removed while others could be enhanced by providing a good organic mulch layer over their root zones. Many of the trees could be lift pruned. The large fir tree in the right photo is tree 2599.

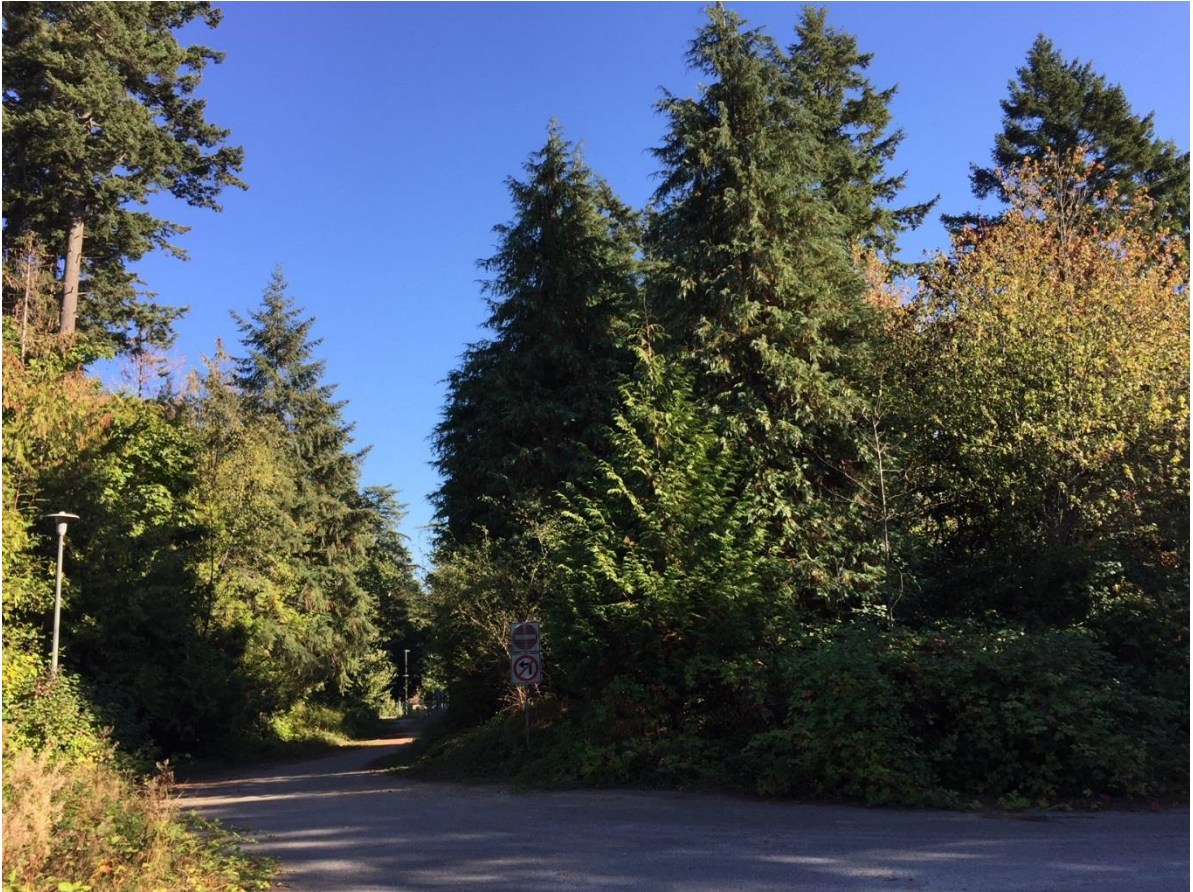
Photo 3. Looking at the island of cypress trees in the area of trees to be retained at the east end of the site.

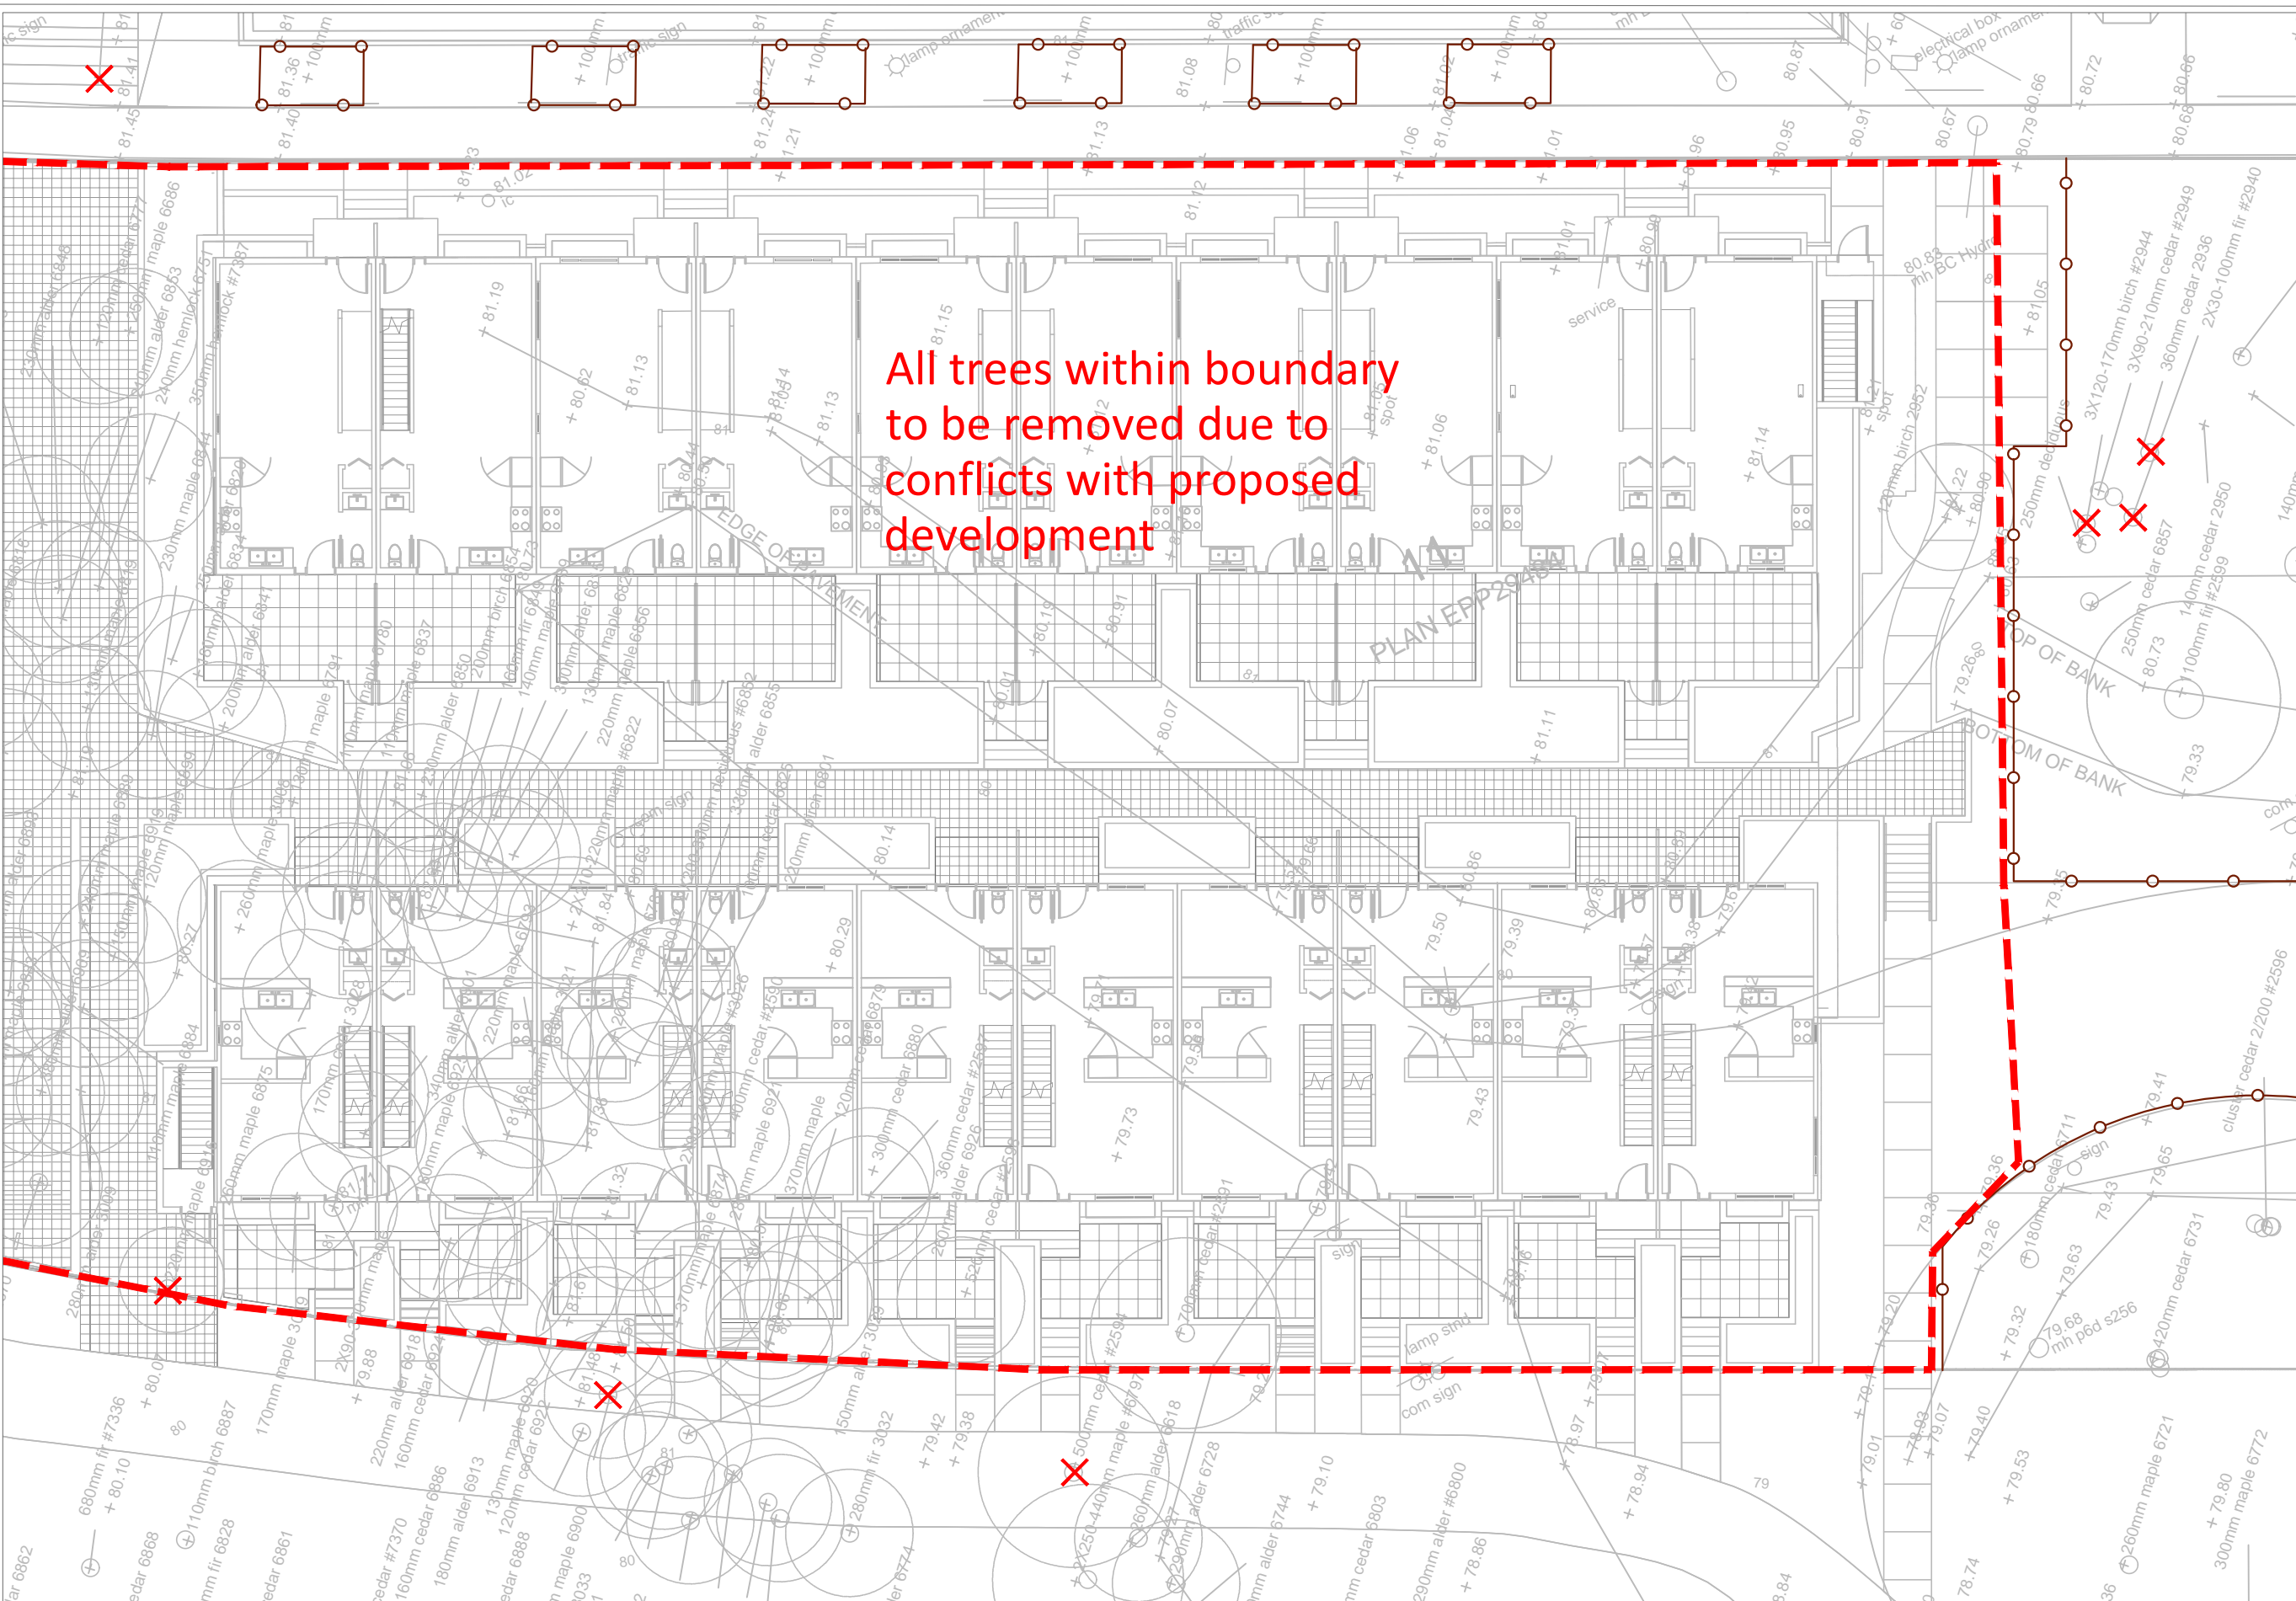
Drawing title: Tree Retention and Removal Plan
Project address: Lot 11
Client: UBC Properties Trust

All trees within boundary to be removed due to conflicts with proposed development
