Re: Arborist reporting for tree management at UBC Lot 8 – Ivy on the Park.

Arboricultural Inventory and Report

Date: December 18, 2017; revised March 7, 2018;
June 6, 2018; July 23, 2018

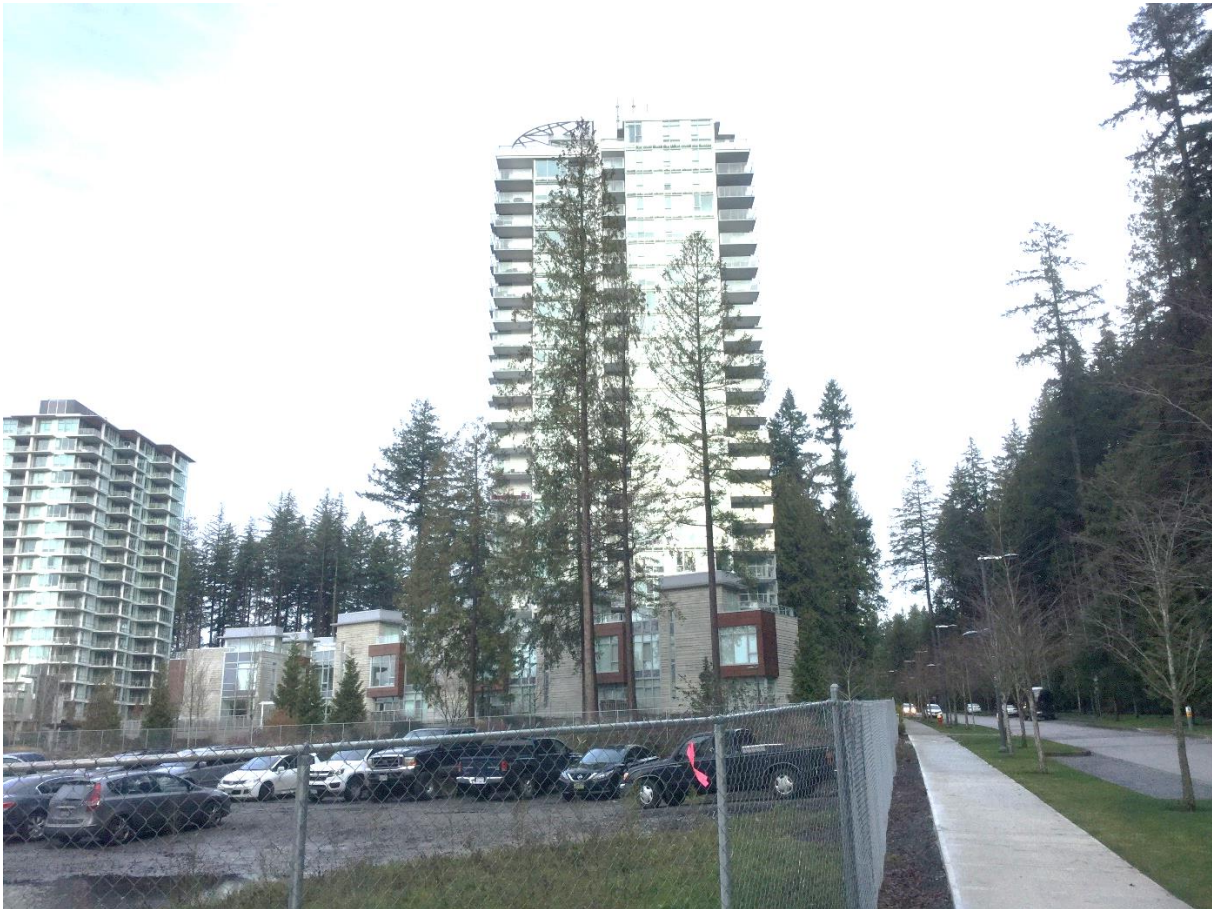
Photo 1. Viewing mature cedars to the north of the site.

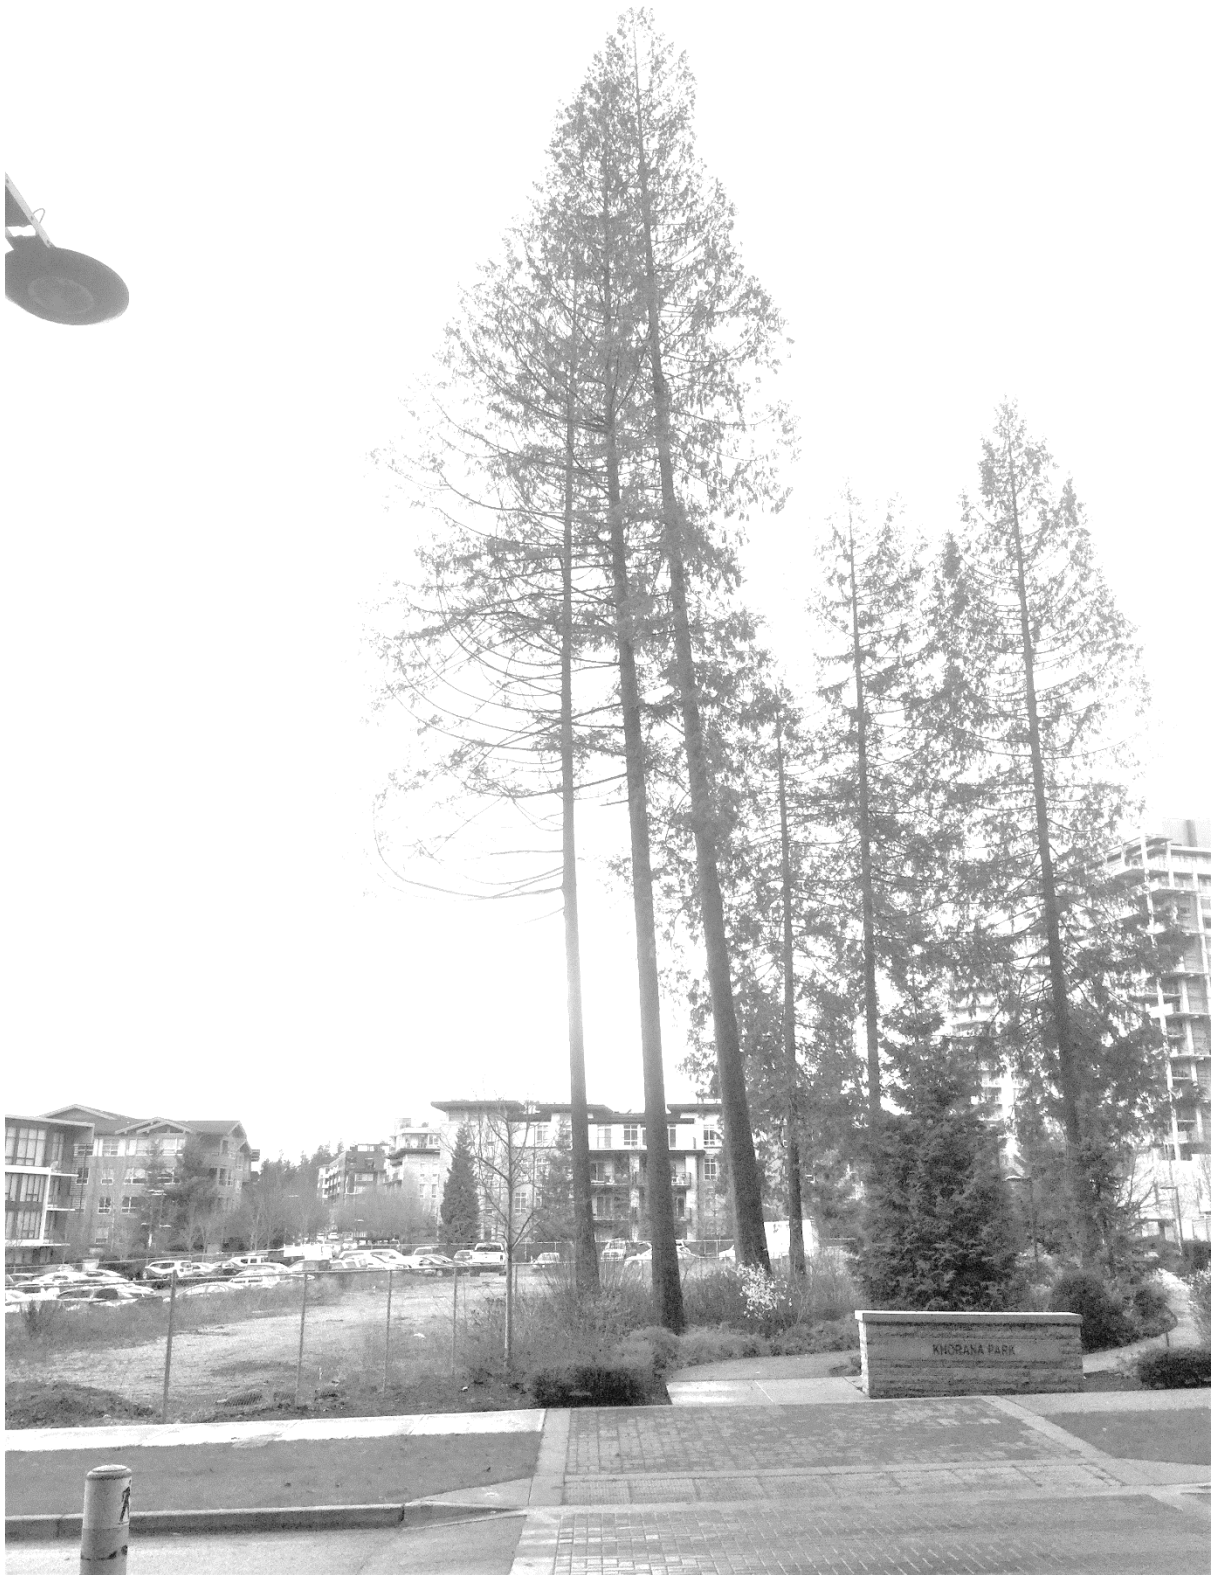
Photo 2. Trees 8123, 8135, 8137, 453, and 454. Note lean of 8135, the tallest tree.

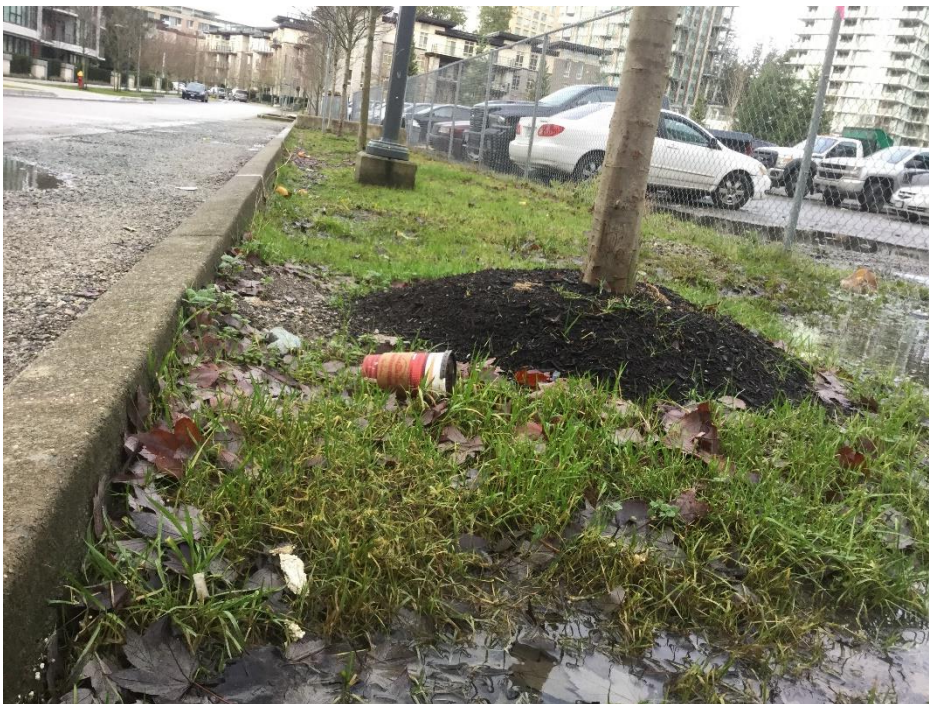
Photo 4. Street trees on Birney Ave have been planted proud. There is good opportunity to improve growing conditions in the boulevard.

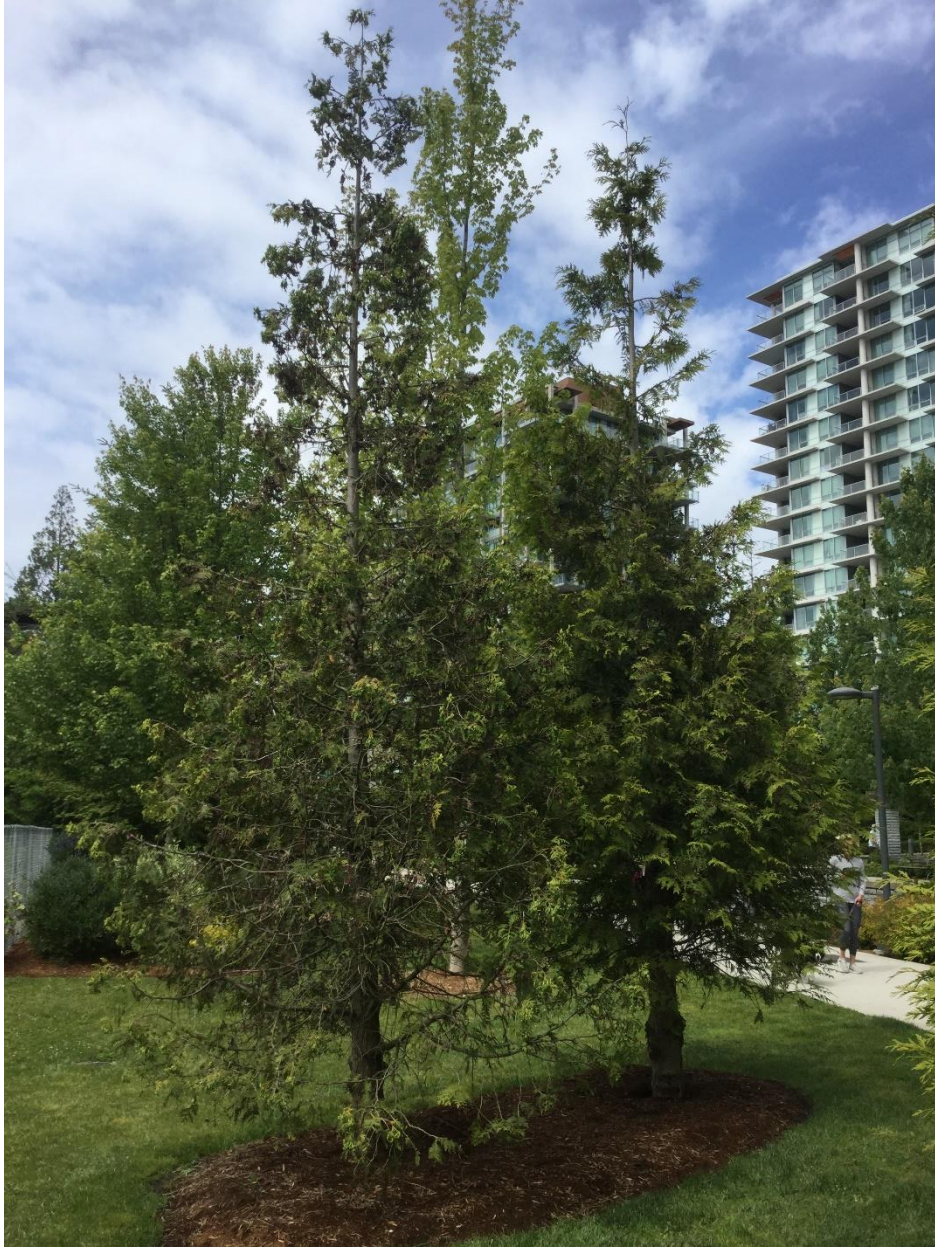
168	Western Redcedar	<i>Thuja plicata</i>	13	6	Poor	Thin, stressed crown. Cause unknown. Lacks vigour required to tolerate relocation.	Low	Remove	In conflict with temporary site access.	2

Photo 6: Cedars 168 and 167 appear to be stressed and may not be good candidates for relocation.

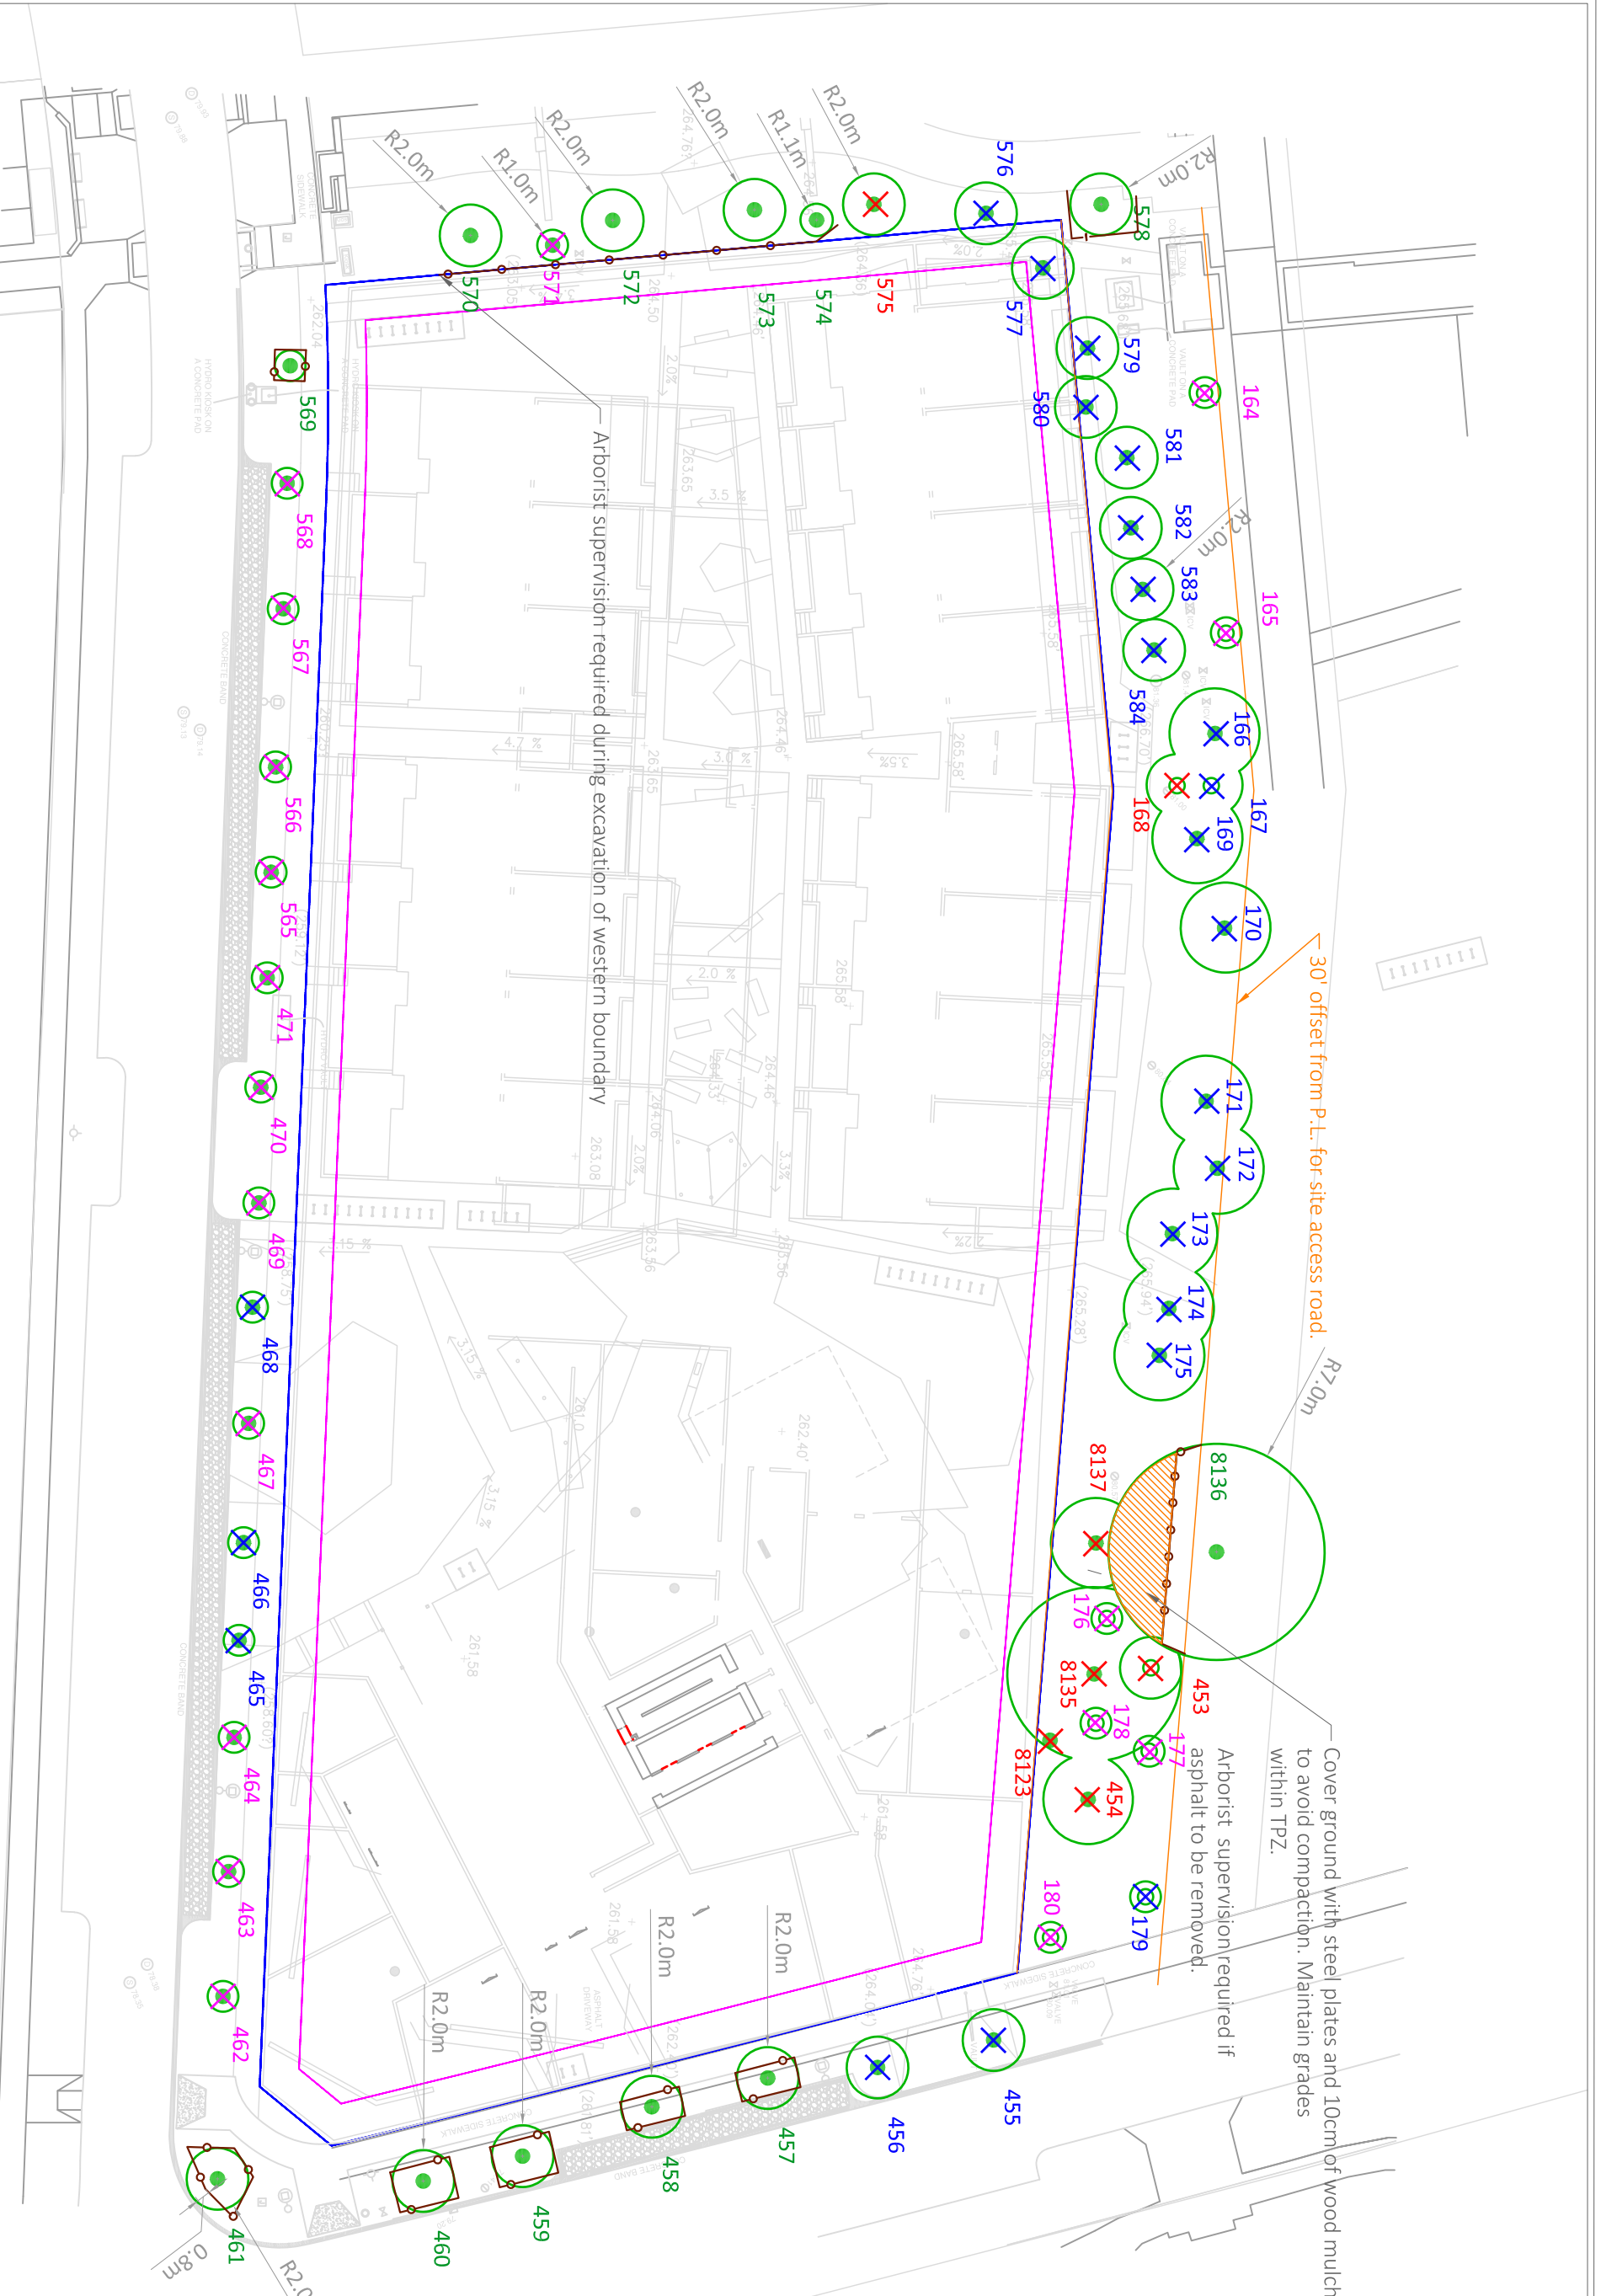
30' offset from P.L. for site access road.

Cover ground with steel plates and 10cm of wood mulch to avoid compaction. Maintain grades within TPZ. Arborist supervision required if asphalt to be removed.
