Arboricultural Inventory and Report

UBC Properties Trust

Daycare Sites – Three Locations

Date: 20181031

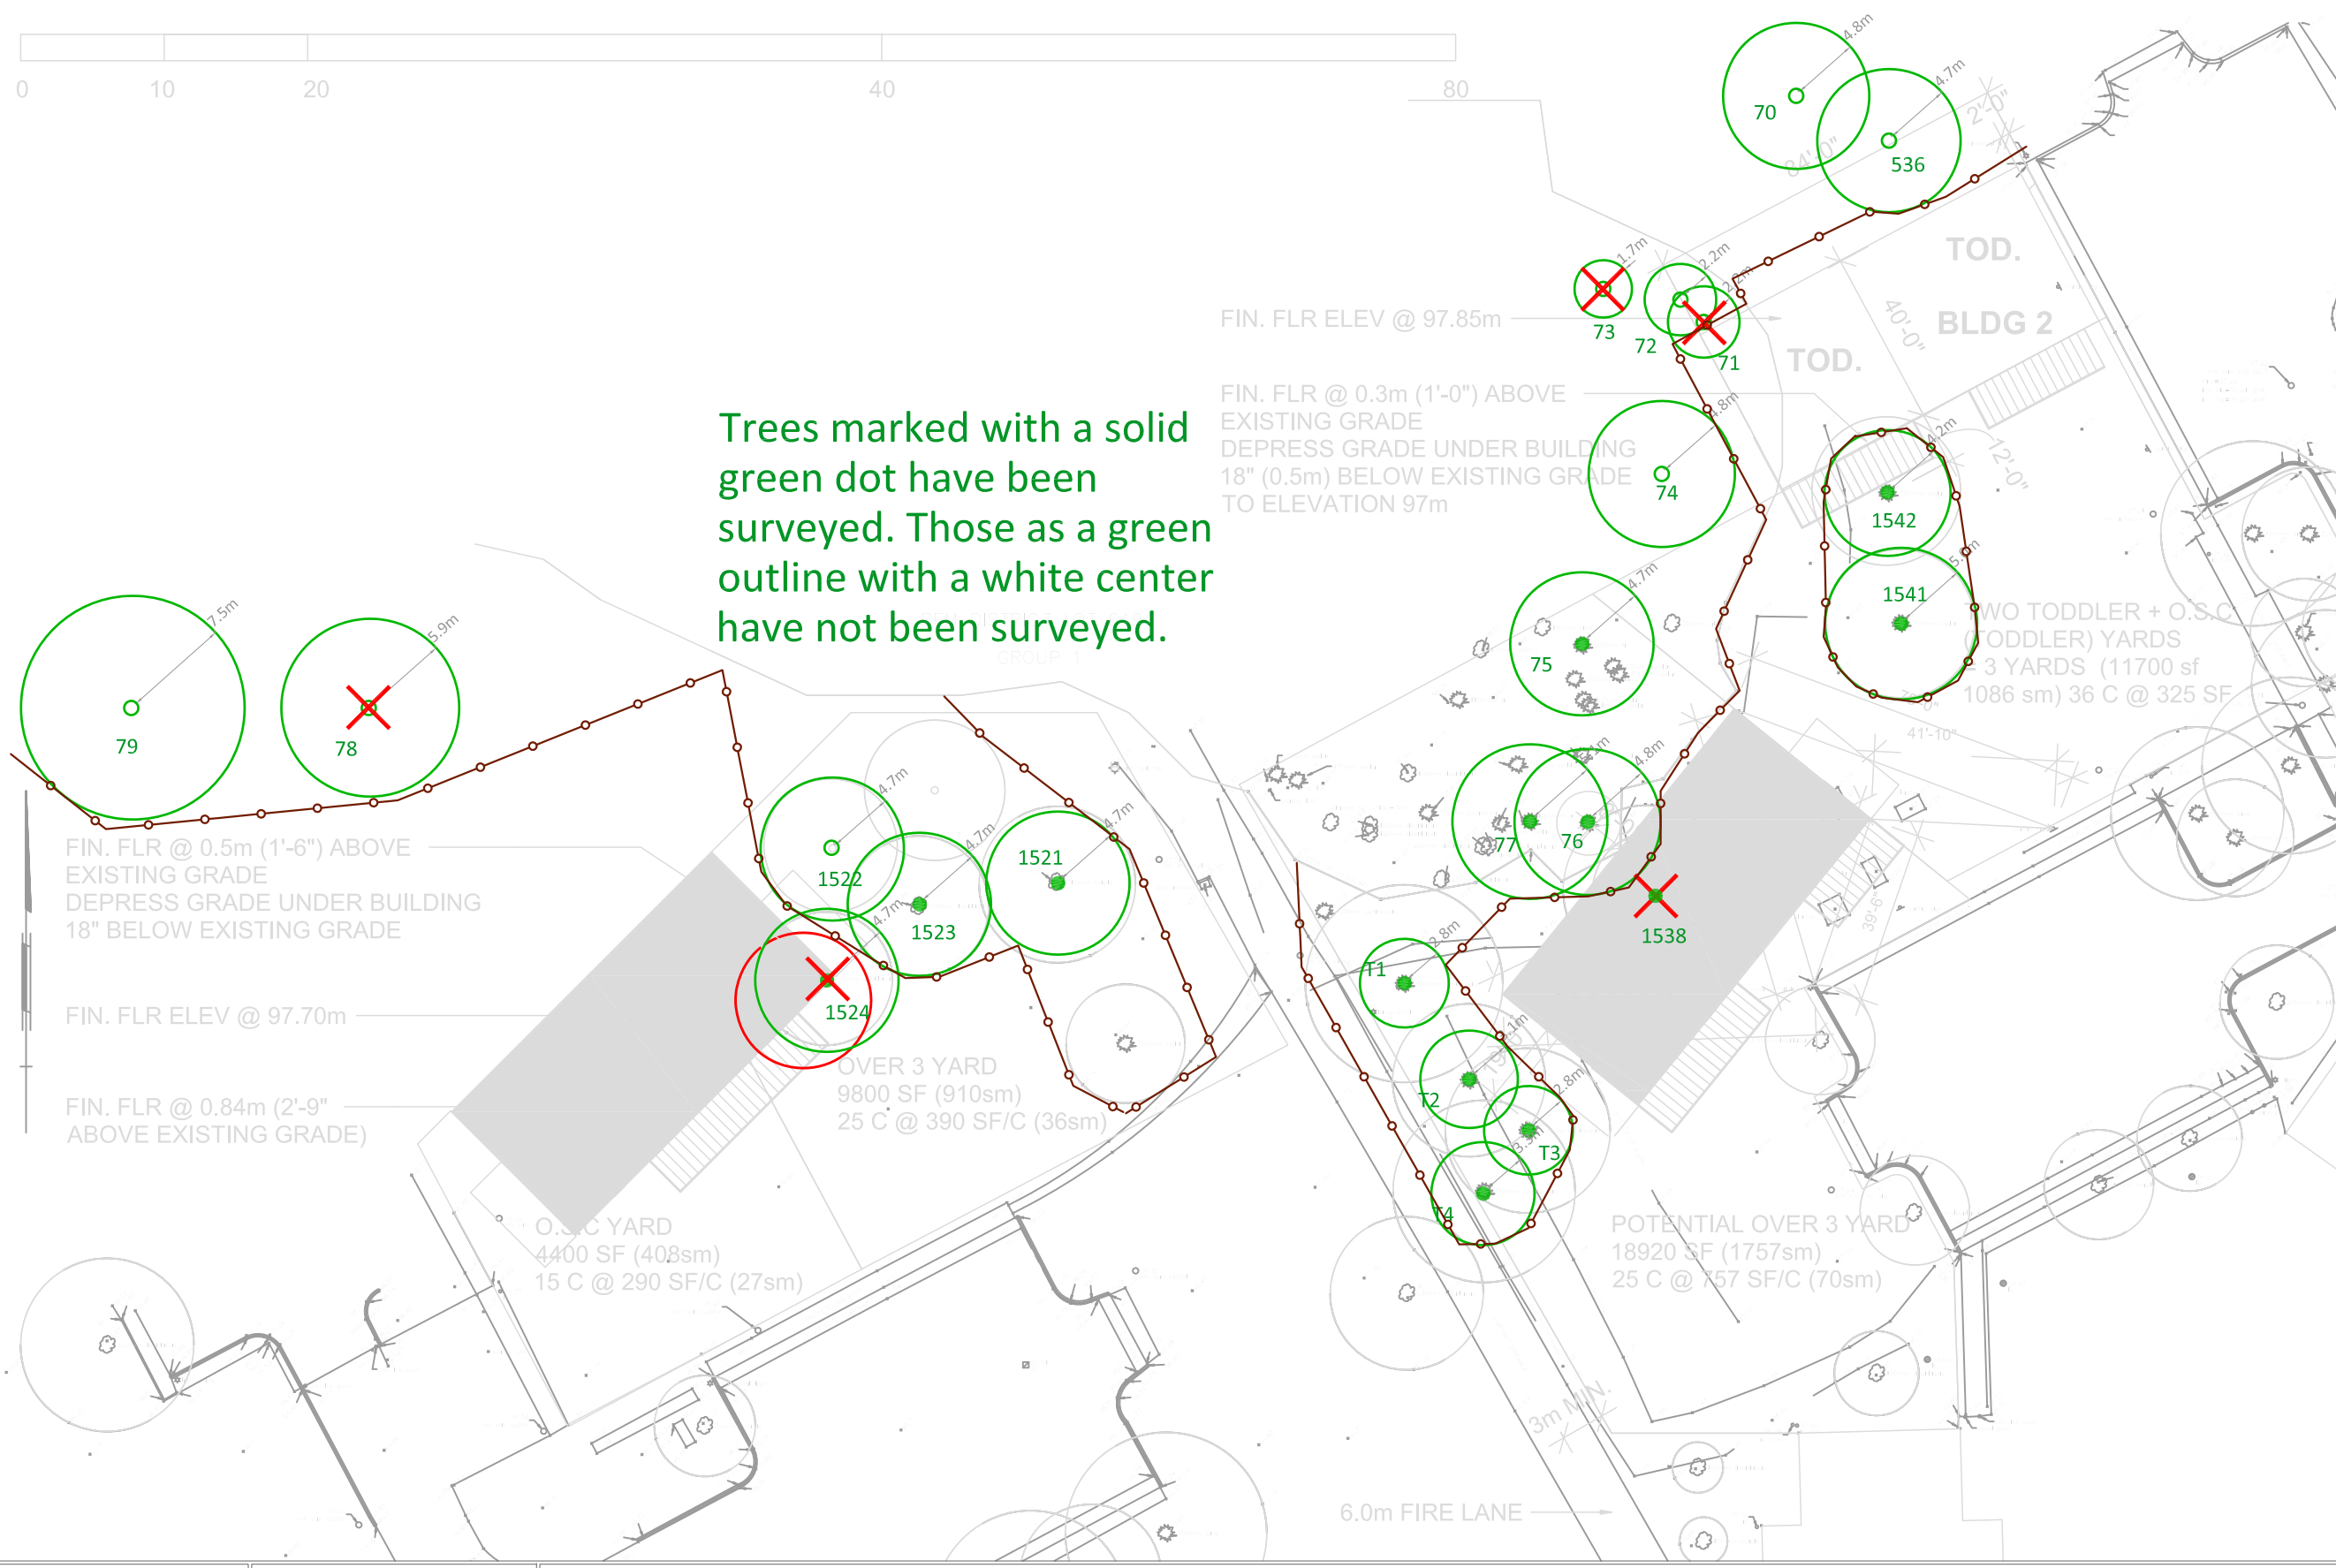
There were 18 protected trees identified for the purposed of this plan either because they were directly adjacent to the proposed development or because they posed a possible risk. (see Appendix 1 for individual tree inventory information).

There were no trees on this site that posed a *high* or *extreme* risk at the time of assessment.

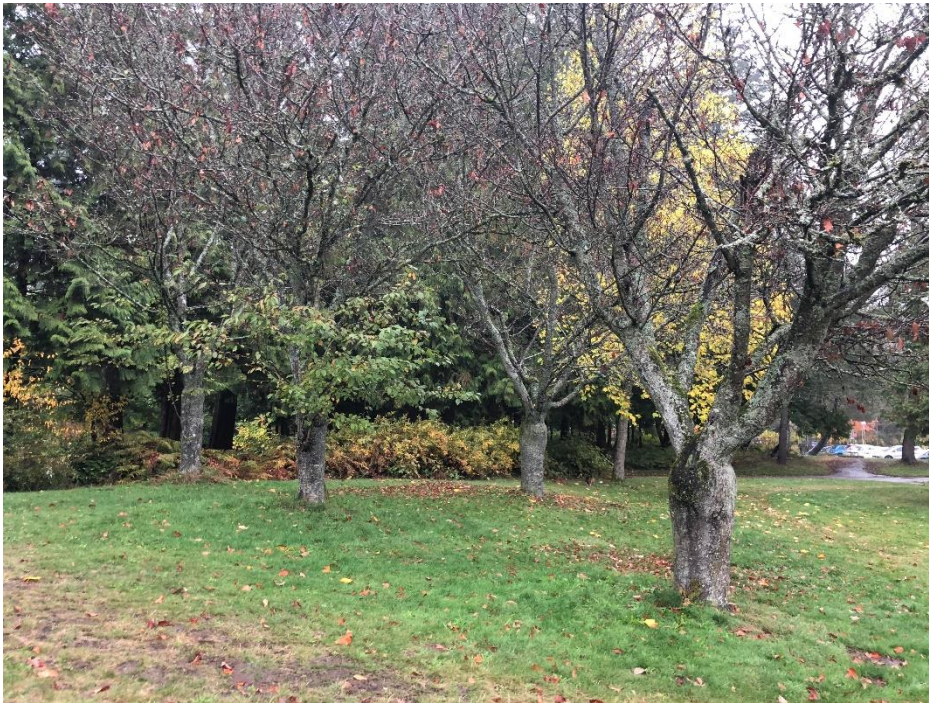
Photo 1. Looking at tree 1524 to the right and 1521-1523 in the background.

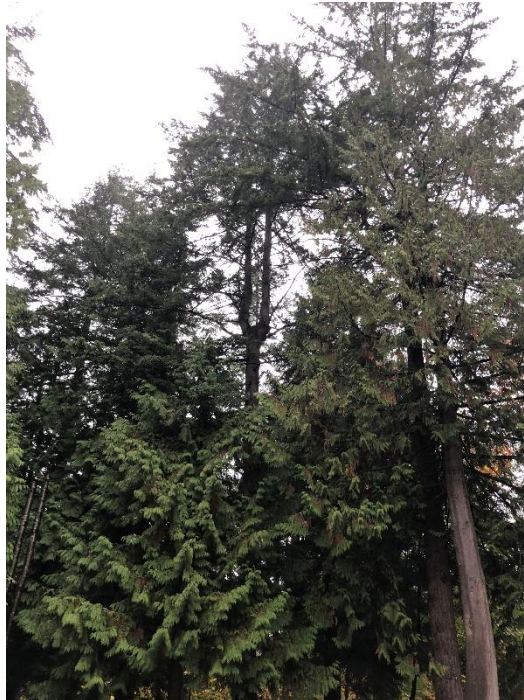
Tag #	Location	Species	DBH (cm)	Height (m)	Health and Structure Rating	Comments	Retention Value Rating	Retain/ Remove	Retention/TPZ Comments	CRZ
70	onsite	Douglas-fir (P. menziesii)	79	32	Moderate	Codom stem with u union at 20 m	Medium	Retain	Requires that building piles are placed out of root zone and tree is lift pruned on north side. Arborist supervision required for footing work.	4.7
71	onsite	Cedar (T. plicata)	38	15	Moderate	At forest edge. Under canopy of cedar behind. Supressed Live crown pruned to 3m	Medium	Remove	Survey has not been completed but stakes indicate that this tree is right up against building edge. Not feasible to retain or work around.	2.3
72	onsite	Cedar (T. plicata)	38	15	Moderate	At forest edge. Under canopy of cedar behind. Supressed Large scar at 2 m on southwest side. Solid wood behind. Live crown pruned to 3m. Only live on south side.	Medium	Retain	Tree has not been surveyed. Appears that arborist lift pruning will be required	2.3

Photo 2. Looking up into the 'U' union located in tree #70. Note that many of the trees have similar attachments that require inspection were noted in the tree tables.

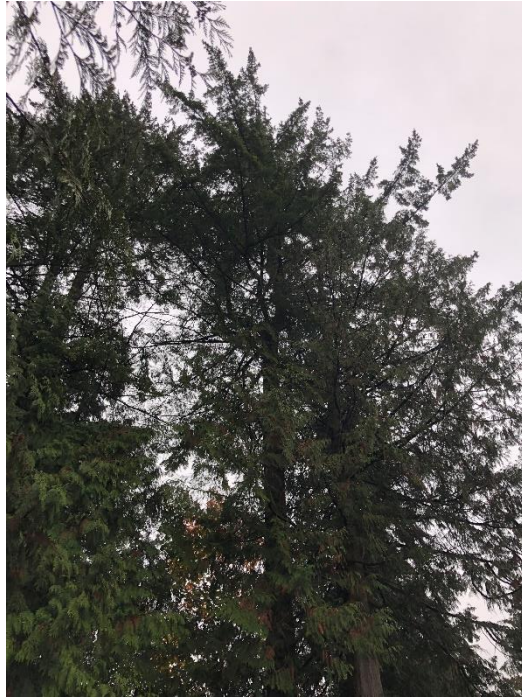
Photo 3. Looking up into trees 76 and 77. Both have similar topping points that require inspection.

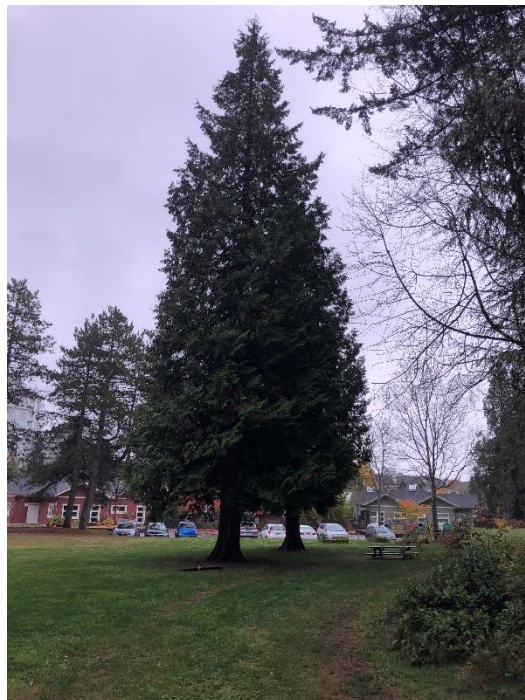
1541	onsite	Cedar (T. plicata)	68	22	Moderate	Slight compaction around base. Lift pruned to 4m. Upper canopy has 3 stems emerging at 18m. 10cm attachments. Prune to retain. Could use mulch around base within dripline.	Medium	Retain	Protect as required. Arborist supervision required for any work within tree protection fencing	4.1
1542	onsite	Cedar (T. plicata)	81	23	Good	Slight compaction around base. Lift pruned to 3m. Could use mulch around base within dripline.	High	Retain	Protect as required. Arborist supervision required for any work within tree protection fencing	4.9
T1	onsite	Cedrus (C. deodara)	48	23	Moderate	Compacted around base. Trail to the west. Single stem.	Medium	Retain	Protect as required. Arborist supervision required for any work within tree protection fencing	2.9
T2	onsite	Cedrus (C. deodara)	52	23	Moderate	Compacted around base. Trail to the west. Single stem.	Medium	Retain	Protect as required. Arborist supervision required for any work within tree protection fencing	3.1

Photo 4. Looking at trees 1541 and 1542.
