# Diamond Head Consulting Ltd. Arborist Report

**Gage South Student Housing and Bus Loop  
Exchange**

**March 10, 2016**

**To be submitted with Tree Retention and Removal  
Plan Prepared by PFS Studio**

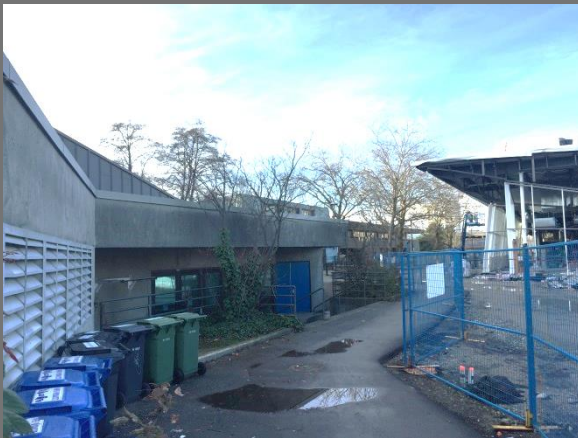
Photo 1. Showing trees 51-53 – Japanese maples that can be relocated.

48	Japanese maple	<i>Acer palmatum</i>	28	4	Normal	4 stems. Treat as 28cm. Minor branch dieback.	Relocate or Remove	2.0
49	Japanese maple	<i>Acer palmatum</i>	24			4 stems. Treat as 24cm. Minor branch dieback.	Relocate or Remove	2.0
50	Japanese maple	<i>Acer palmatum</i>	22			3 stems treat as 22cm	Relocate or Remove	2.0
51	Japanese maple	<i>Acer palmatum</i>	26			4 stems treat as 26cm. By stairs - boxed on 3 sides	Relocate or Remove	2.0
52	Japanese maple	<i>Acer palmatum</i>	25			3 stems, treat as 25cm. By stairs - boxed in on 3 sides	Relocate or Remove	2.0
53	Japanese maple	<i>Acer palmatum</i>	21			3 stems, treat as 21cm. By stairs - boxed in on 3 sides	Relocate or Remove	2.0

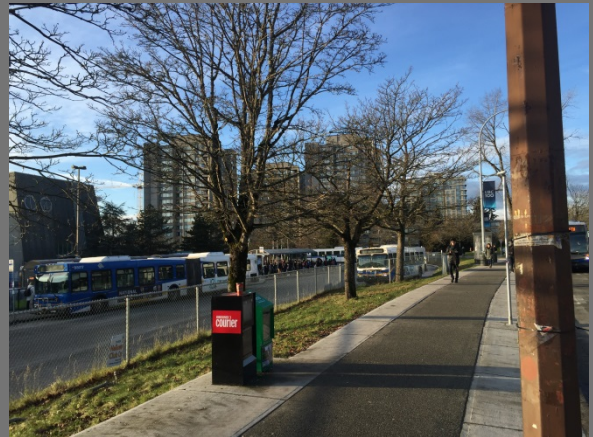
Photo 2. Looking at the mature hedge maples – trees 22-30.

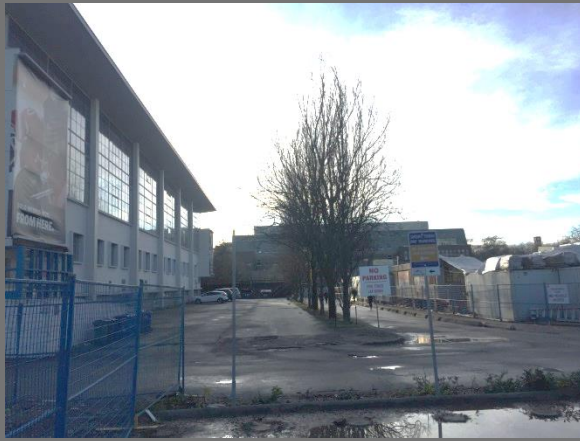
Photo 3. Trees 40-47 oaks and beeches.

40	Fastigate Beech	<i>Fagus sylvatica Dawyck</i>	32	9	Normal	In parking island. Slight dieback in crown.	Remove. Within proposed development area	2.0
41	Oak	<i>Quercus spp.</i>	43	10	Normal	In parking island.	Remove. Within proposed development area	2.6
42	Fastigate Beech	<i>Fagus sylvatica Dawyck</i>	24	8	Normal	In parking island.	Remove. Within proposed development area	2.0
43	Oak	<i>Quercus spp.</i>	42	9	Normal	In parking island.	Remove. Within proposed development area	2.5
44	Fastigate Beech	<i>Fagus sylvatica Dawyck</i>	28	9	Normal	In parking island.	Remove. Within proposed development area	2.0
45	Fastigate Beech	<i>Fagus sylvatica Dawyck</i>	27,11	9	Normal	In parking island.	Remove. Within proposed development area	2.0
46	Fastigate Beech	<i>Fagus sylvatica Dawyck</i>	29	9	Normal	In parking island.	Remove. Within proposed development area	2.0
47	Fastigate Beech	<i>Fagus sylvatica Dawyck</i>	33	11	Normal	In parking island.	Remove. Within proposed development area	2.0

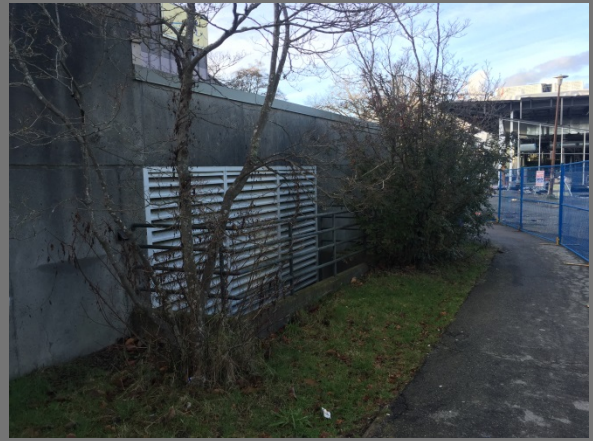
Photo 4. Trees 48-50. Japanese maples that can be relocated.

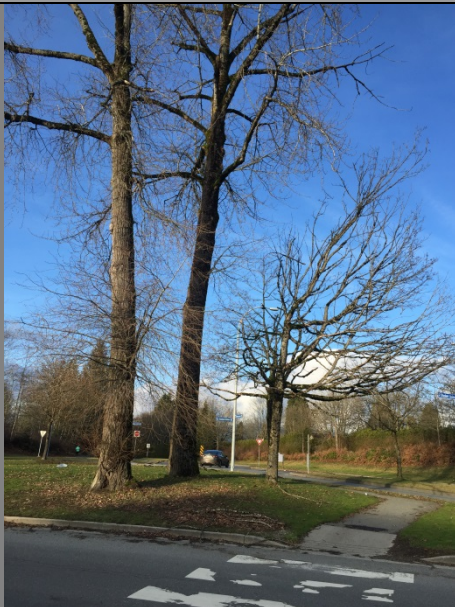
Photo 5. Trees 3-5A. Black cottonwoods and maples.

5A	Hedge maple	<i>Acer campestre</i>	39	7	Poor	Tree is in decline. Dead top. By sidewalk .		2.3
6	Hedge maple	<i>Acer campestre</i>	28	7	Normal	Normal structure and form. Little increment in growth. Tree has been stressed.	Remove. Within proposed development area	2.0
7	Hedge maple	<i>Acer campestre</i>	33	7	Normal	Normal structure and form. Little increment in growth. Tree has been stressed.	Remove. Within proposed development area	2.0
8	Hedge maple	<i>Acer campestre</i>	27	7	Normal	Normal structure and form. Little increment in growth. Tree has been stressed.	Remove. Within proposed development area	2.0
9	Hedge maple	<i>Acer campestre</i>	26	7	Normal	Normal structure and form. Little increment in growth. Tree has been stressed.	Remove. Within proposed development area	2.0
10	Hedge maple	<i>Acer campestre</i>	20	7	Normal	Normal structure and form. Little increment in growth. Tree has been stressed.	Remove. Within proposed development area	2.0

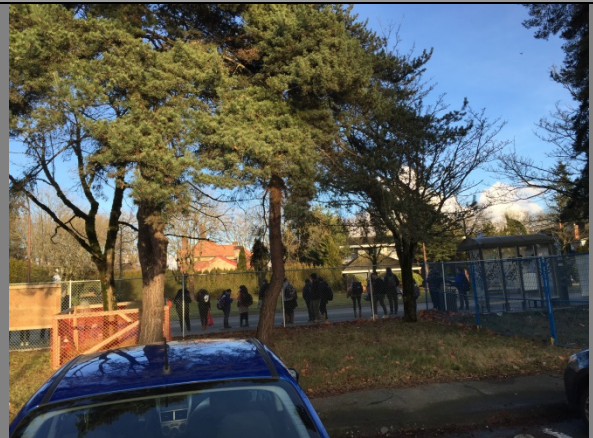
Photo 6. Trees . 31-34 Black Pines and maples.

33	Black pine	<i>Pinus Nigra</i>	22	8	Normal	Slight kink and windswept form	Remove. Within proposed	2.0
