# Arboricultural Inventory and Report

For:  
Polygon Homes

Site Location:  
The Conservatory – UBC Lot 5  
(at Berton Avenue and Binning Road)

Date: November 18, 2019

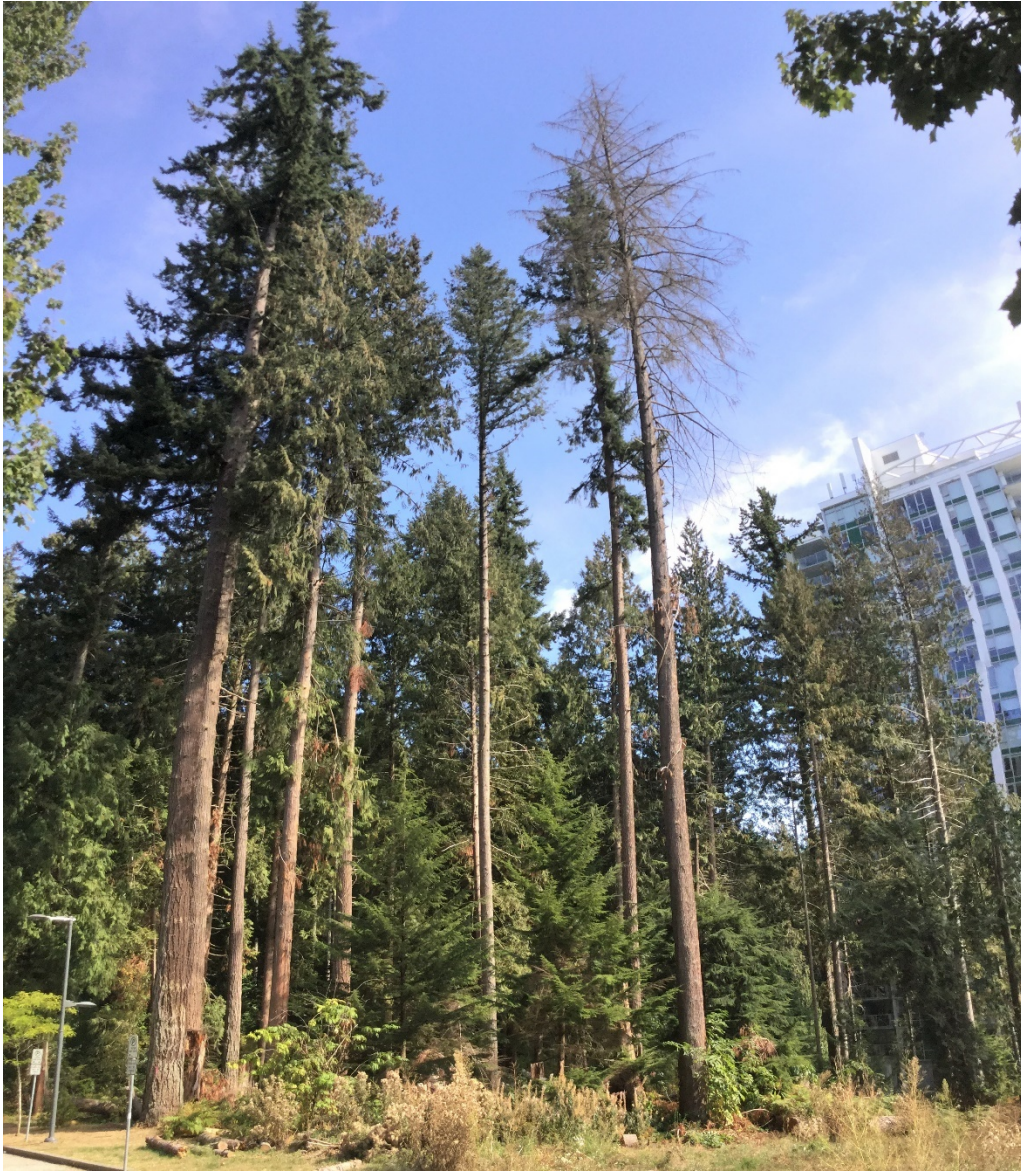
There were no trees on this site that posed a *high* or *extreme* risk to targets that were present at the time of assessment. One notably tall dead hemlock tree, number 3302 (Photo 1), appears to have died in the last two to three years and had evidence of recent woodpecker activity in the upper third of the main stem. Tree 3322 is also a dead hemlock that could impact parking bays on the west side of Binning Road. These trees are not currently assessed to be a high-risk but have the potential to impact off-site targets and we advise their removal within the next year, regardless of on-site development plans or progress.

Photo 1. Overview of the on-site stand from the west. Dead hemlock number 3302 is in the center of shot.

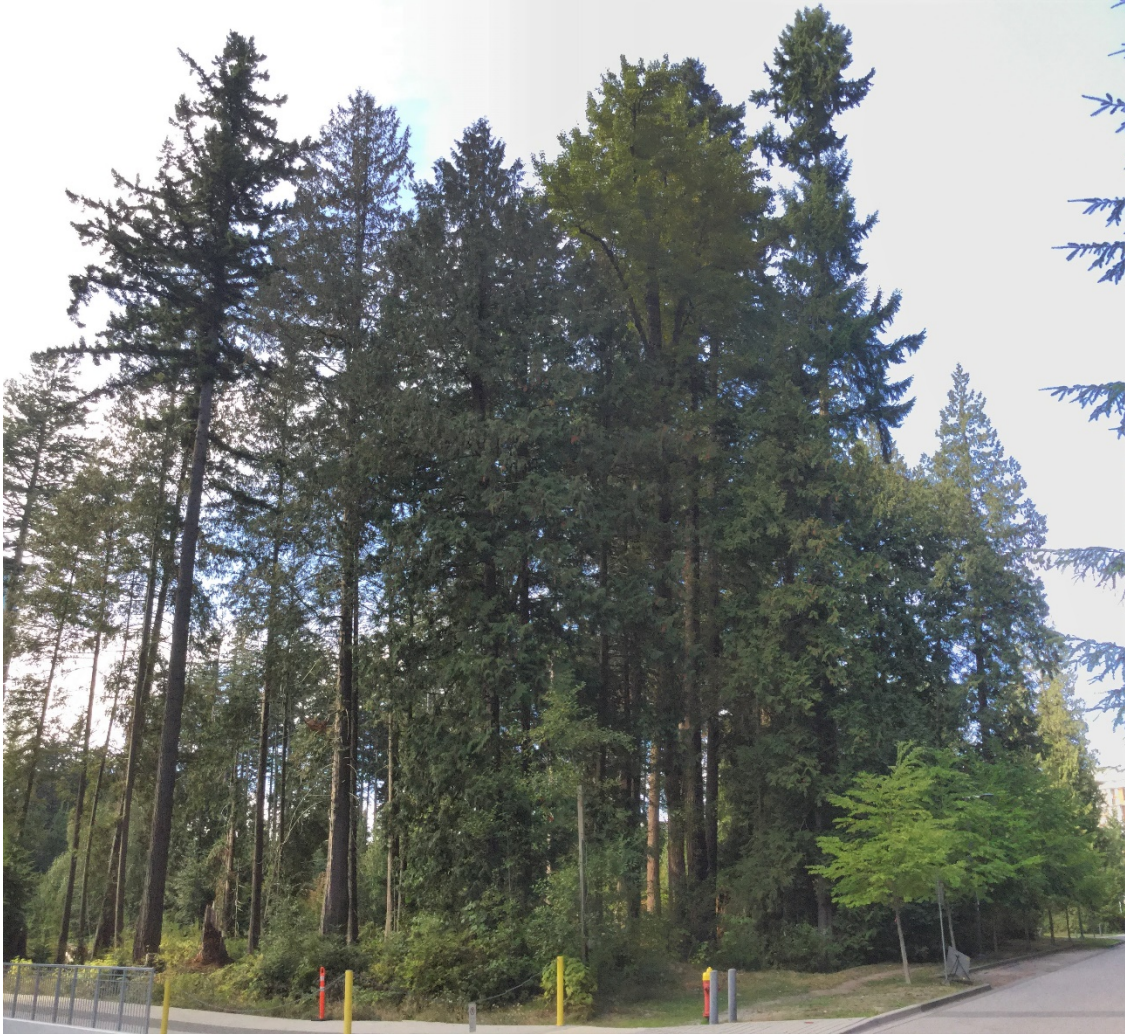
Photo 2. Overview of the on-site stand from the south east.

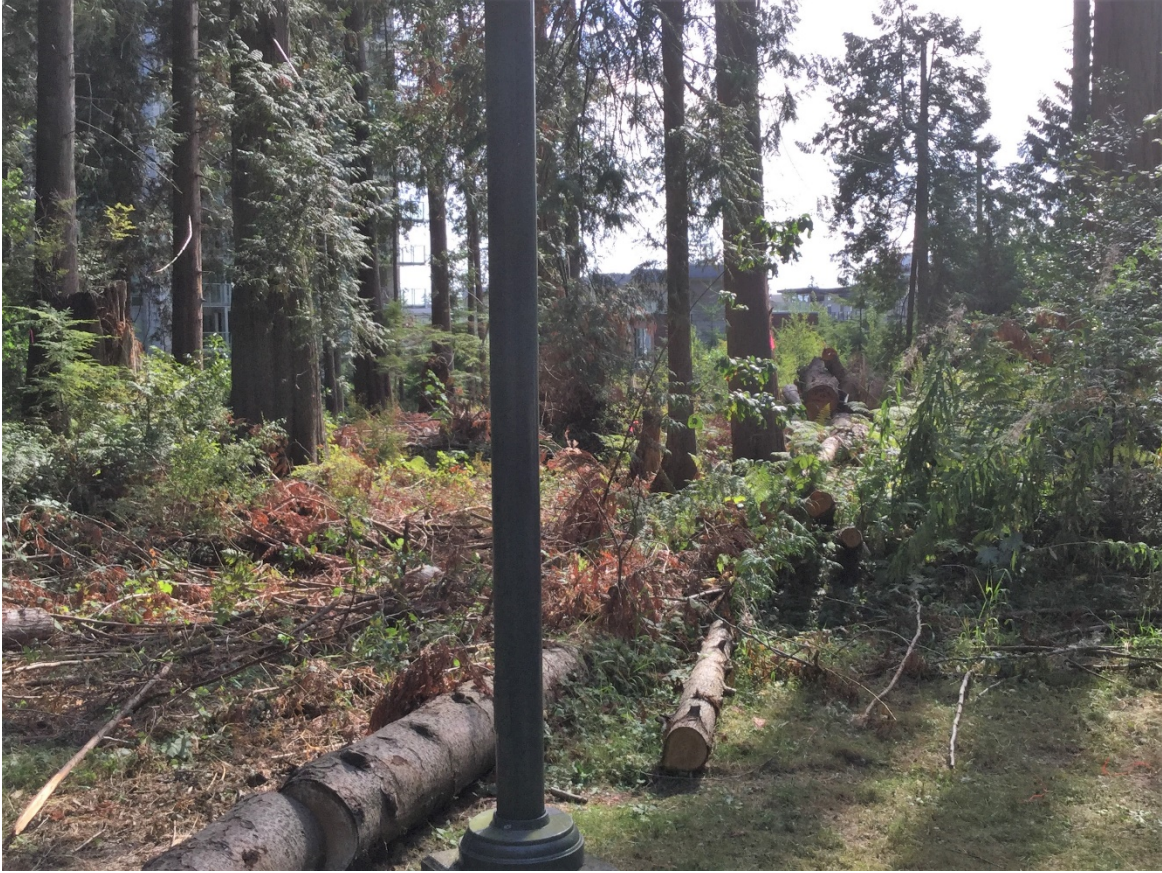
The on-site stand had been significantly impacted by windthrow failure of large trees. This had created a newly exposed edge on the west side and many of the exposed trees had poor trunk taper in this context. Several large dominant trees that had good trunk taper and crown development in context of their exposed situation remained at or outside the new stand edge (Photo 4).

Photo 3. Example of windthrow failure of a large tree in the on-site stand.

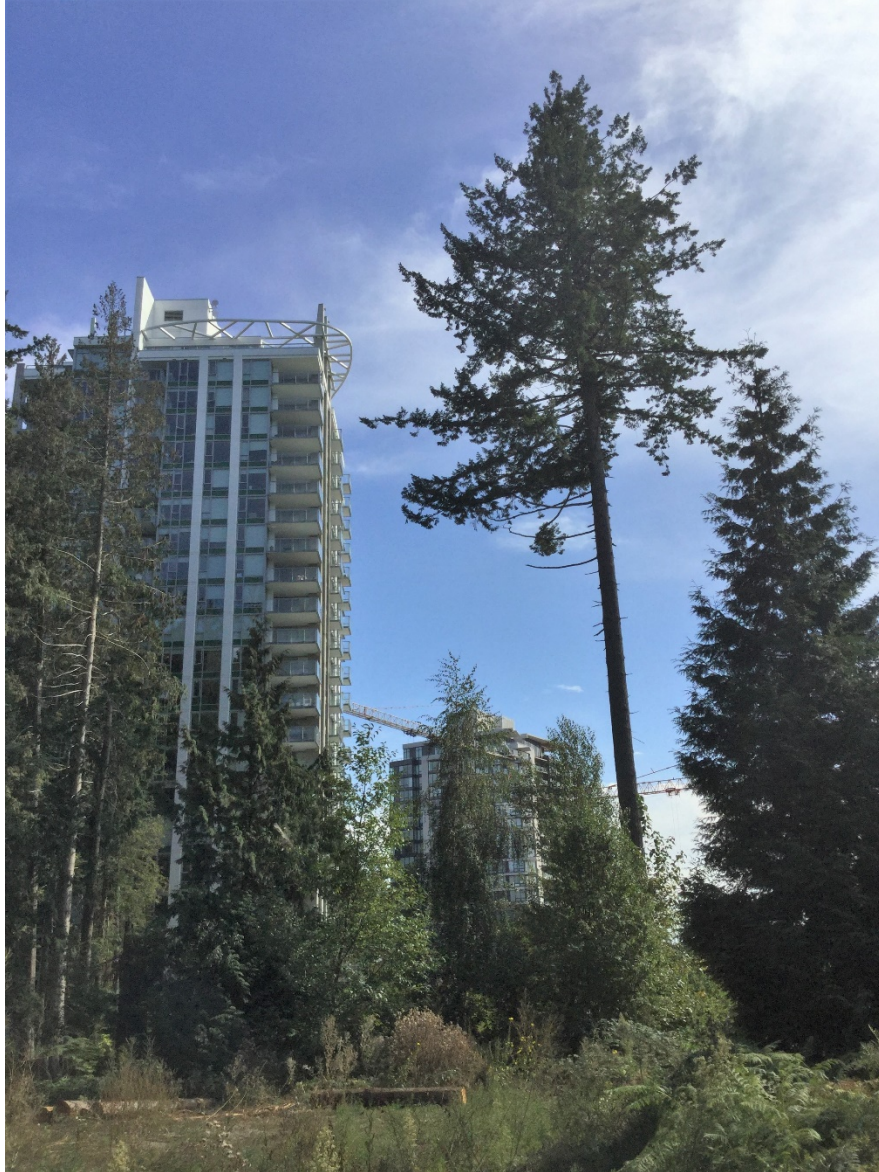
Photo 4 Tree 3288 exposed by windthrow and clearance that has good trunk taper and crown form in this open context.
