Arboricultural Inventory and Report

For:
UBCPT

Site Location:
TEF4
6190 Agronomy Road, UBC

Date: February 4, 2020

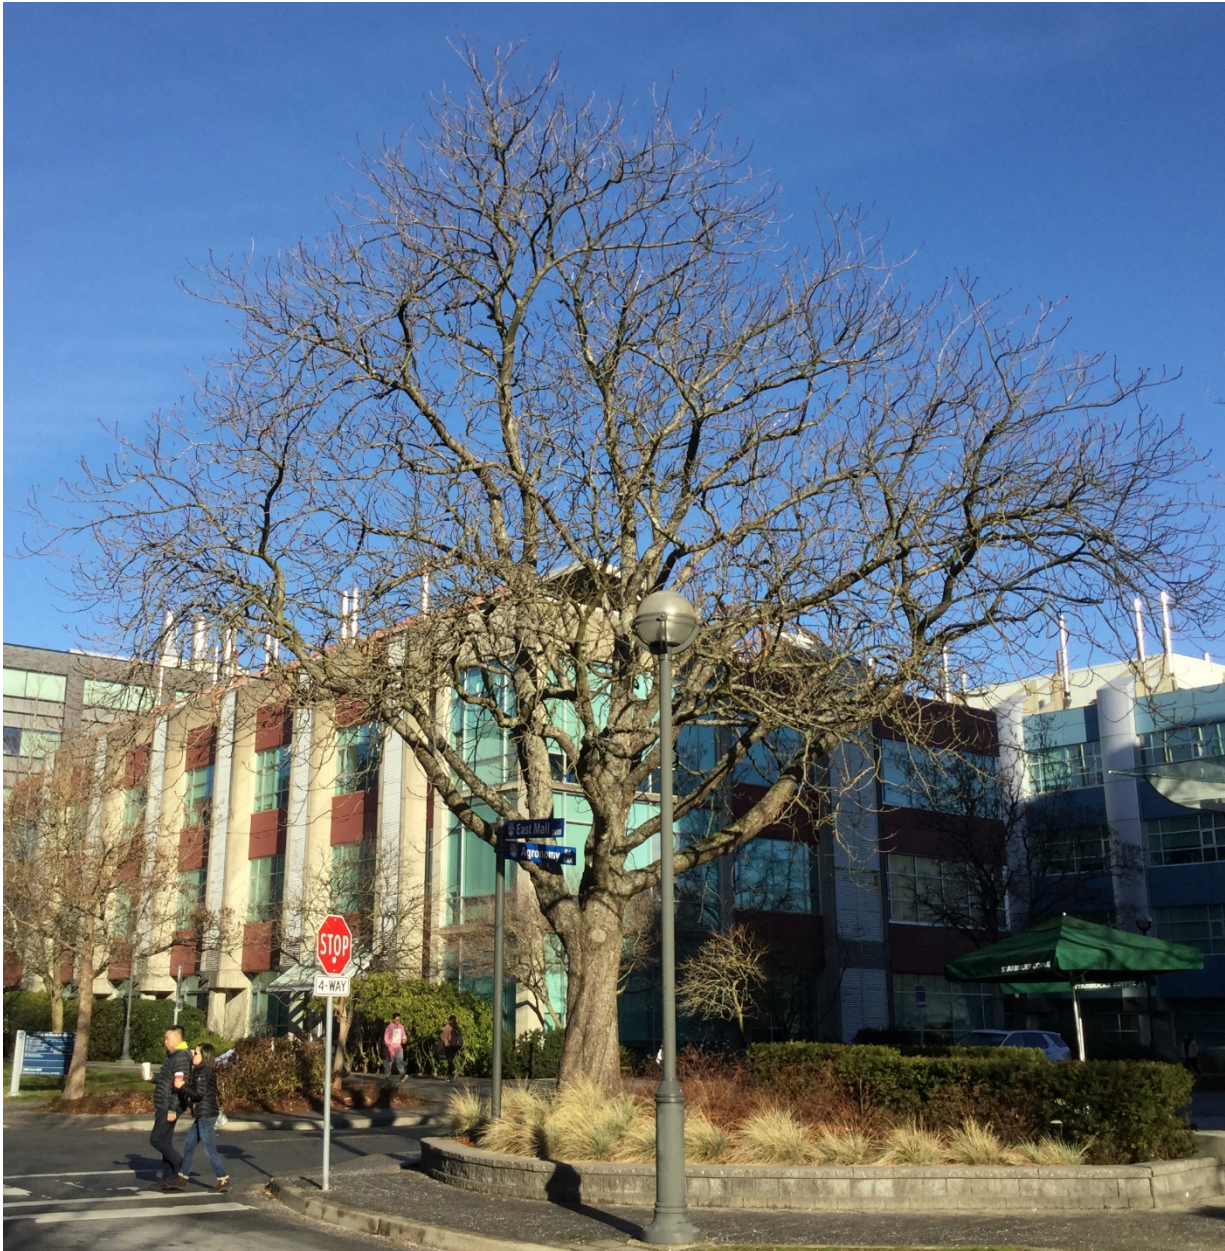
Photo 1. Overview of tree 3782.

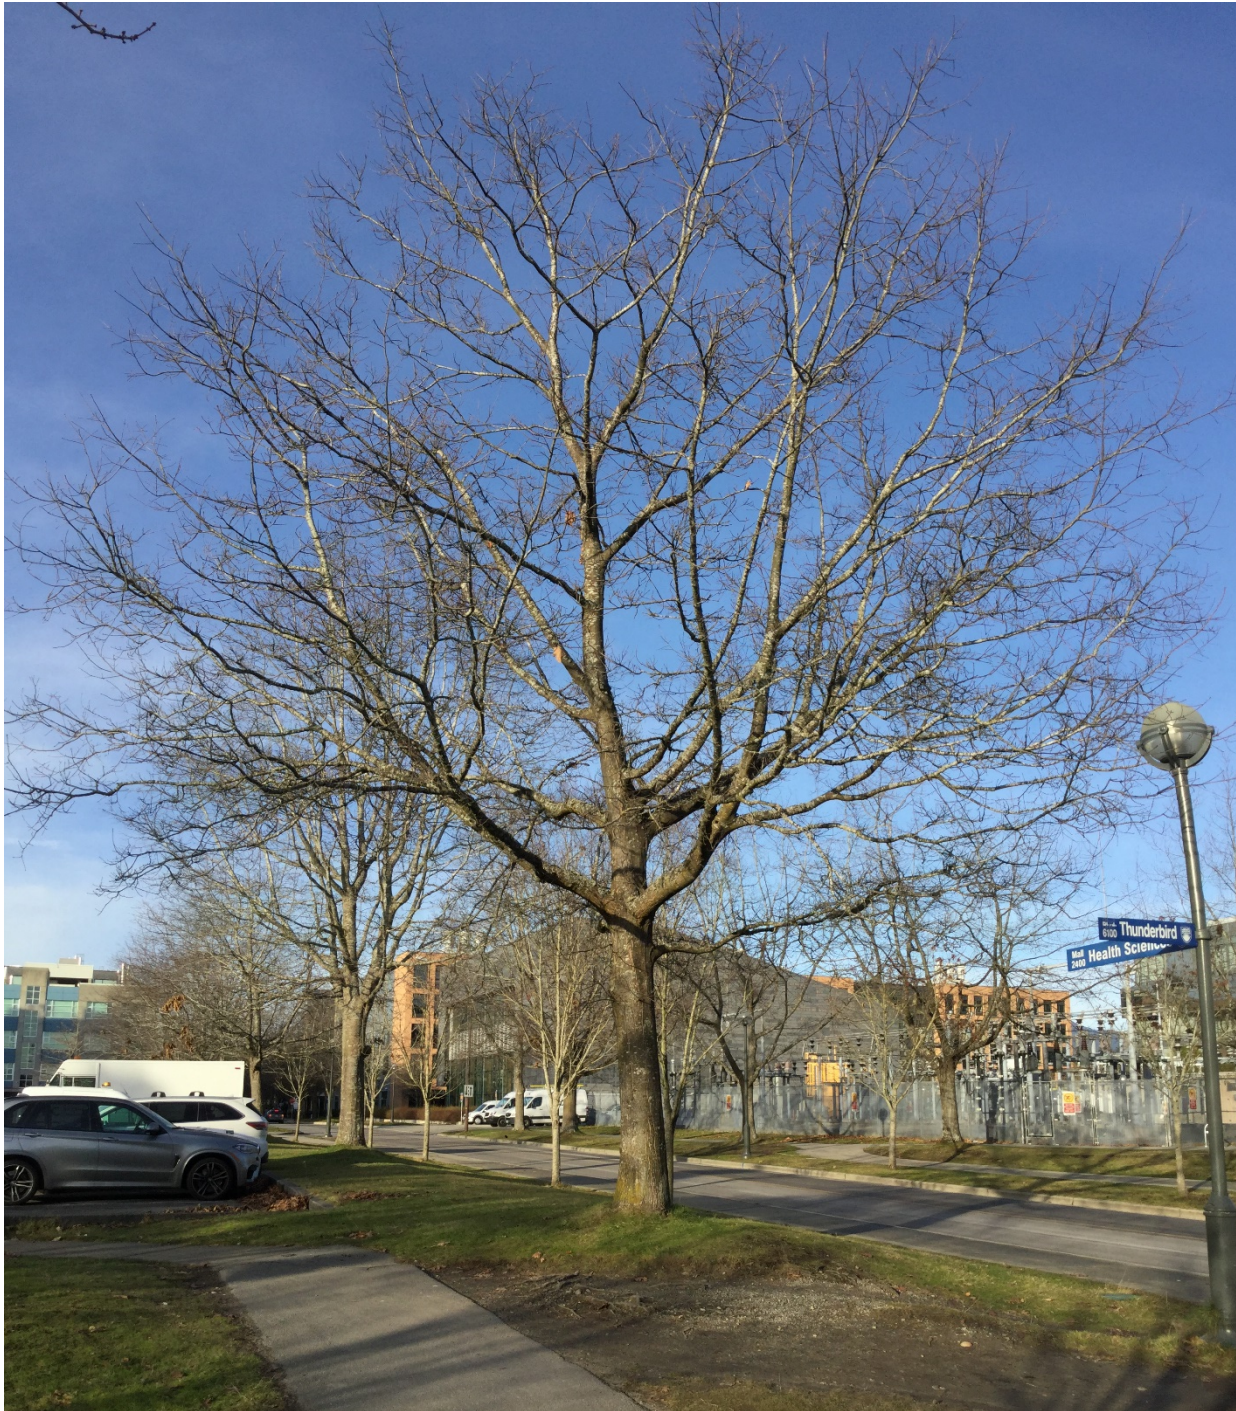
Photo 2. Overview of tree 3526.

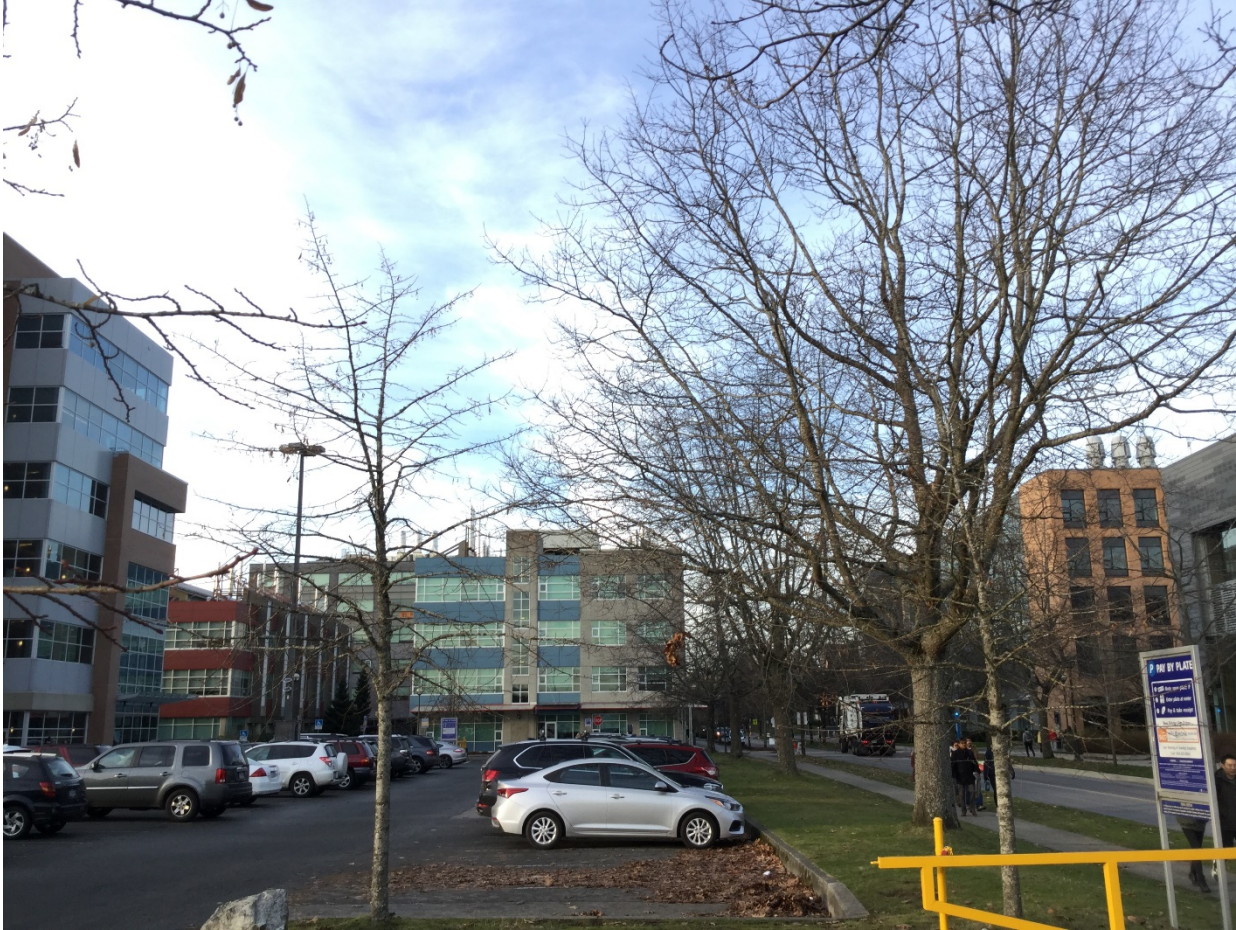
Photo 3. View looking north from the eastern parking lot entrance off Health Science Mall.
