Arboricultural Inventory and Report

MacLeod Building
UBC Point Grey Campus
2356 Main Mall
Musqueam Traditional Territory

Date: April 29, 2020

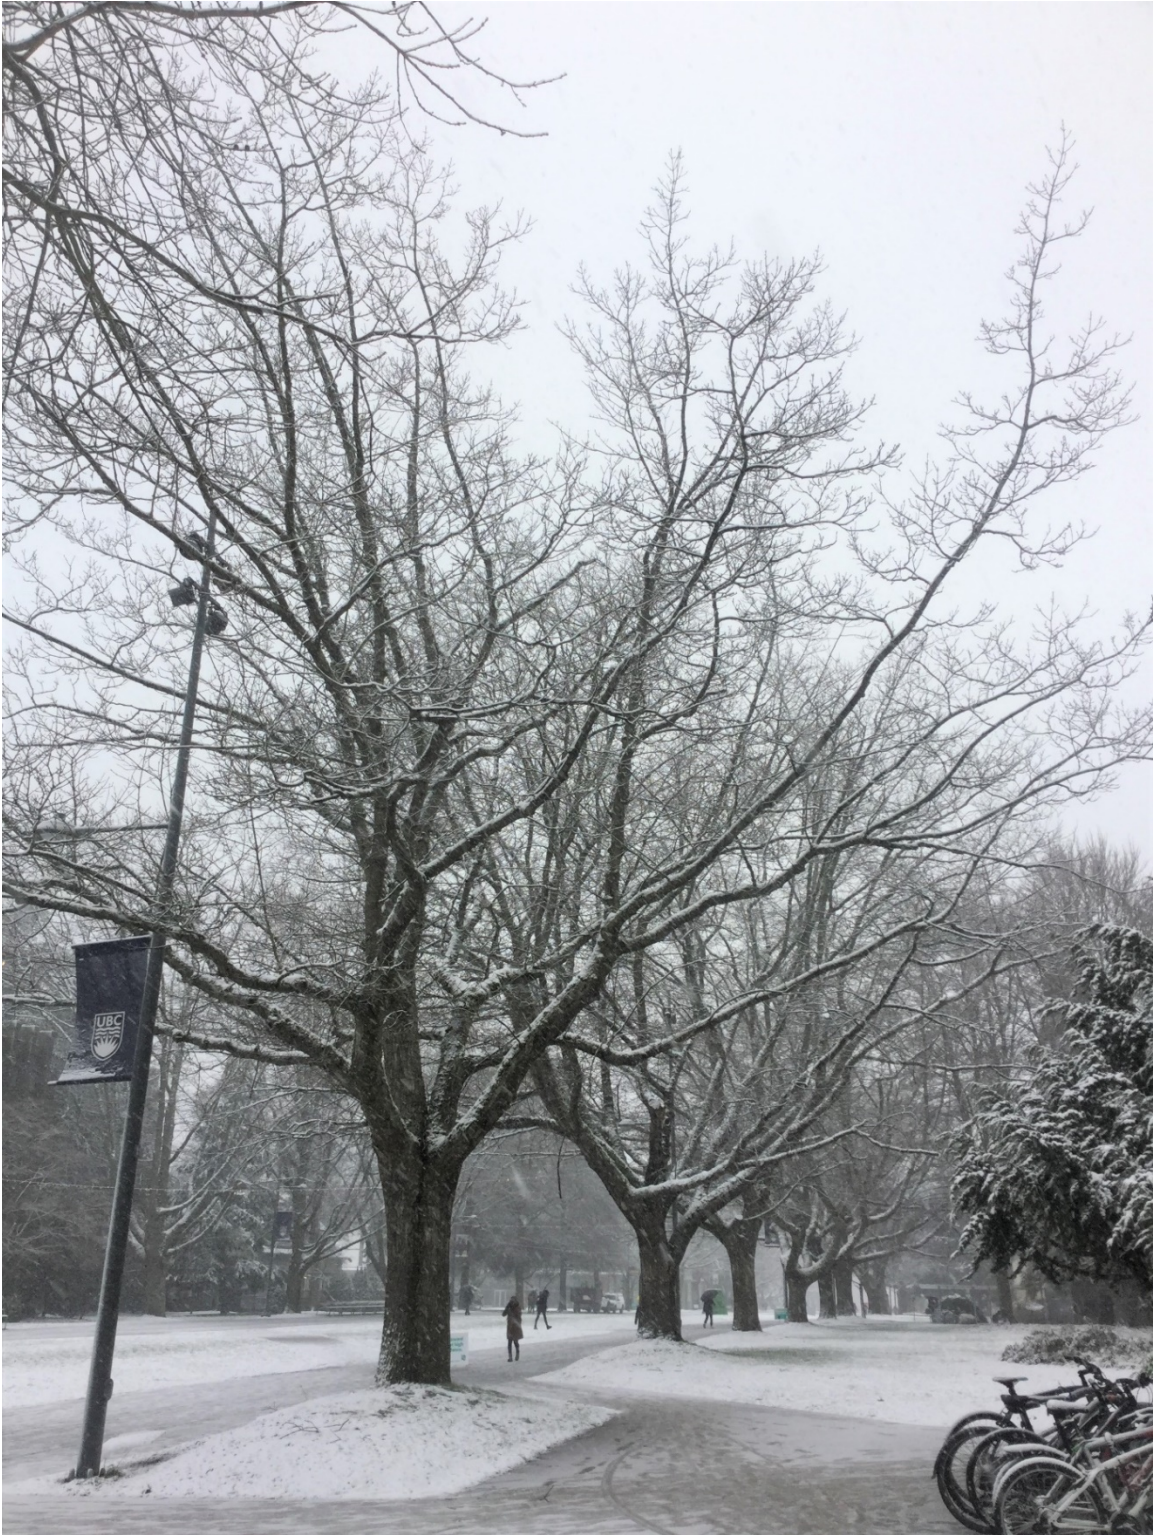
Most of the trees inventoried were in good or moderate condition and have been well maintained. The red oaks growing adjacent to the paved Main Mall walkway are likely to have been impacted by the upgrades to the walkway, but all appear to be in moderate or good condition. Regular monitoring and inspections of the trees are recommended due to the high use of the area by pedestrians and high value of the trees to the surrounding landscape.

Photo 1. View of the red oak trees on Main Mall, looking north. Tree #2757 is far left.

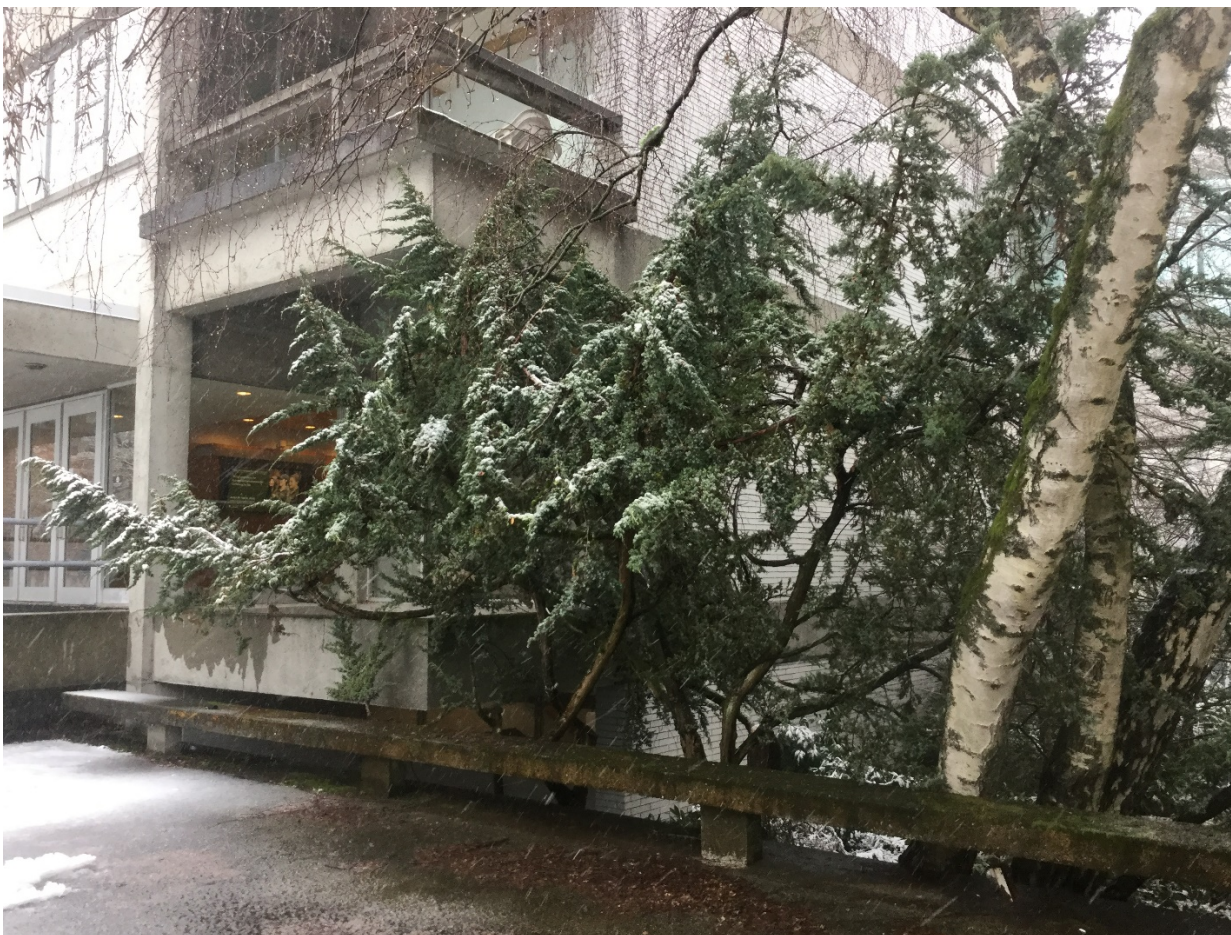
Photo 2. View, from left, of trees #2769, #2770 (junipers) and #2771 (birch), with the entrance to the MacLeod Building visible far left.

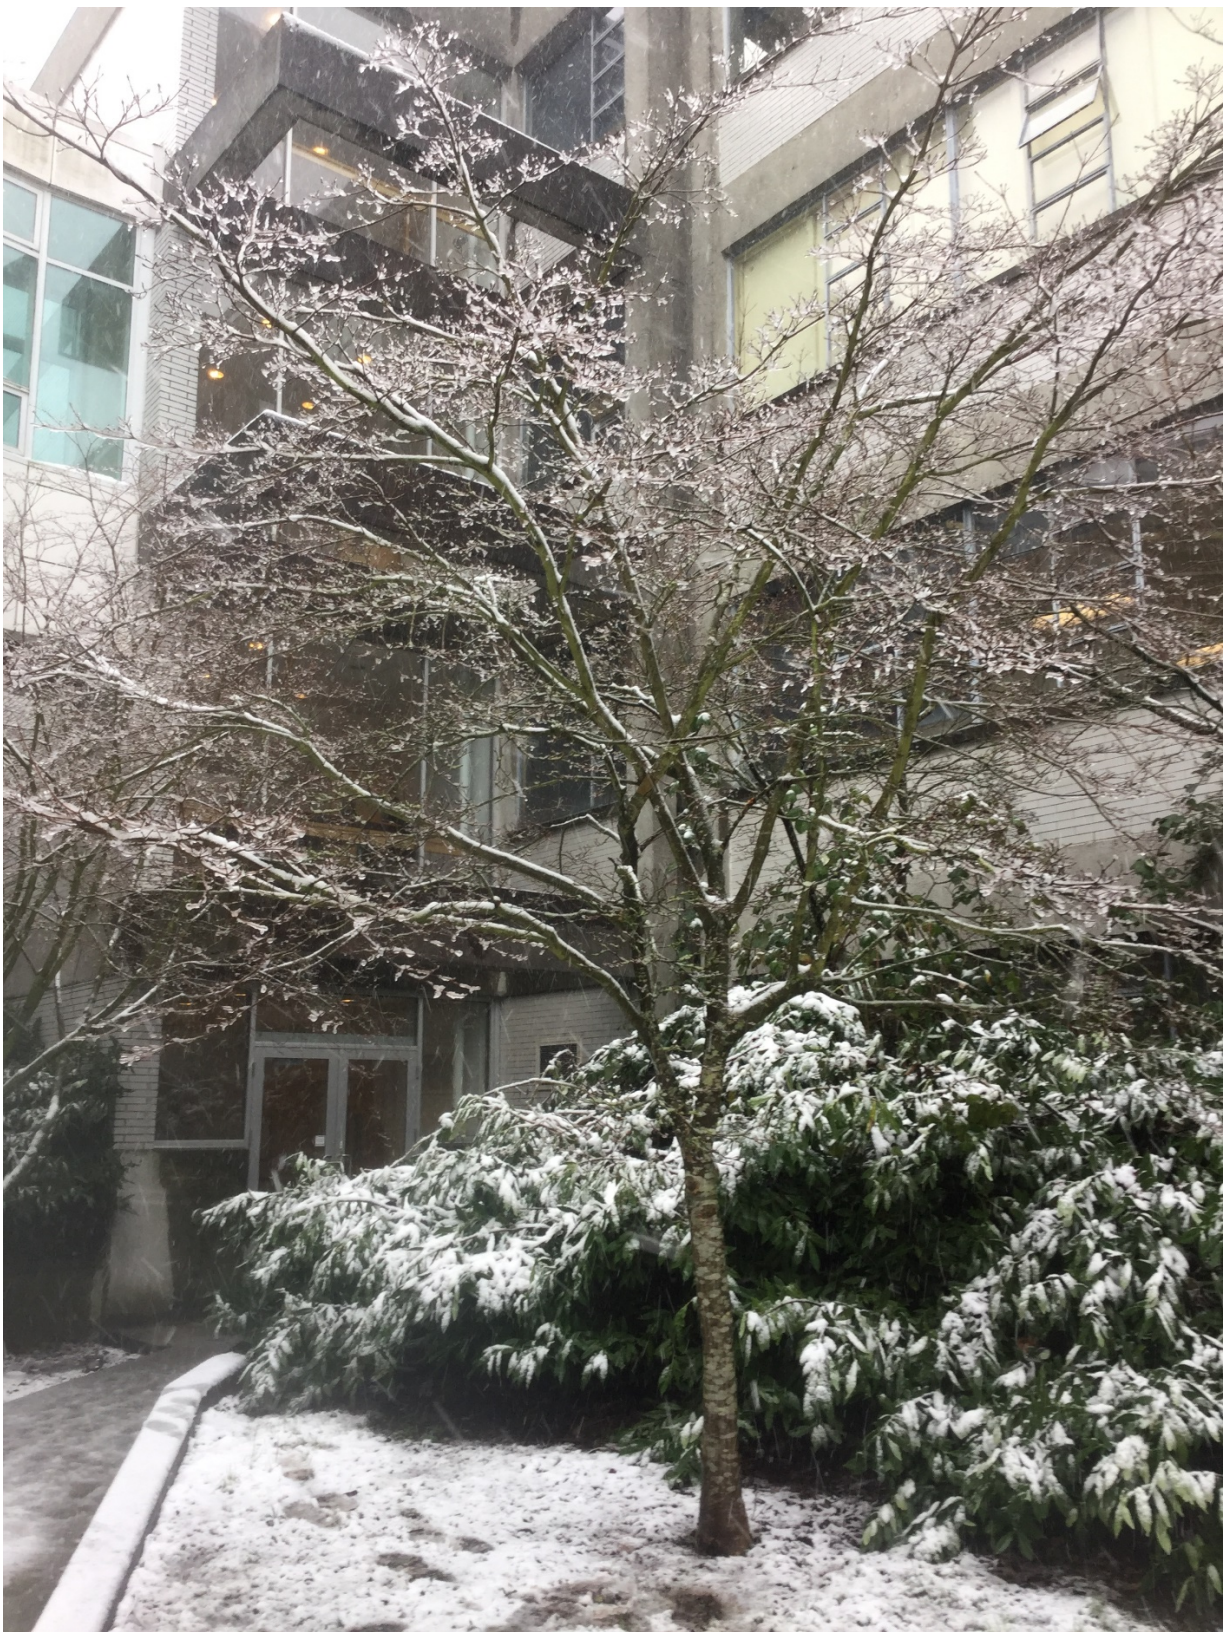
2780	Kousa Dogwood	Cornus kousa	12	5	40- 59%	2	Good	Growing in bed between buildings. 3m from building, 1m from concrete sidewalk to south.	Medium	Remove	In conflict with proposed work.

Photo 3. View of tree #2780, typical of the dogwoods growing to the south of the MacLeod Building, between it and the building to the south.

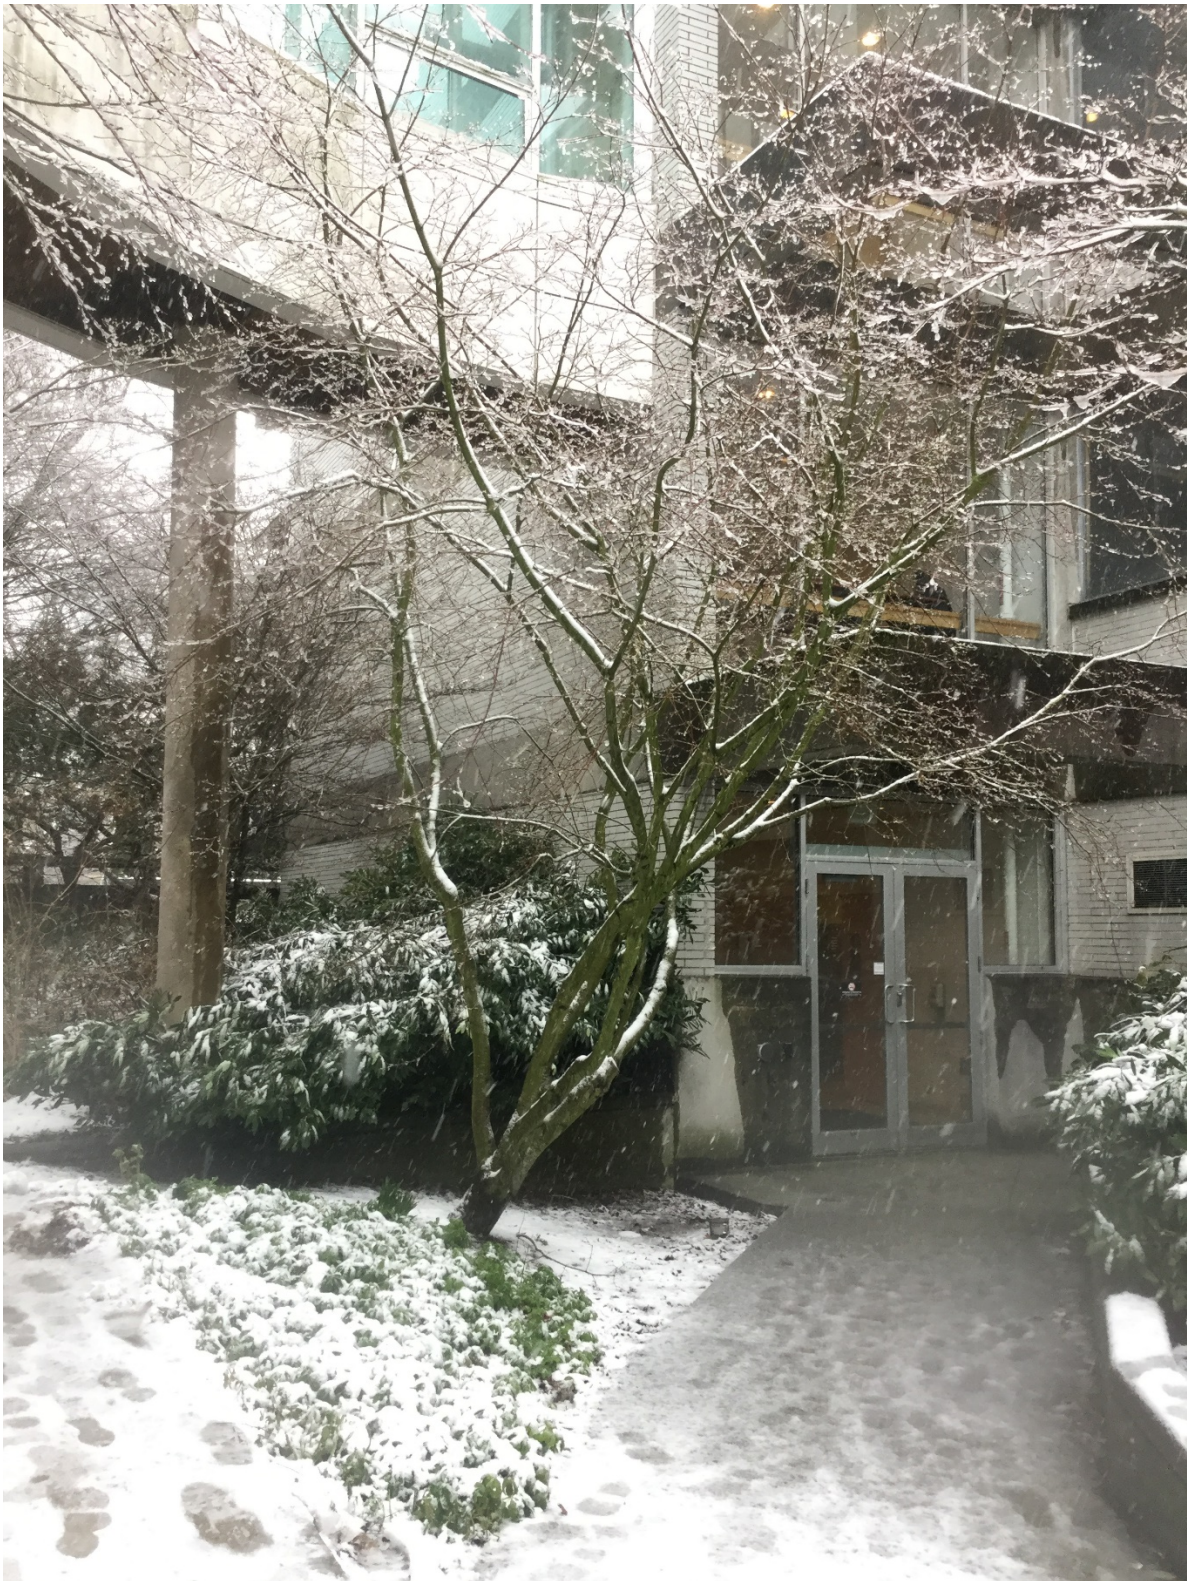
Photo 4. View of tree #2778, typical of the maples growing to the south of the MacLeod Building, between it and the building to the south. The south entrance to the MacLeod Building is visible behind.
