Tree Preservation Plan

Museum of Anthropology

6393 NW Marine Drive
Vancouver BC V6T 1Z2

University of British Columbia

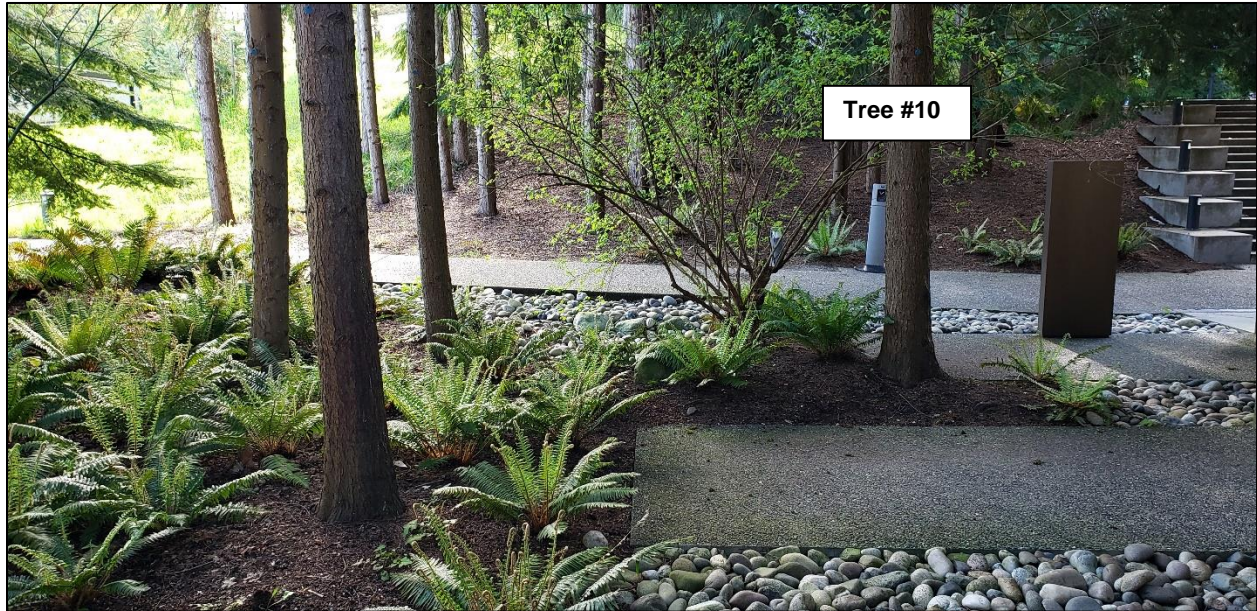
The seismic upgrade of the columns at the main entry of the building requires an excavation to facilitate access to the footings. Tree #10 is growing within this area and would not survive this level of root disturbance. It would not be reasonable to relocate the tree and it would be unlikely to survive if this were attempted. Therefore, the tree should be removed before excavations commence. A small shrub (#17) on the south side of the excavation would also need to be removed because of its close proximity to the excavation.

The bases of western hemlocks growing at the north side of the main entry. Tree #10 should be removed before the construction work commences due to unresolvable conflict with the excavation.

The remaining trees on either side of the front entrance should be enclosed with protective fencing for the duration of the construction activity. Fencing should be placed at the edge of the existing concrete so as to maximize the potential root zone protected. It is possible that roots from some of these trees will be damaged during the excavation. However, the presence of existing concrete surfaces makes it difficult to predict how extensive this might be. Supervision by the project arborist during the excavation will help determine how much of an impact (if any) the work has had on the trees being retained.

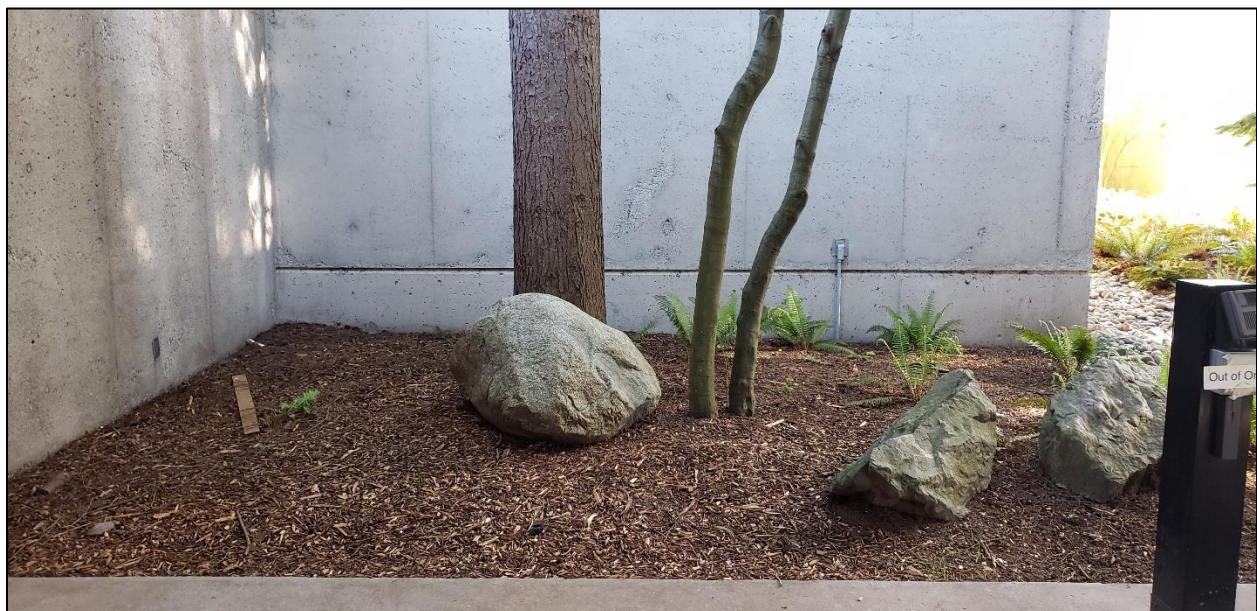
The base of trees #11 and #12 positioned at the north side of the main entry. Given the already limited soil volume around these trees, it is imperative that their root zones are well protected.

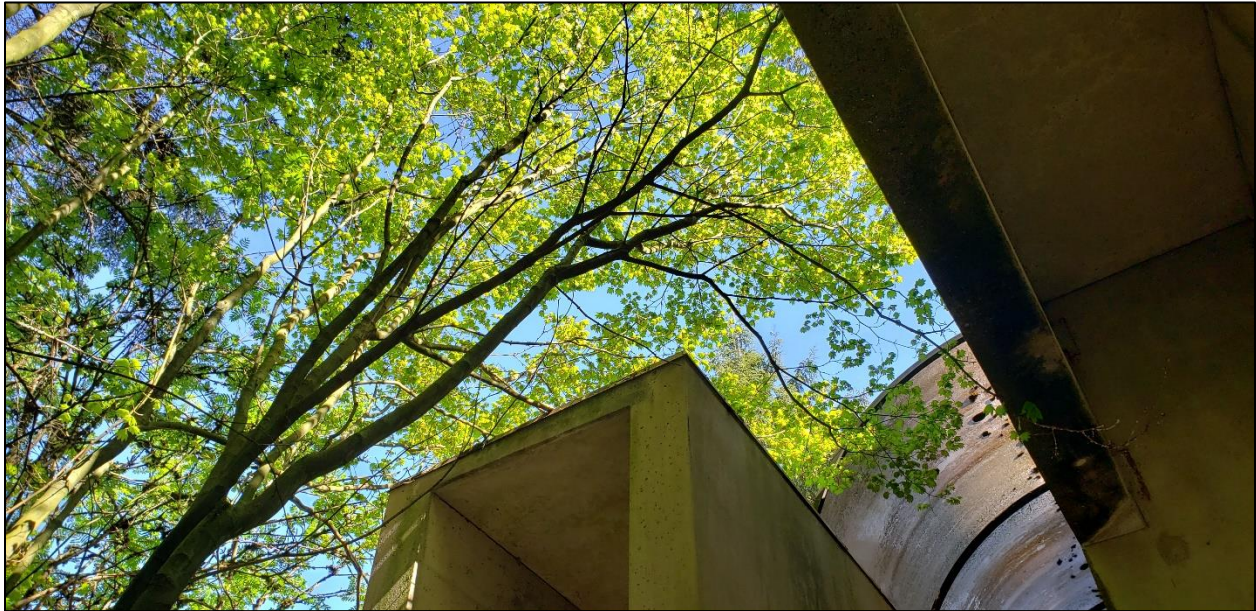
Trees overhanging the building should be sympathetically pruned back prior to work on the façade commencing. This should be carried out by a certified arborist under the direction of the project arborist.

The trees around the perimeter of the building may be impacted by the envelope restoration work. Any clearance pruning should be carried out by Certified Arborists, under strict specifications provided by the project arborist before the restoration work commences. The extent of root zone protection will depend to a large degree on the construction methods and equipment being employed. Our main concern is the need to protect the soil from compaction which can occur with repeated foot or equipment traffic. Linear protective fencing should be installed between the trees and the building where possible. Where work or access routes come into conflict with tree root zones, the project arborist will brief the work crews and monitor the levels of traffic. Decompaction of the soil may be required once the construction activity in each area has been completed.

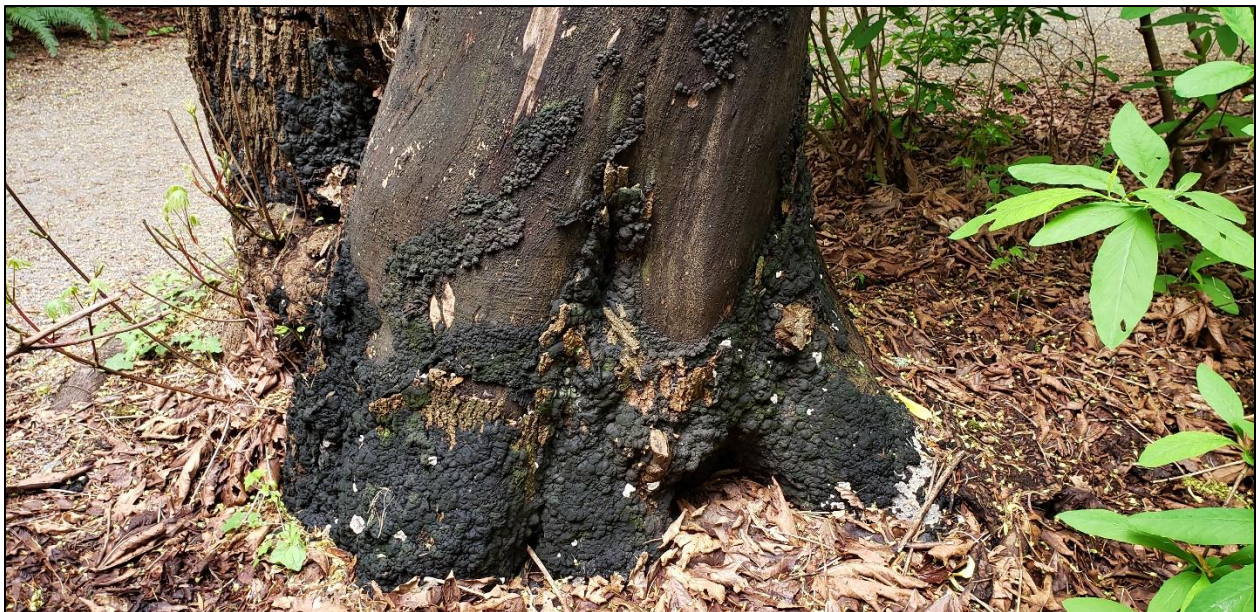
48	Western Hemlock (<i>Tsuga heterophylla</i>)	18,10	9	2	3	3	3	1	L	Severe canopy die back and potentially unstable. Remove before construction commences.
49	Big Leaf Maple (<i>Acer macrophyllum</i>)	90	28	5	8	6	5	1	L	Kretzschmaria deusta fungal decay pathogen present. Uneven canopy from loss of stems. Remove the majority of the tree leaving a 10 metre tall wildlife stem, before construction commences.
50	Western Hemlock (<i>Tsuga heterophylla</i>)	25	16	3	4	4	3	5	H	Close to gravel path. Protect as part of the woodland group.
51	Western Hemlock (<i>Tsuga heterophylla</i>)	26	18	5	3	4	4	5	H	Close to wooden retaining wall. Deadwood in the lower canopy. Protect as part of the woodland group.

The base of tree #49 showing fungal decay pathogen *Kretzschmaria deusta*. Trees with identified hazards should be considered for removal prior to construction staff occupying the site.

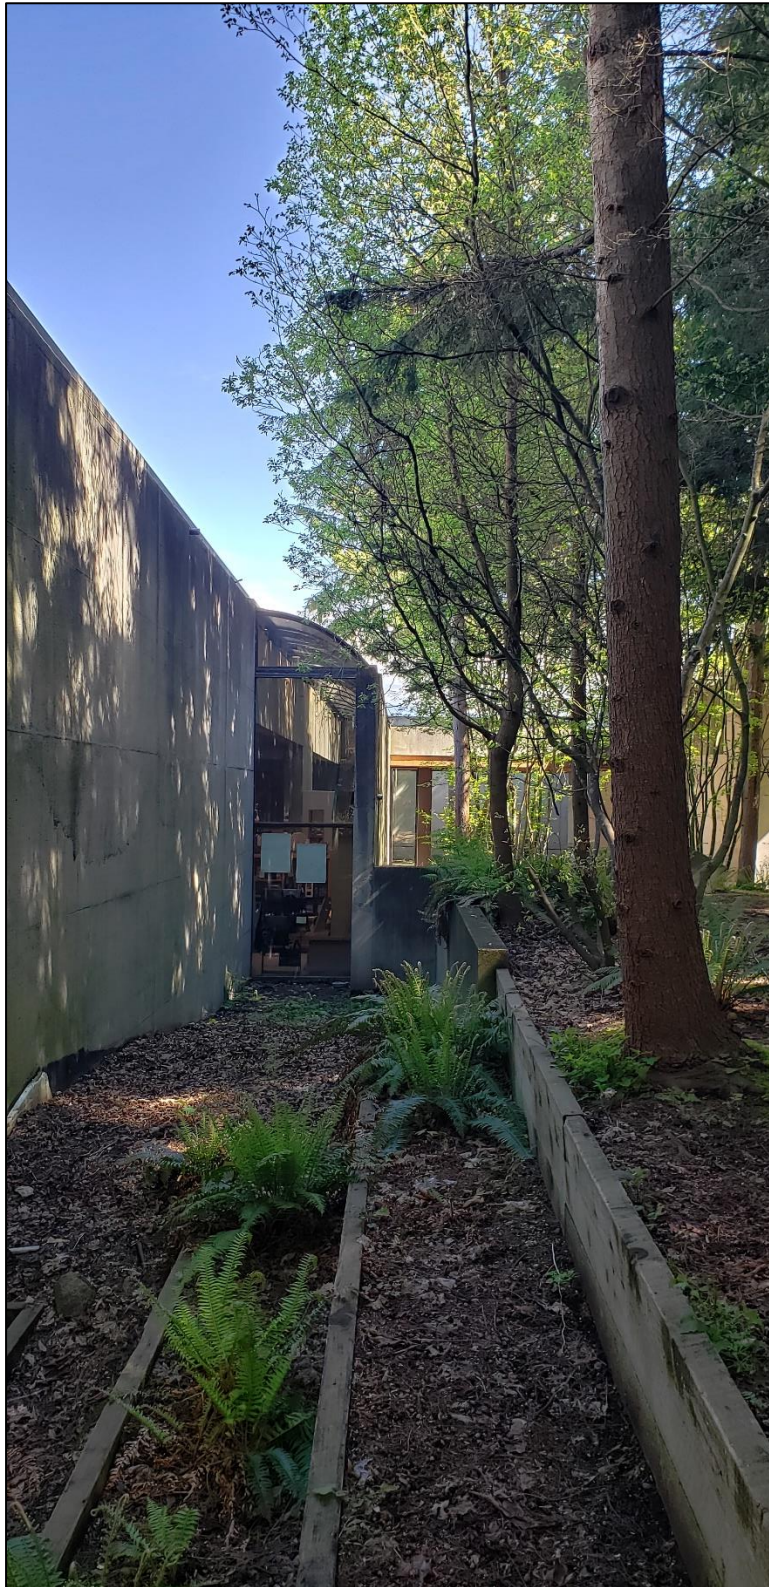
Trees along the east side of the building will require root zone protection during the façade cleaning.

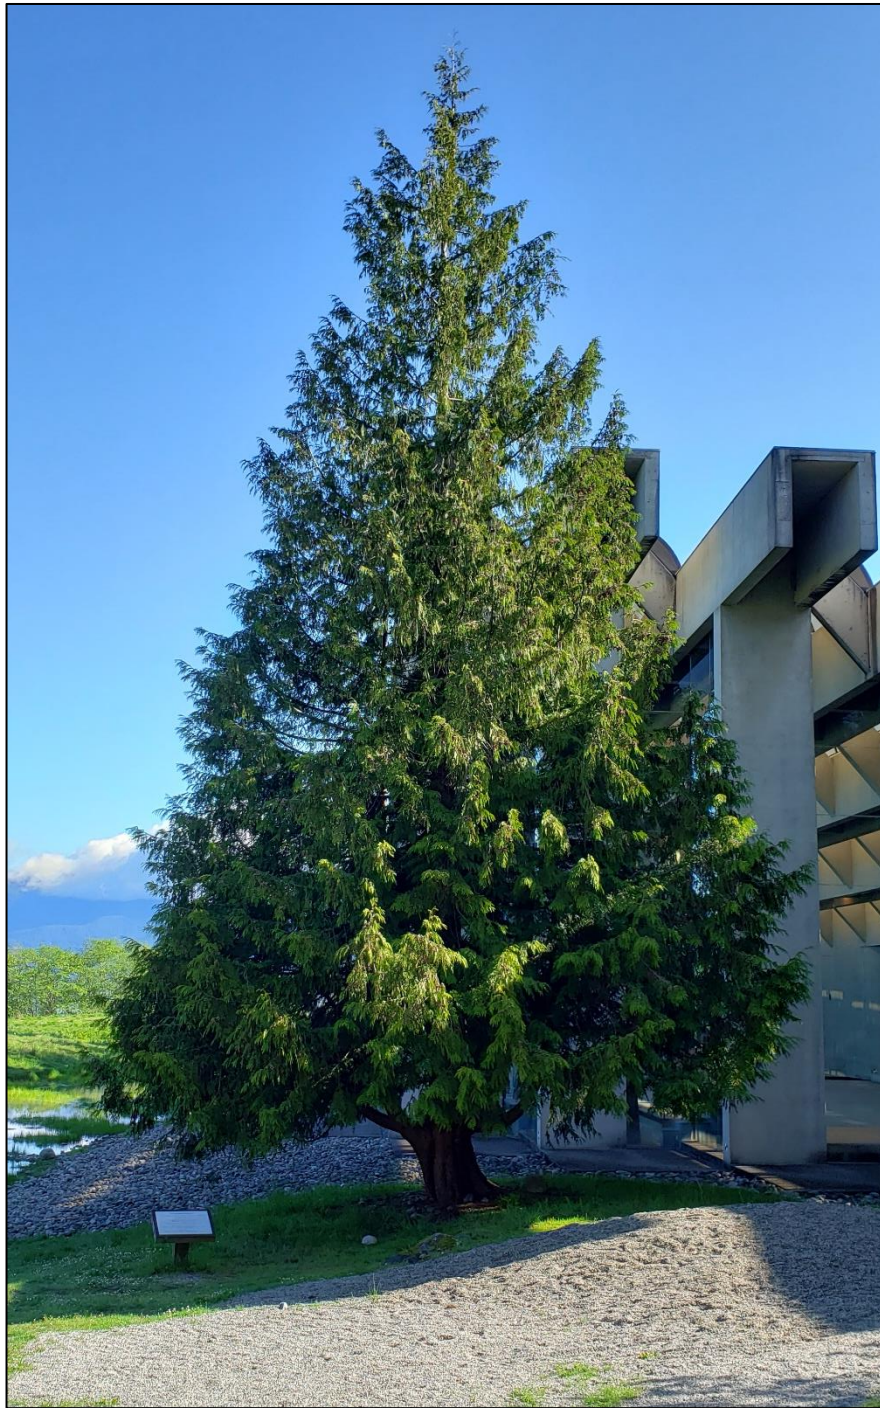
The western red cedar #96 to the south west of the great hall sits very close to the area being excavated for the pouring of a large concrete slab. The base of the tree sits very close to the line of excavation and the loss of roots would make the trees survival

impossible. Given the relative open access and lack of obstacles for the arborists removing the tree, it should be possible to preserve some of the larger diameter wood in useable lengths for local craft persons. Similarly, it should be possible for an excavator to extract the stump from the ground in one piece and deposit it elsewhere on site for use as a nurse stump. The tree has performed well on the site and has no doubt extended its roots into the moist soil conditions around the pond. This bodes well for the replacement of the tree with a similar native, moisture loving species such as western red cedar.

Western red cedar tree #96 is too close to the excavation and installation of the concrete slab to survive. It should be removed before construction work commences and where possible, the resulting wood used by local craft persons.

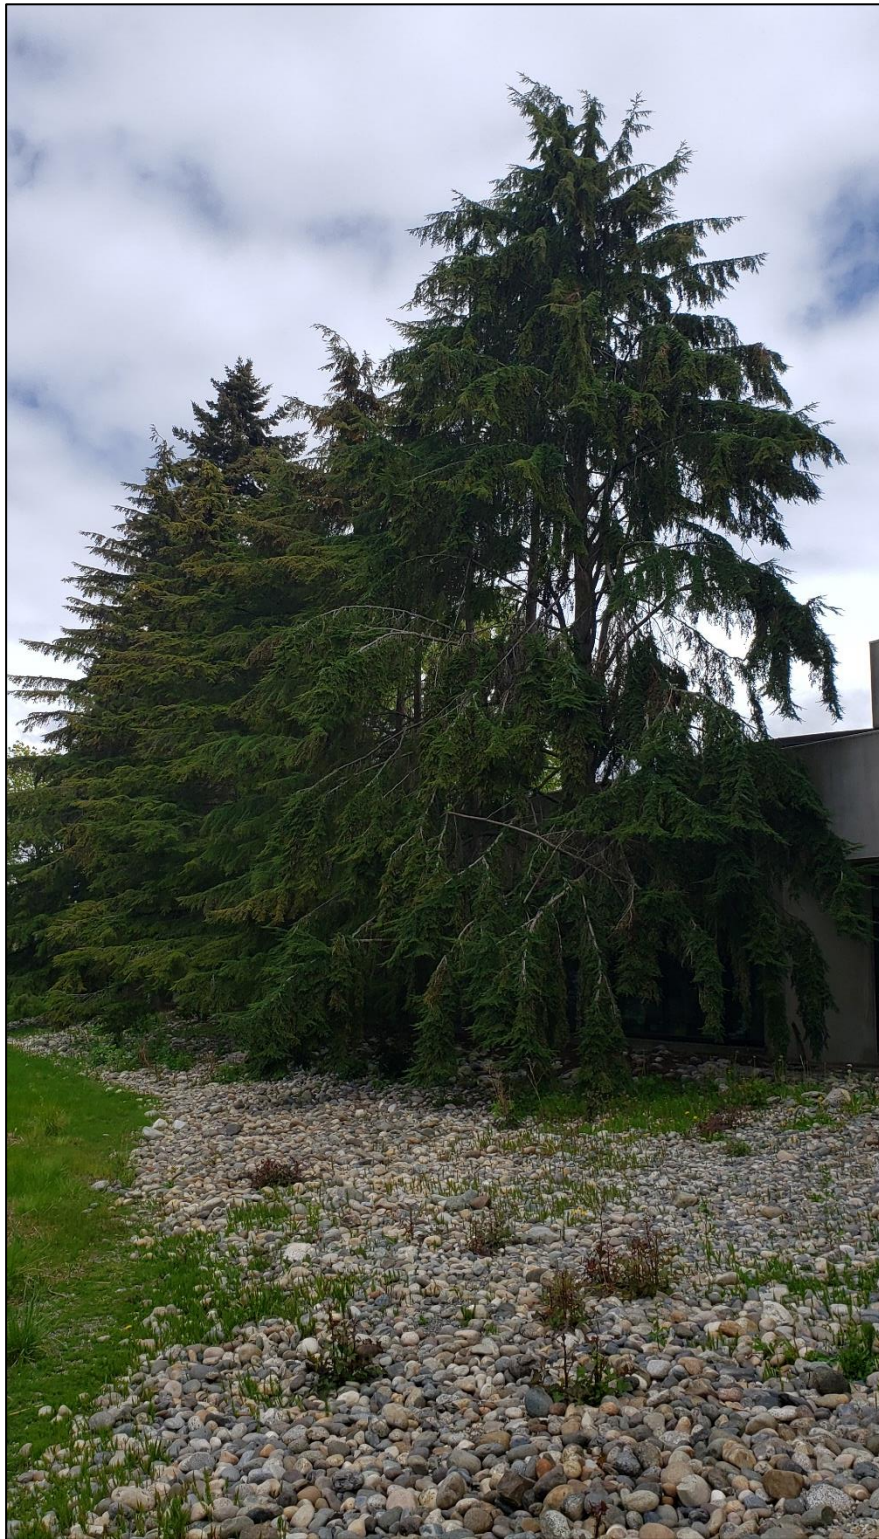
The western hemlocks along the western façade were planted to provide shade to the exhibits on that side of the building. Some trees have been lost over time and gaps in the line have appeared. Some of the remaining trees show signs of decline potentially due to a combination of heavy pruning and poor soil conditions. An excavation at the southern end of the line of trees will mean the removal of tree #97. It may also cause non-survivable damage to the roots of tree #98 although this may not be confirmed until the excavation is carried out and the extent of any root damage is known. Given the loss of trees in this location and the general decline of those remaining, replacement planting should be planned. Native conifers such as western red cedar and Douglas fir should be considered with stock size being limited to specimens that can be reasonably installed by hand, without causing damage to the root zones of the other trees. A mix of species planted in a non-linear pattern may help to diversify the group and promote the longevity of the feature.

The western hemlocks along the west façade should be protected following the removal of trees impacted by the required excavation towards the southern end of the row. Replacement planting using native conifers will help to ensure the longevity of this important group.

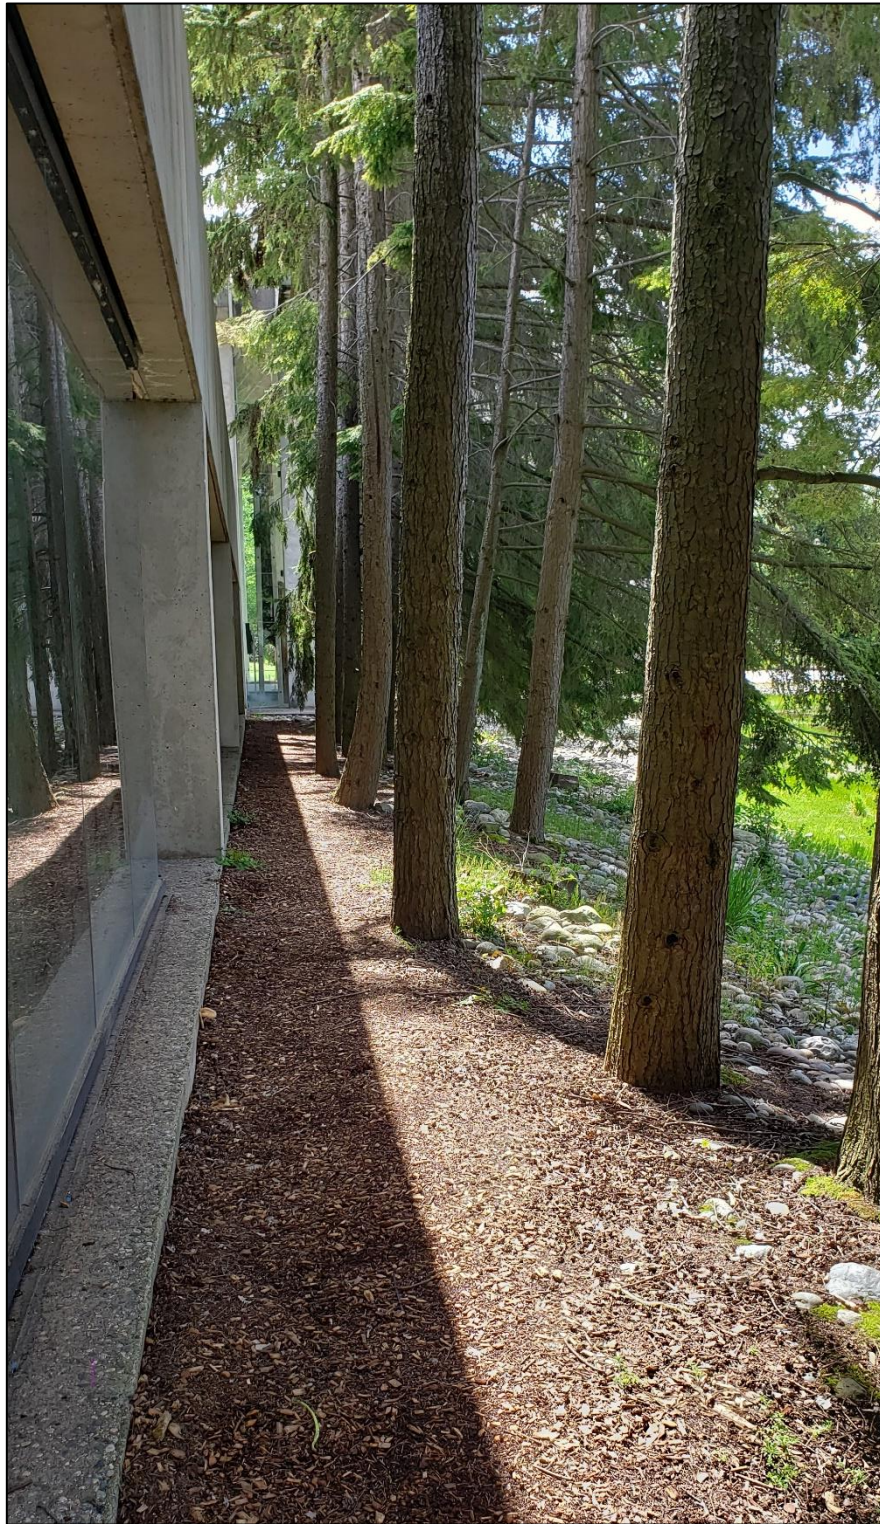
The ground between the western hemlocks and the western façade is used by security personnel and may be prone to compaction. Aerating this soil and providing an alternative walking route will help to improve the long term health of these trees.
