Arboricultural Inventory and Report

UBC Properties Trust

BCR Lot 9

Wesbrook Mall and Gray Avenue, UBC

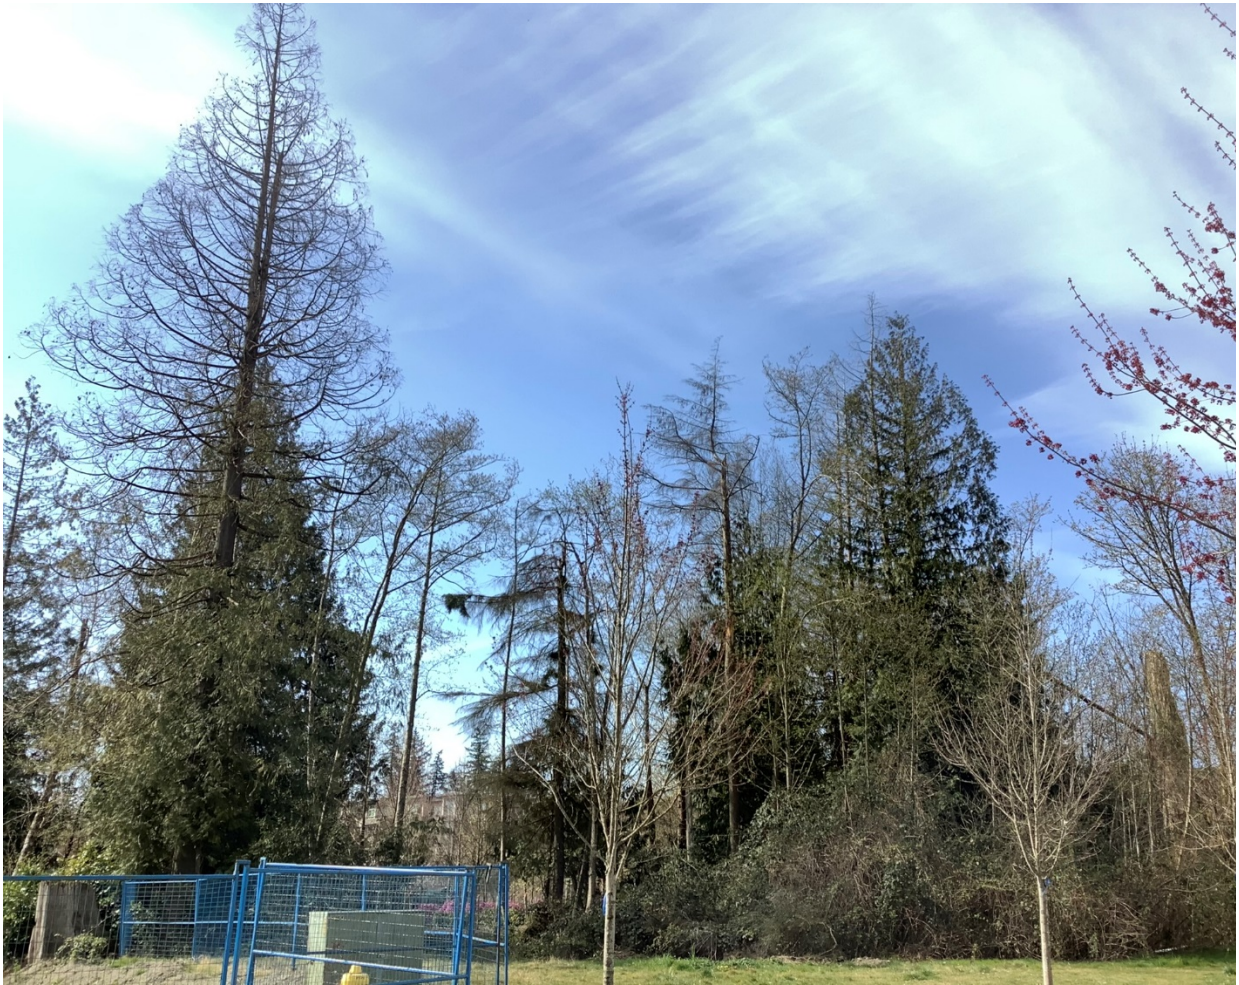
Photo 1. View looking southwest towards the site from Gray Avenue. Tree #341 is the large dead tree in the far left, with the row of boulevard trees in the foreground and the stand in the background.

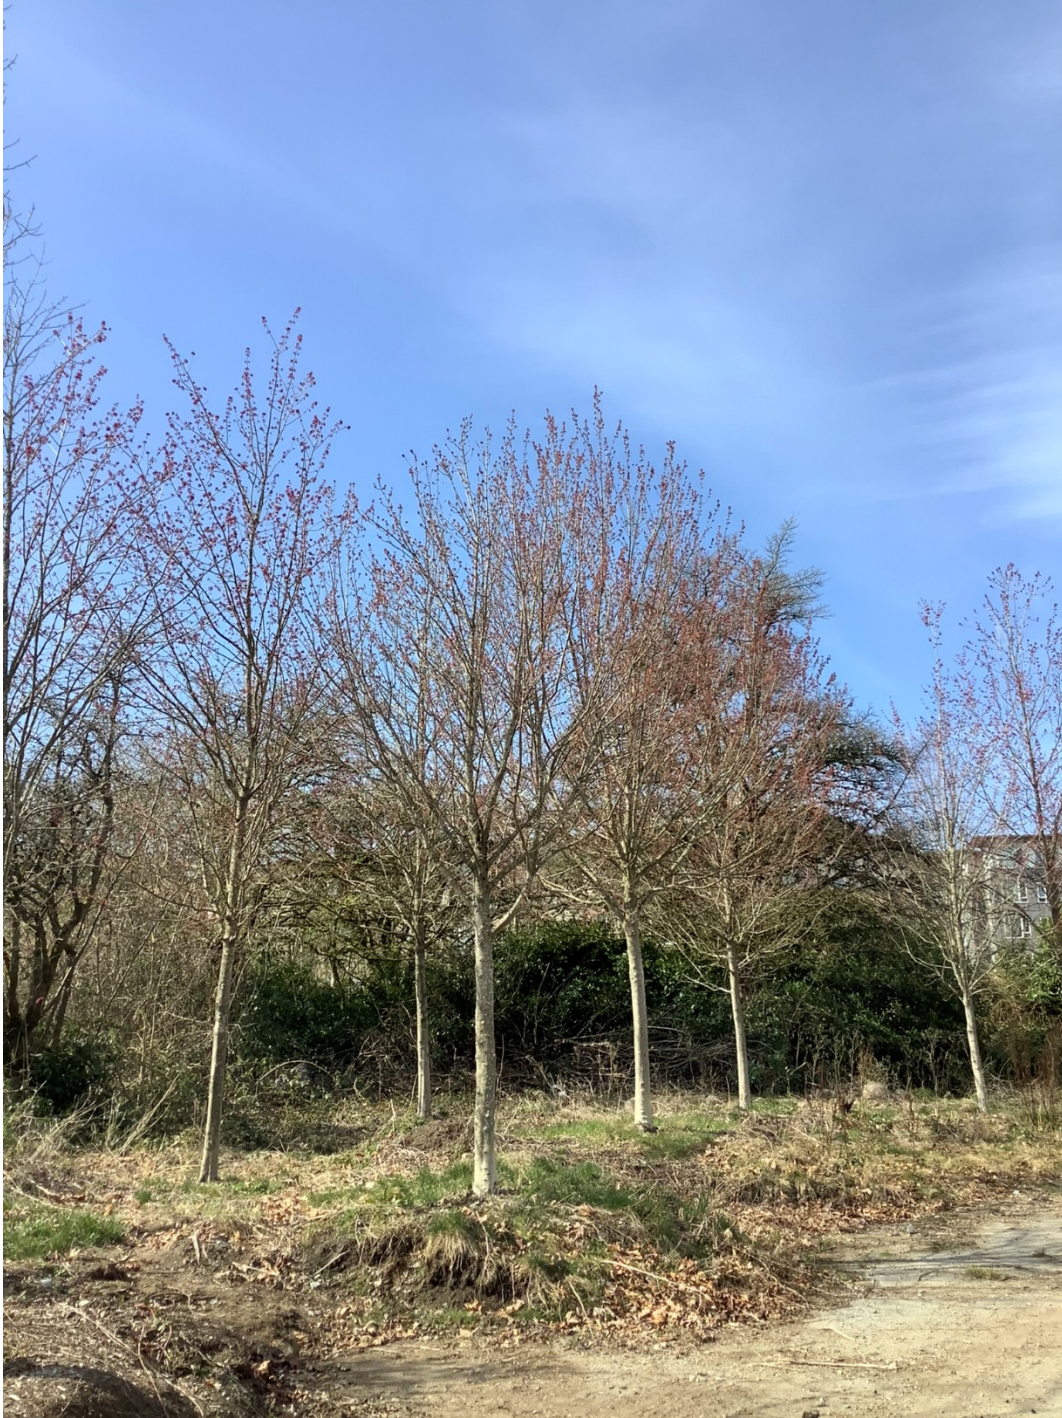
Photo 2. Showing Group-1, of red maples. These trees have since been transplanted off-site. These trees were typical of the nursery stock that was found throughout the subject site.
