Project #: 322

Site Address: 5920 Iona Drive, Vancouver B.C.

Date: February 11, 2022

GOODE  
ARBORICULTURE CONSULTING  
*Tree Preservation Report*

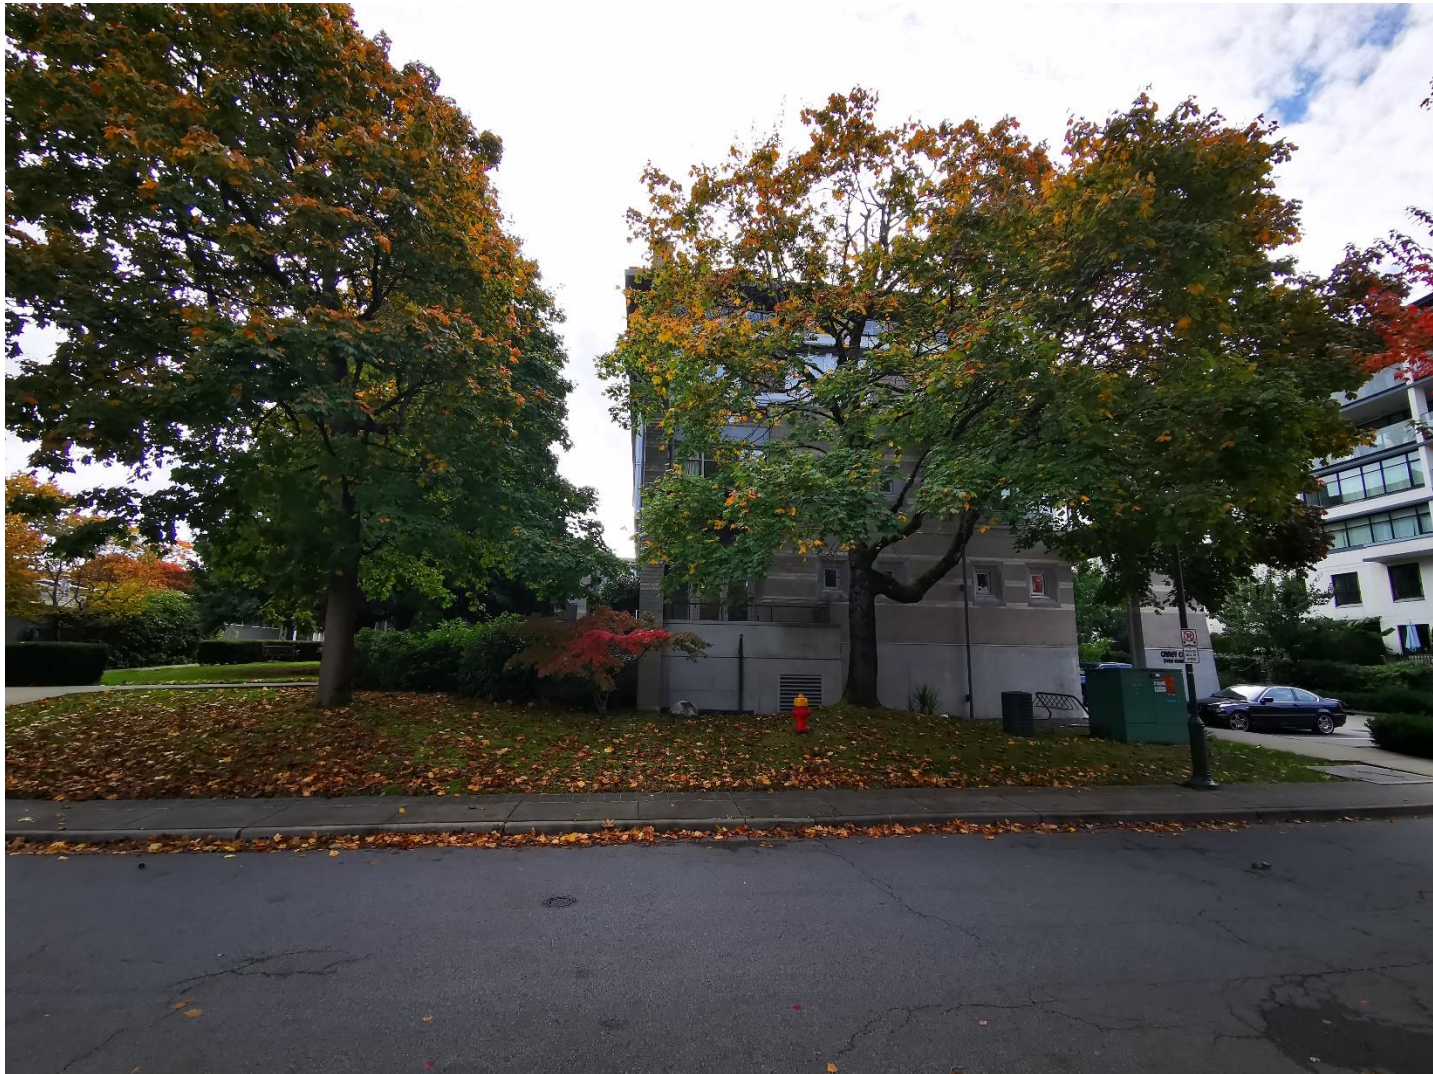
*Image 2 – Trees #2523-2524 located along Iona Drive.*

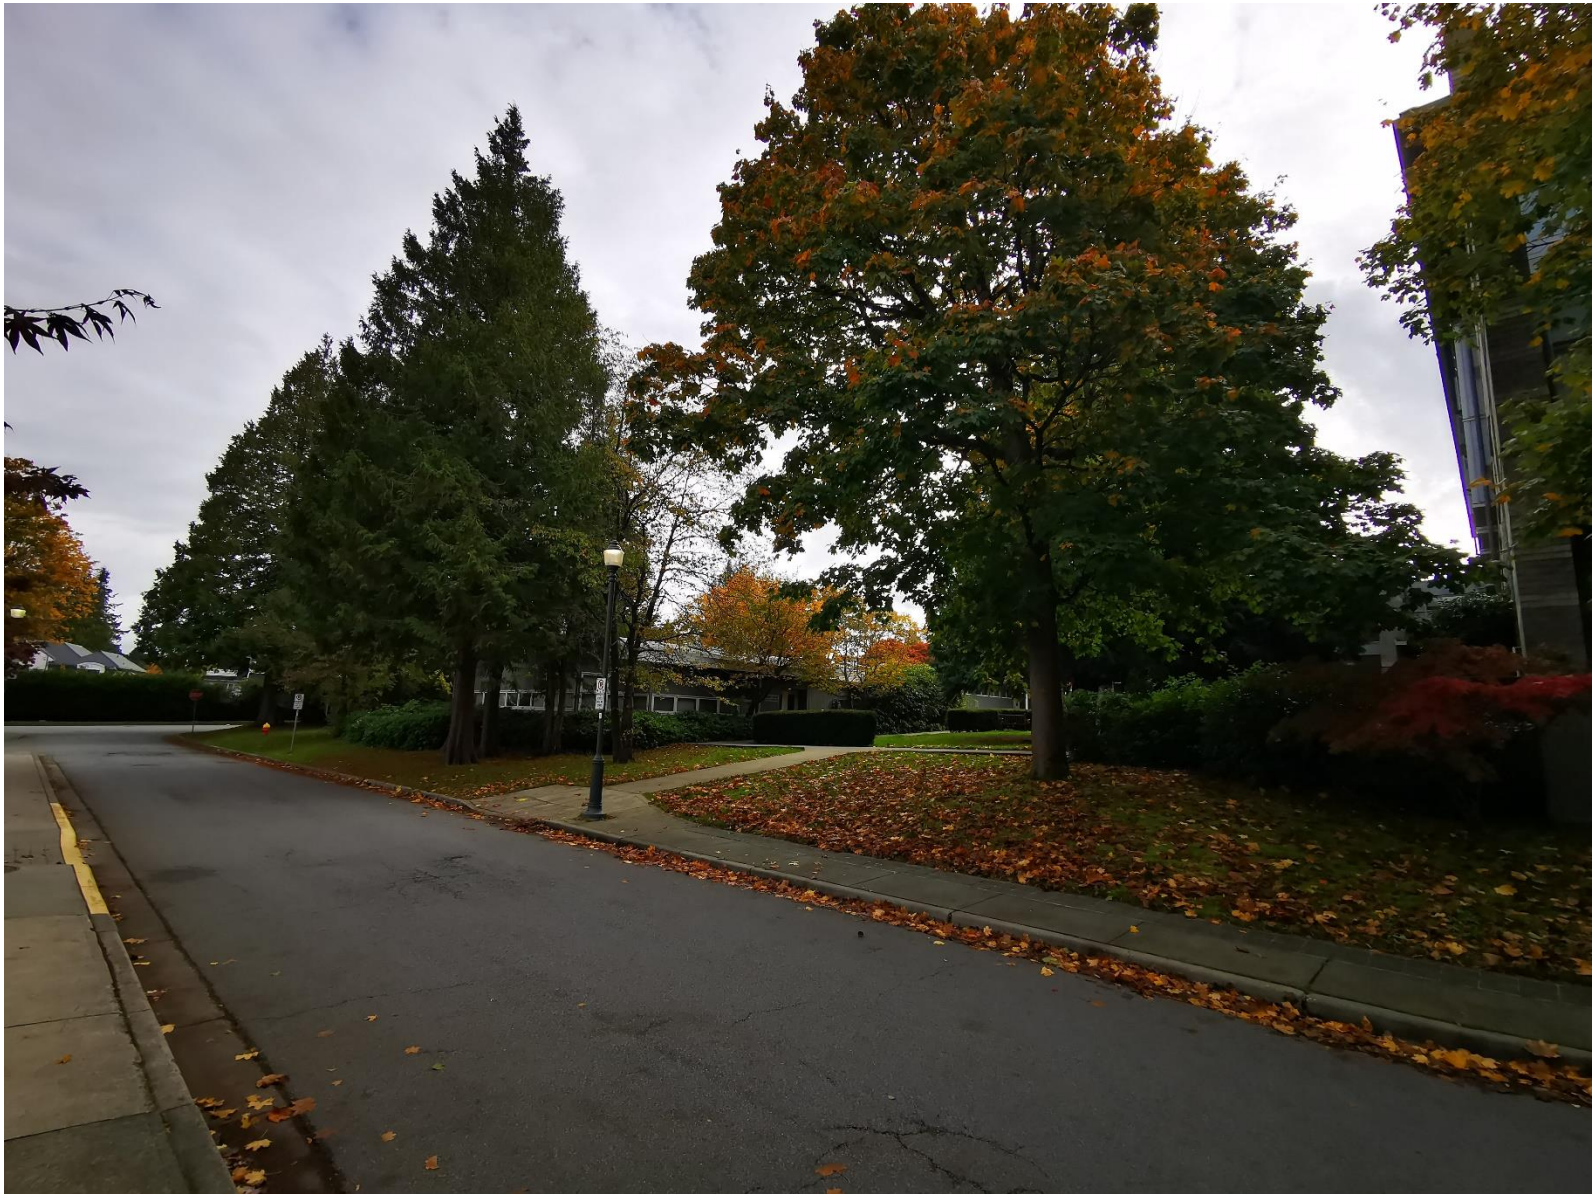
*Image 3 – Photograph of Cedar tree along Iona Drive.*

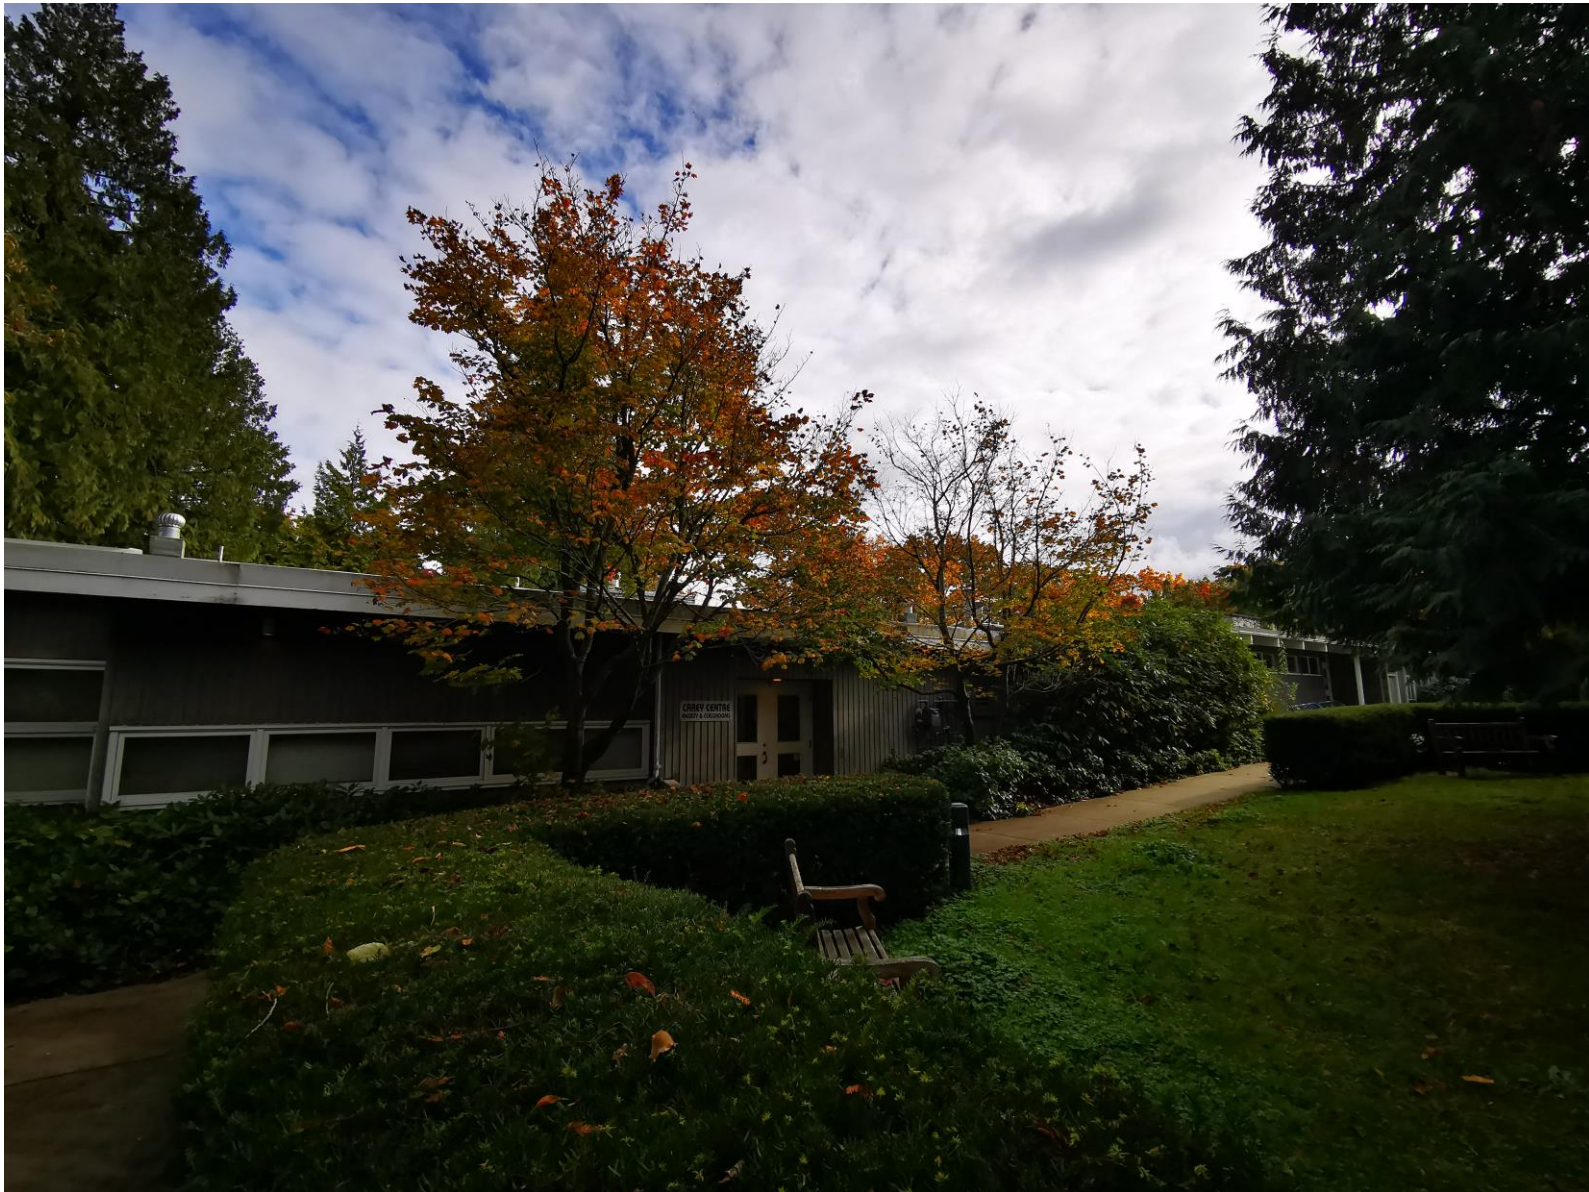
*Image 4 – Photograph of Maple Trees 10002-10003 on-site.*

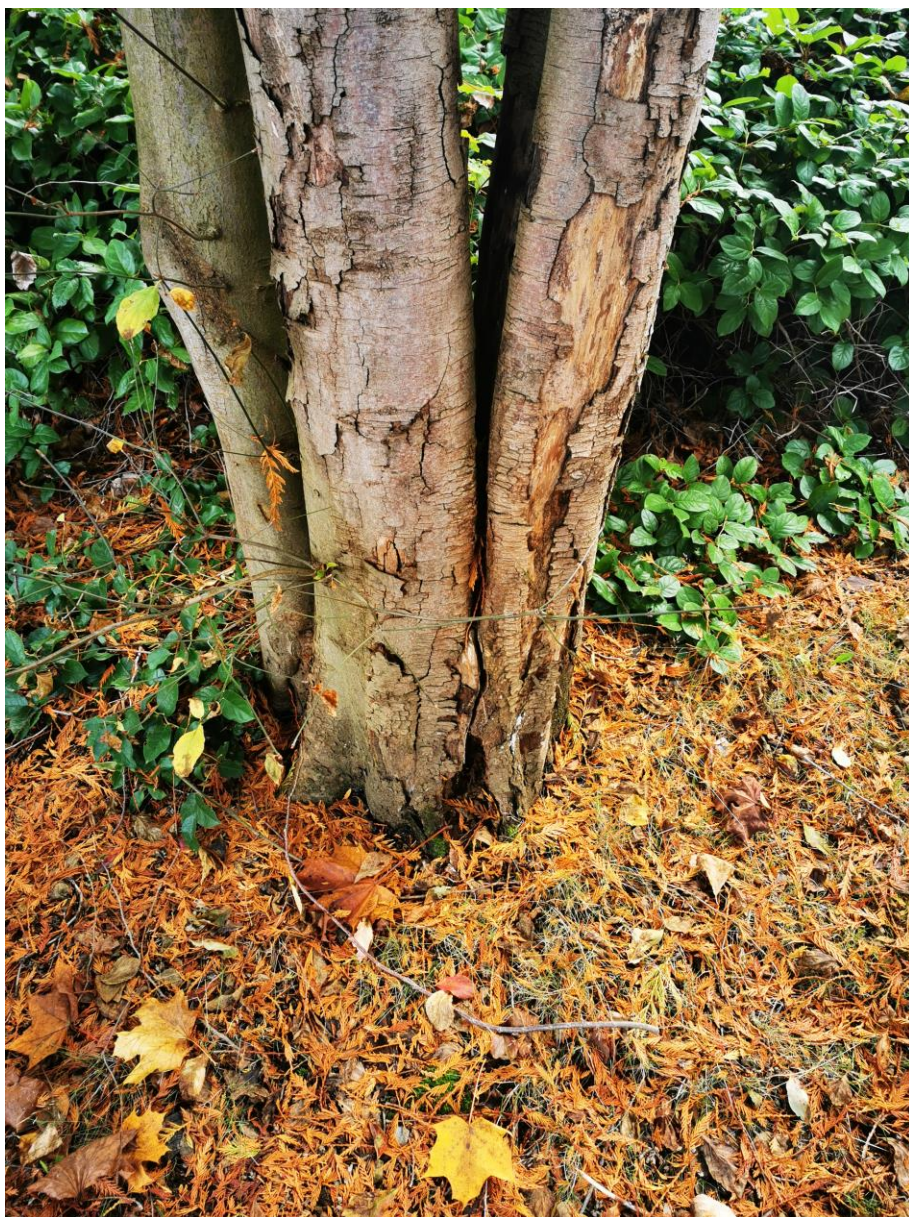
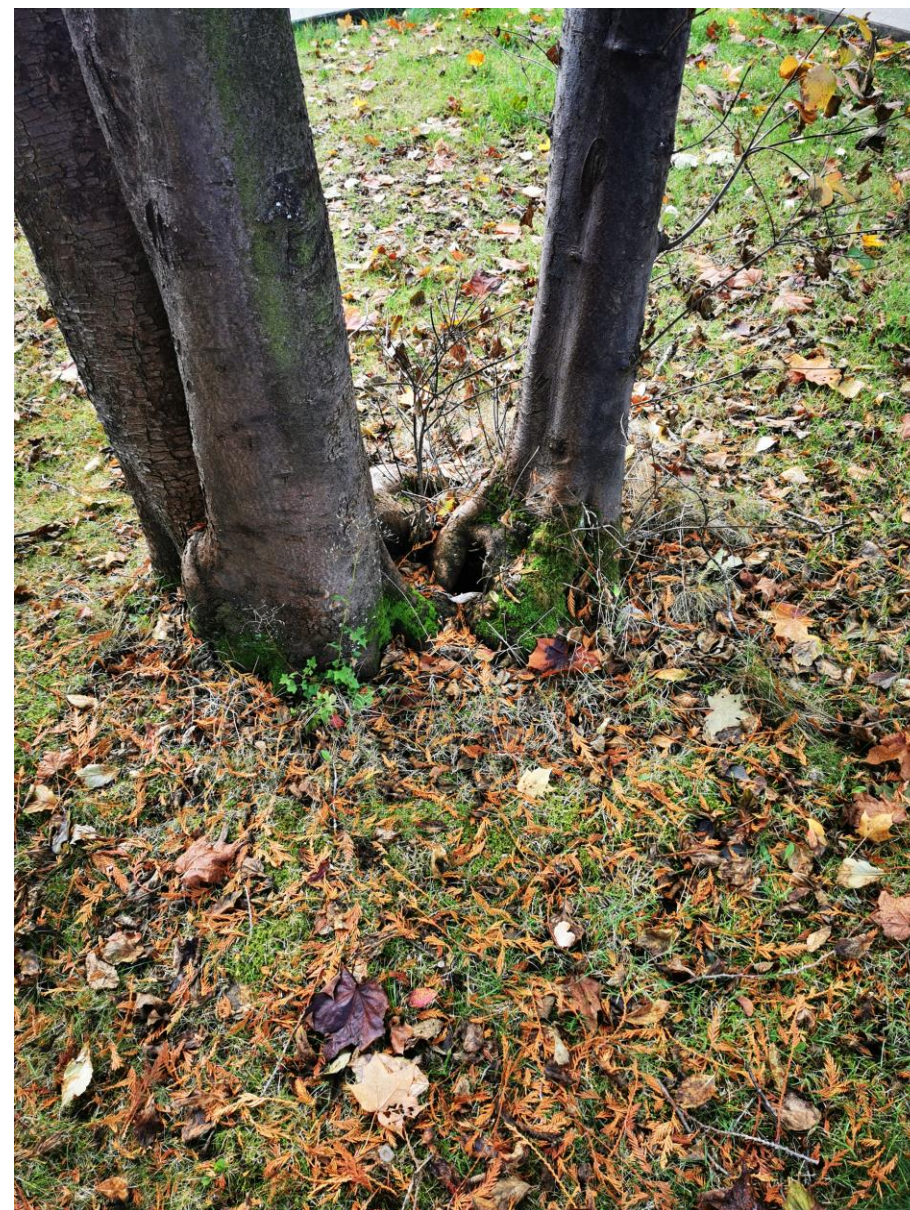
*Image 5 – Photograph of decayed base of Dogwood trees #2237-2238.*

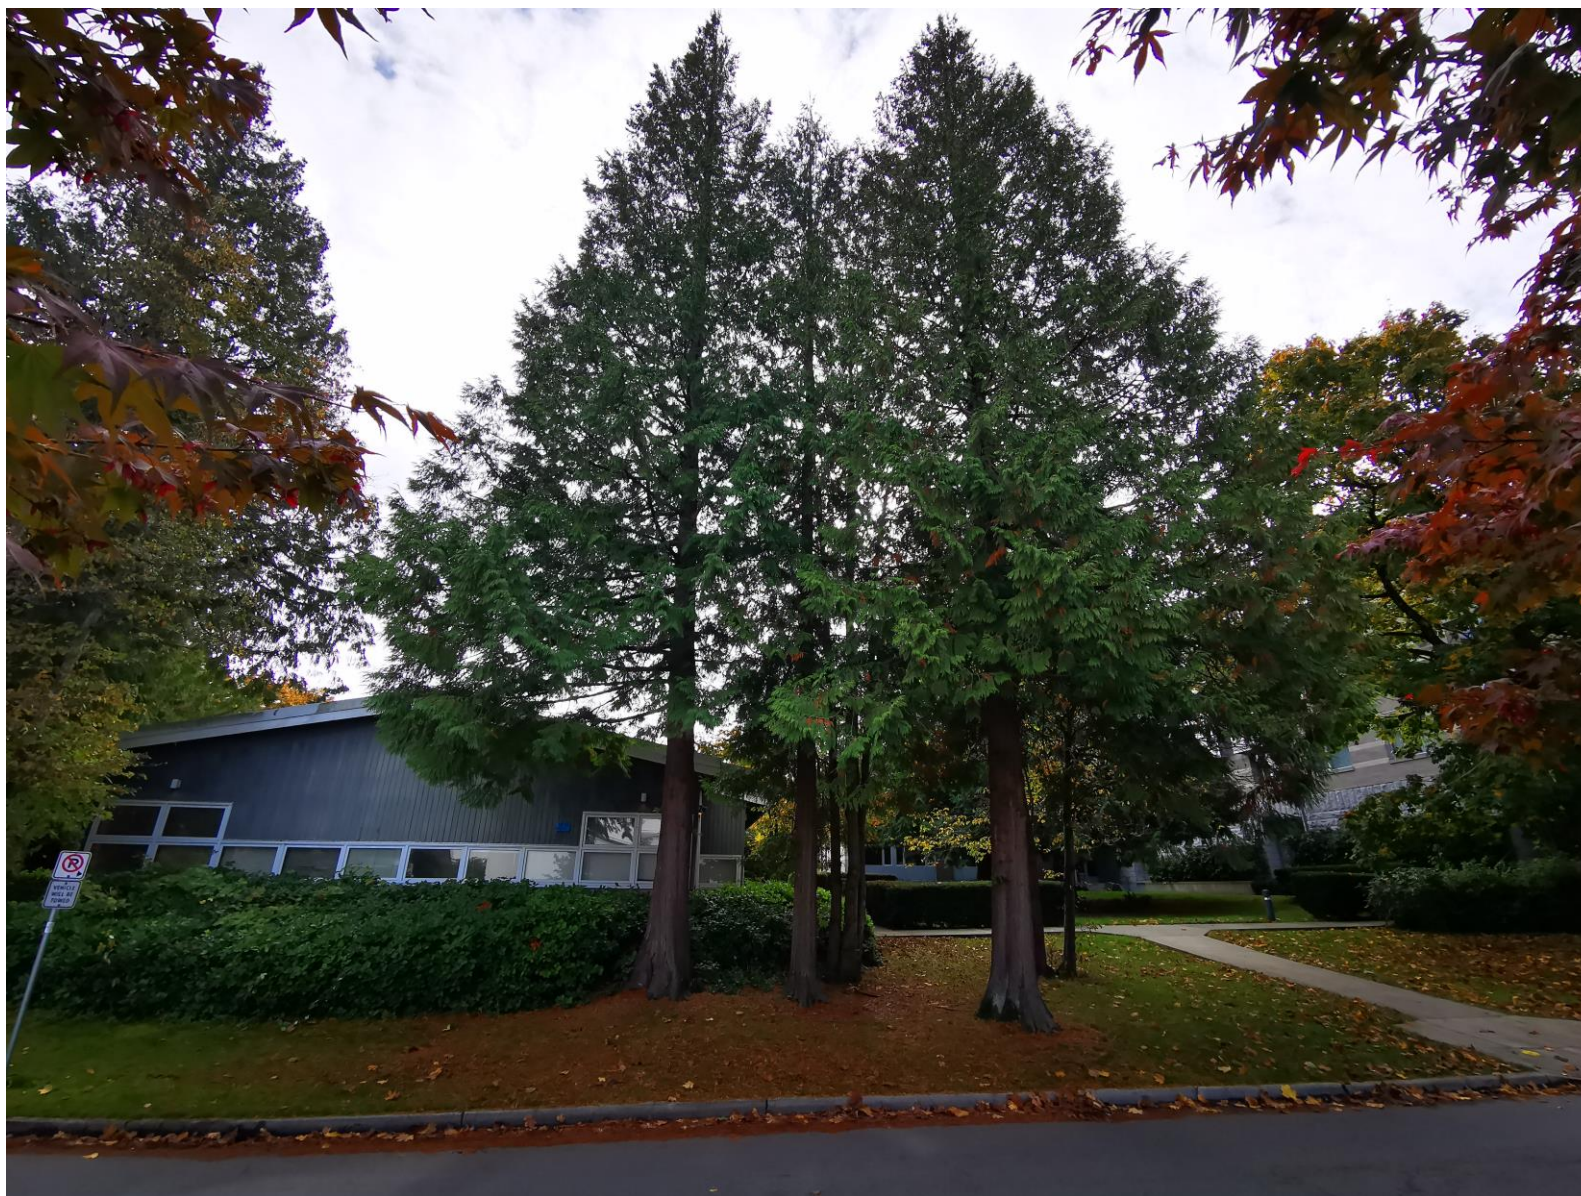
*Image 6 – Photograph of Dogwood & Cedar trees #2237-2238.*

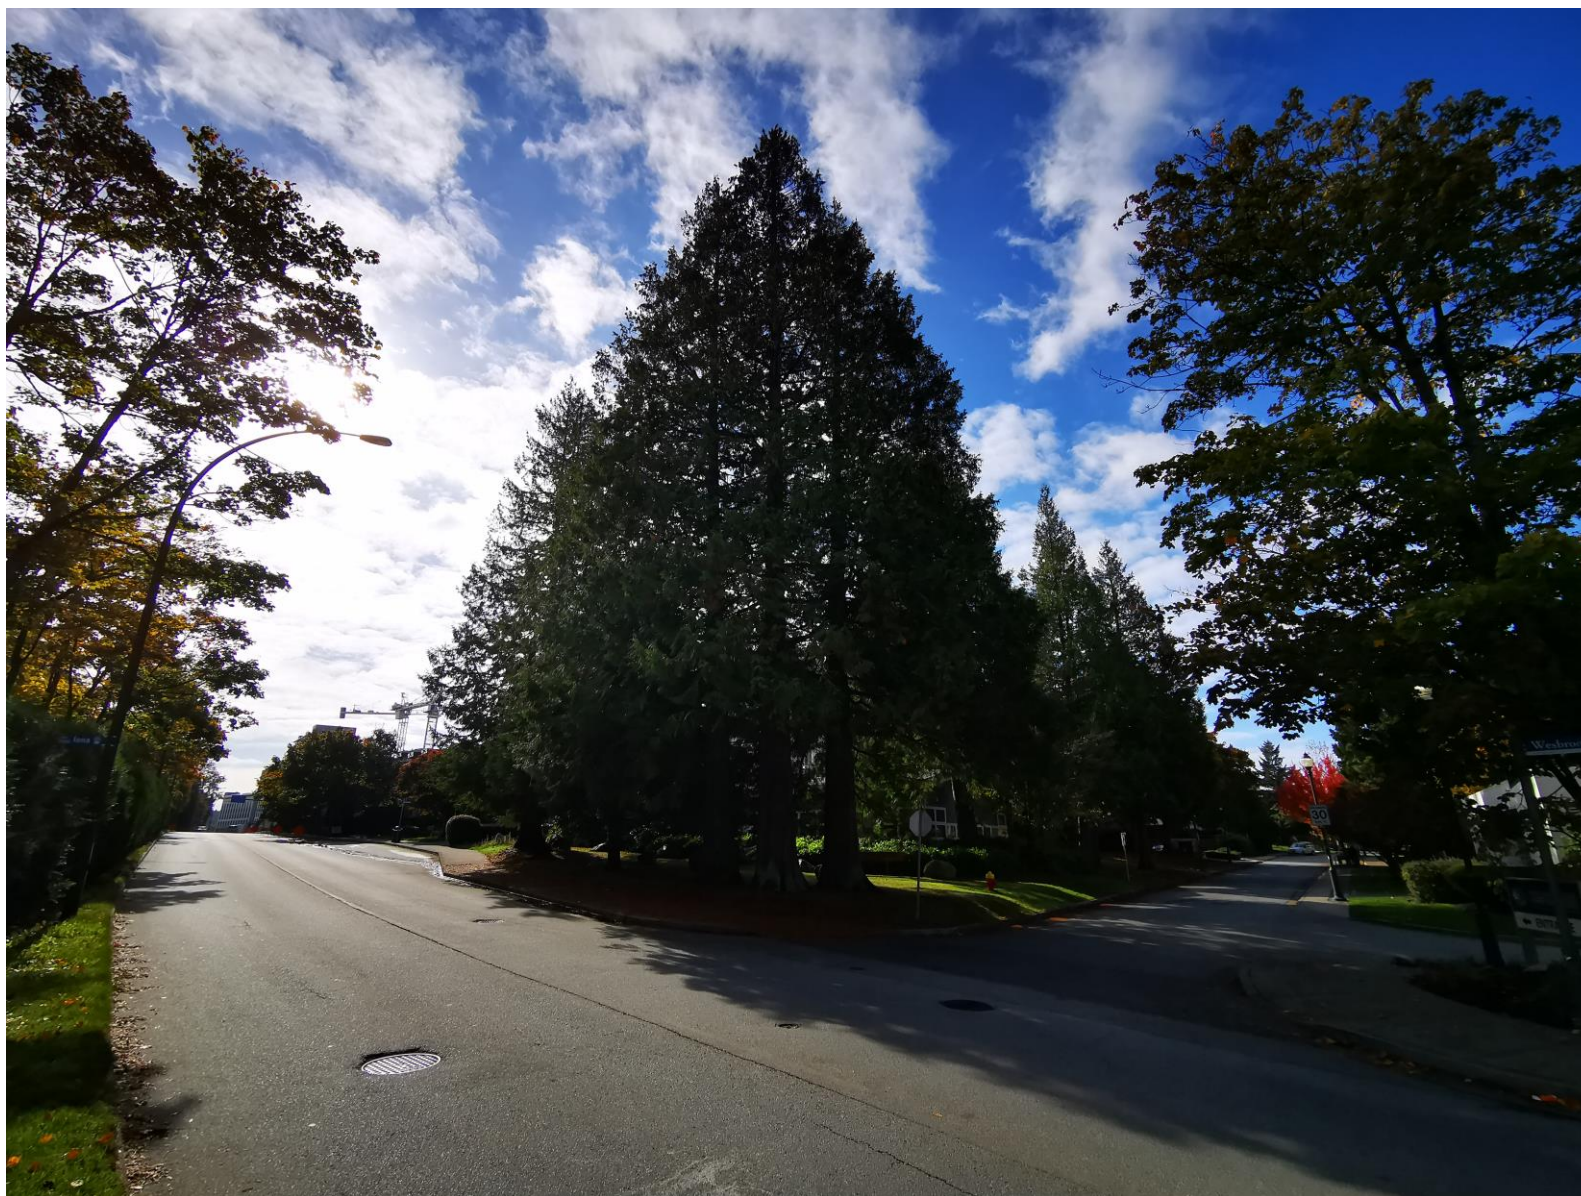
*Image 7 – Photograph of Corner of Westbrook Mall and Iona Drive.*

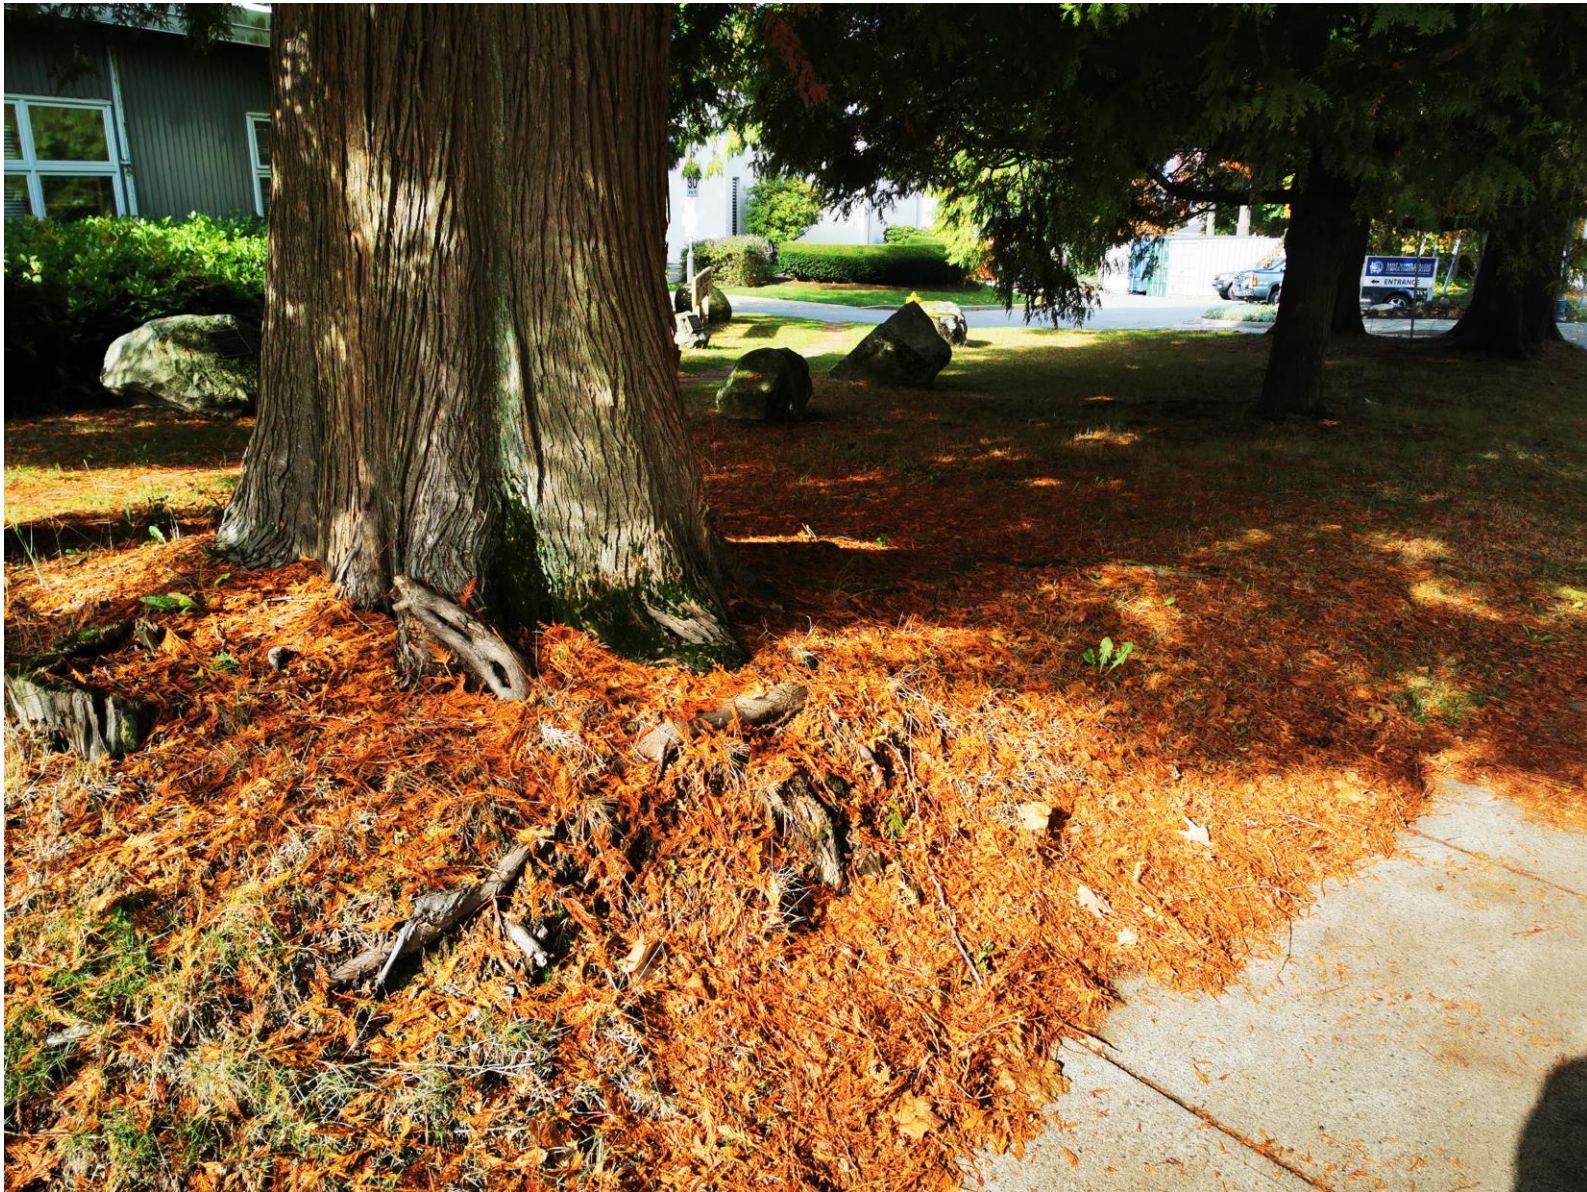
*Image 8 – Photograph of raised base of Cedar tree #2519.*

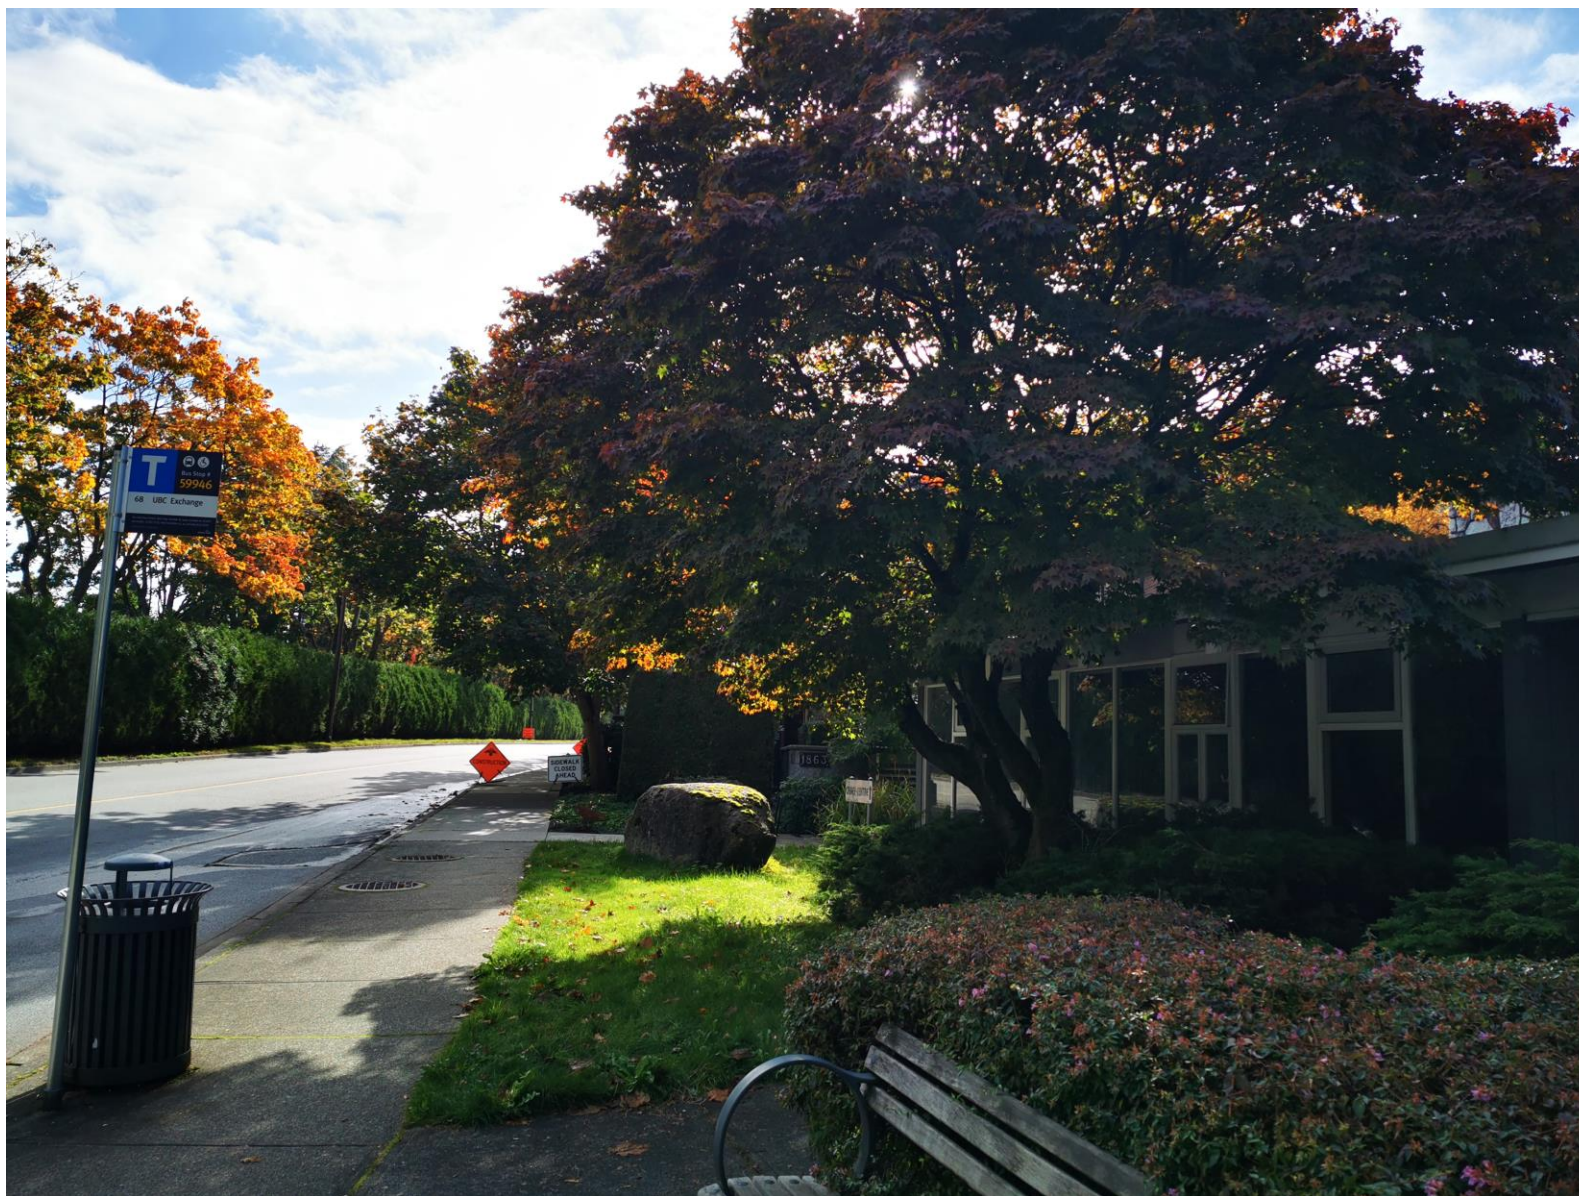
Image 9 – Photograph of Maple tree #2328.

2328	Yes	On-site	Japanese Maple <i>Acer japonicum</i>	10+ 35+ 35	6	70	Specimen is visually in good health and condition, forks AGL.	Remove to accommodate proposed site plans.	High	Remove	5.2
9982	Yes	Off-site	Katsura <i>Cercidiphyllum japonicum</i>	8+8 +8	9	70	Specimen is visually in good health and condition, forks AGL.	Protect throughout development with tree protection barriers.	High	Retain	1.6
2516	Yes	Off-site	Katsura <i>Cercidiphyllum japonicum</i>	35	12	80	Specimen is visually in good health and condition.	Protect throughout development with tree protection barriers.	High	Retain	2.3
9978	Yes	On-site	Japanese Maple <i>Acer japonicum</i>	8+8 +8	6	70	Specimen is visually in good health and condition, forks AGL.	Protect throughout development with tree protection barriers.	High	Retain	1.6
9977	Yes	On-site	Japanese Maple <i>Acer japonicum</i>	8+8 +8	6	70	Specimen is visually in good health and condition, forks AGL.	Remove to accommodate proposed site plans.	High	Remove	1.6

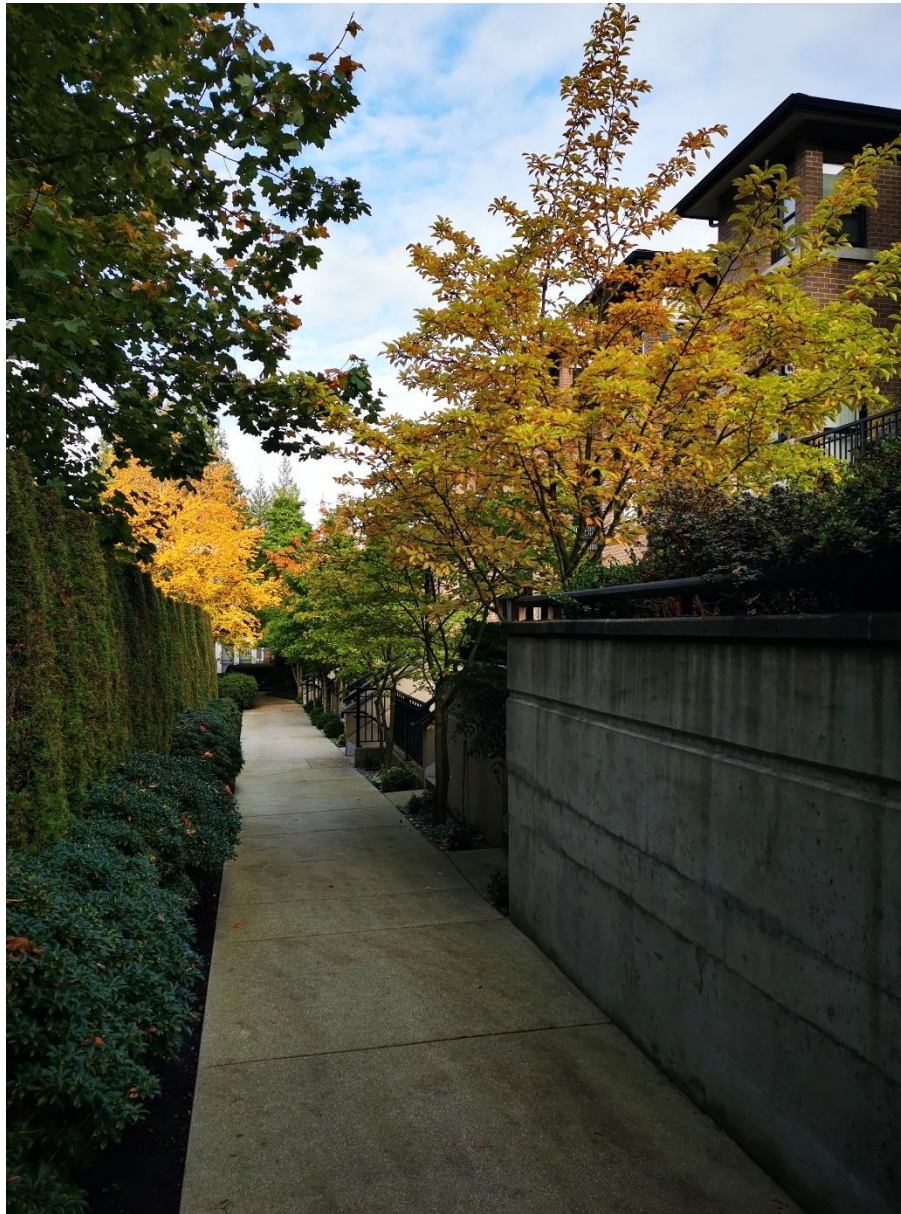
*Image 10 – Photograph of Off-site Magnolia & Katsura Trees along east property line.*

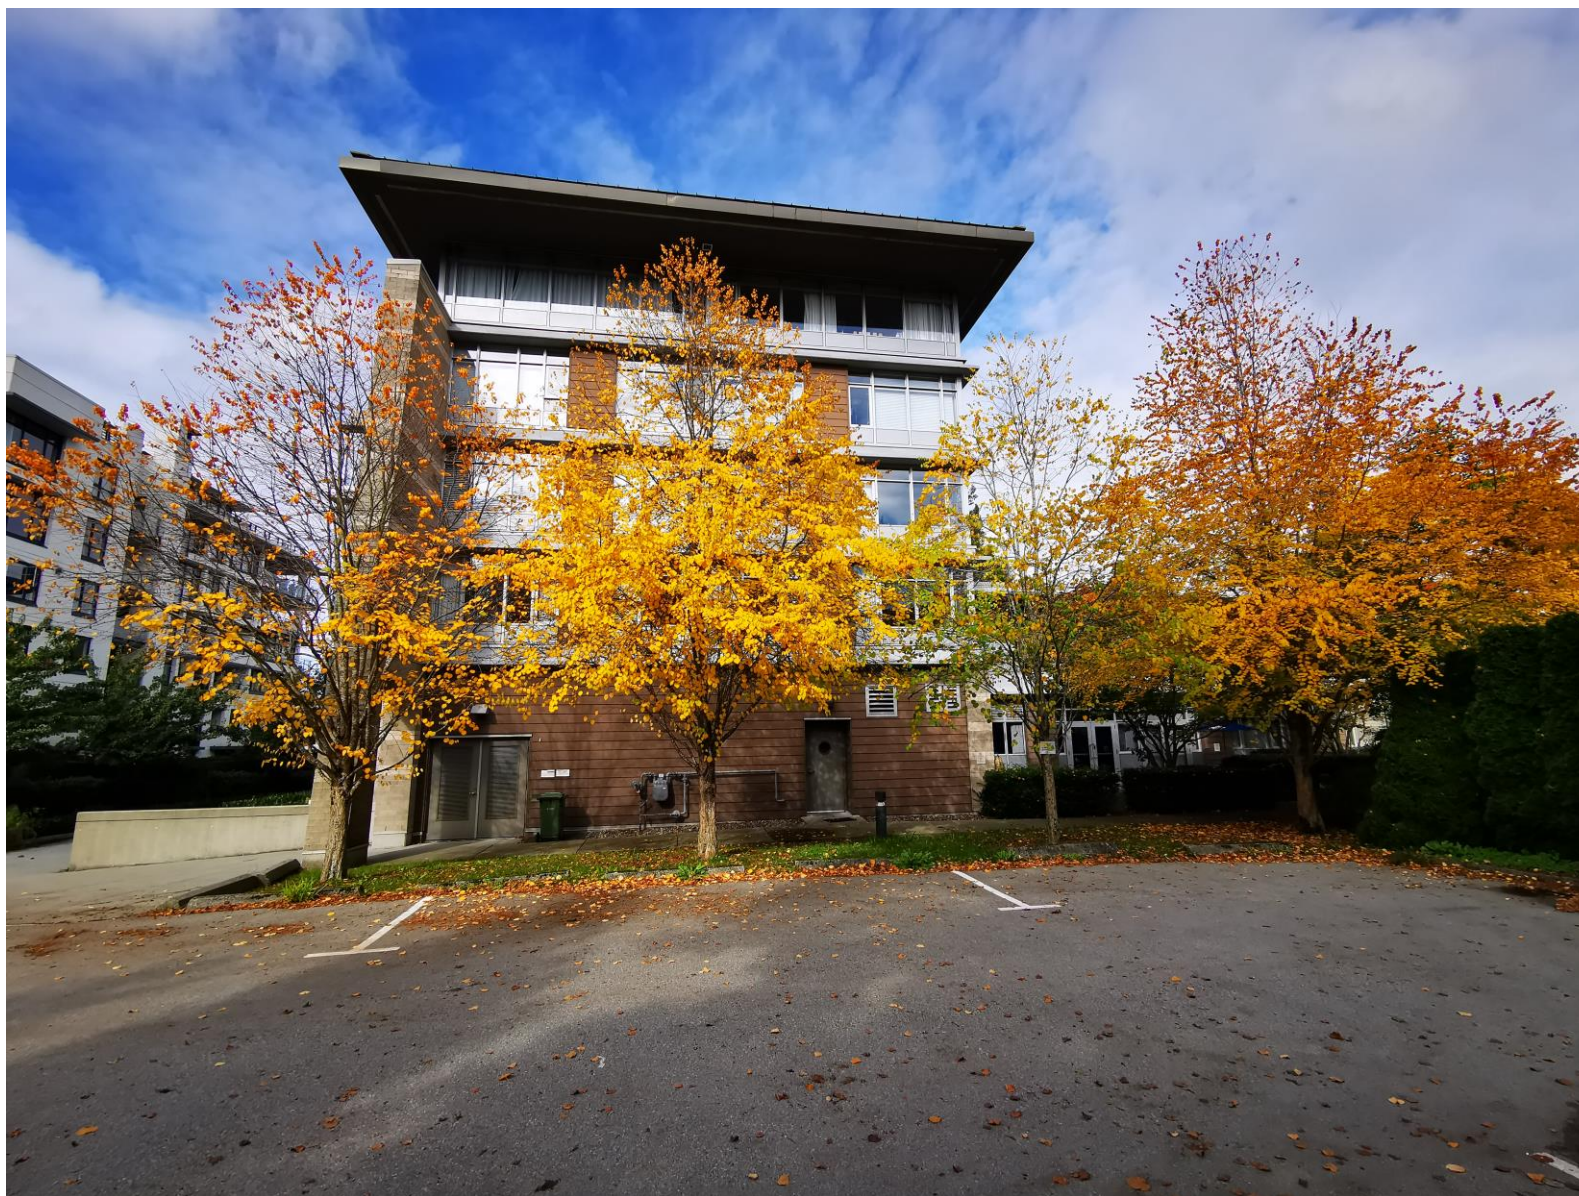
*Image 11 – Photograph of Katsura trees #2528, 9933, 2527, 9935.*

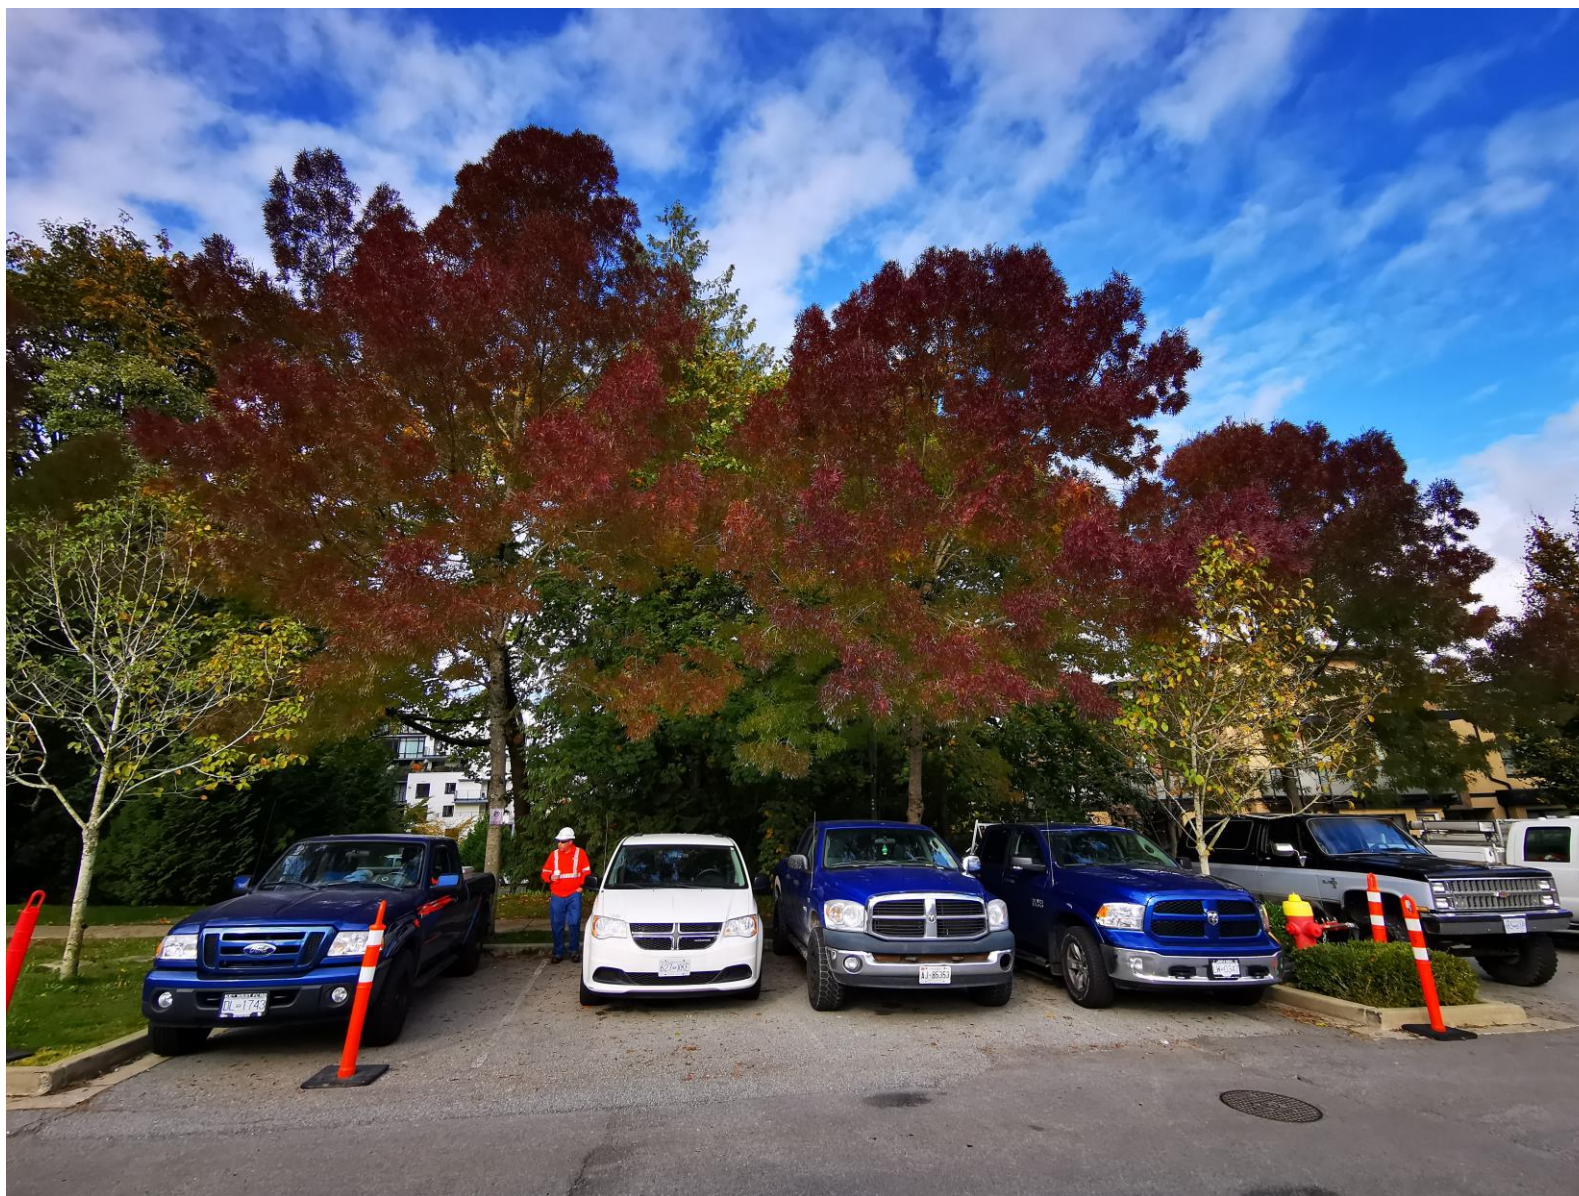
Image 12 – Photograph of City Ash trees #5188,5187,5194.

5187	Yes	City	Ash <i>Fraxinus sp.</i>	30	12	70	Specimen is visually in good health and condition, lean over Walter Rd.	Protect throughout development with tree protection barriers.	High	Retain	2
5194	Yes	City	Ash <i>Fraxinus sp.</i>	30	12	70	Specimen is visually in good health and condition, damage to bark at base	Protect throughout development with tree protection barriers.	High	Retain	2
9826	Yes	City	Magnolia <i>Magnolia sp.</i>	10	5	70	Specimen is visually in good health and condition.	Protect throughout development with tree protection barriers.	High	Retain	0.7
9829	Yes	City	Magnolia <i>Magnolia sp.</i>	10	5	70	Specimen is visually in good health and condition.	Protect throughout development with tree protection barriers.	High	Retain	0.7
9830	Yes	City	Ash <i>Fraxinus sp.</i>	20	11	70	Specimen is visually in good health and condition, corrected lean.	Protect throughout development with tree protection barriers.	High	Retain	1.3

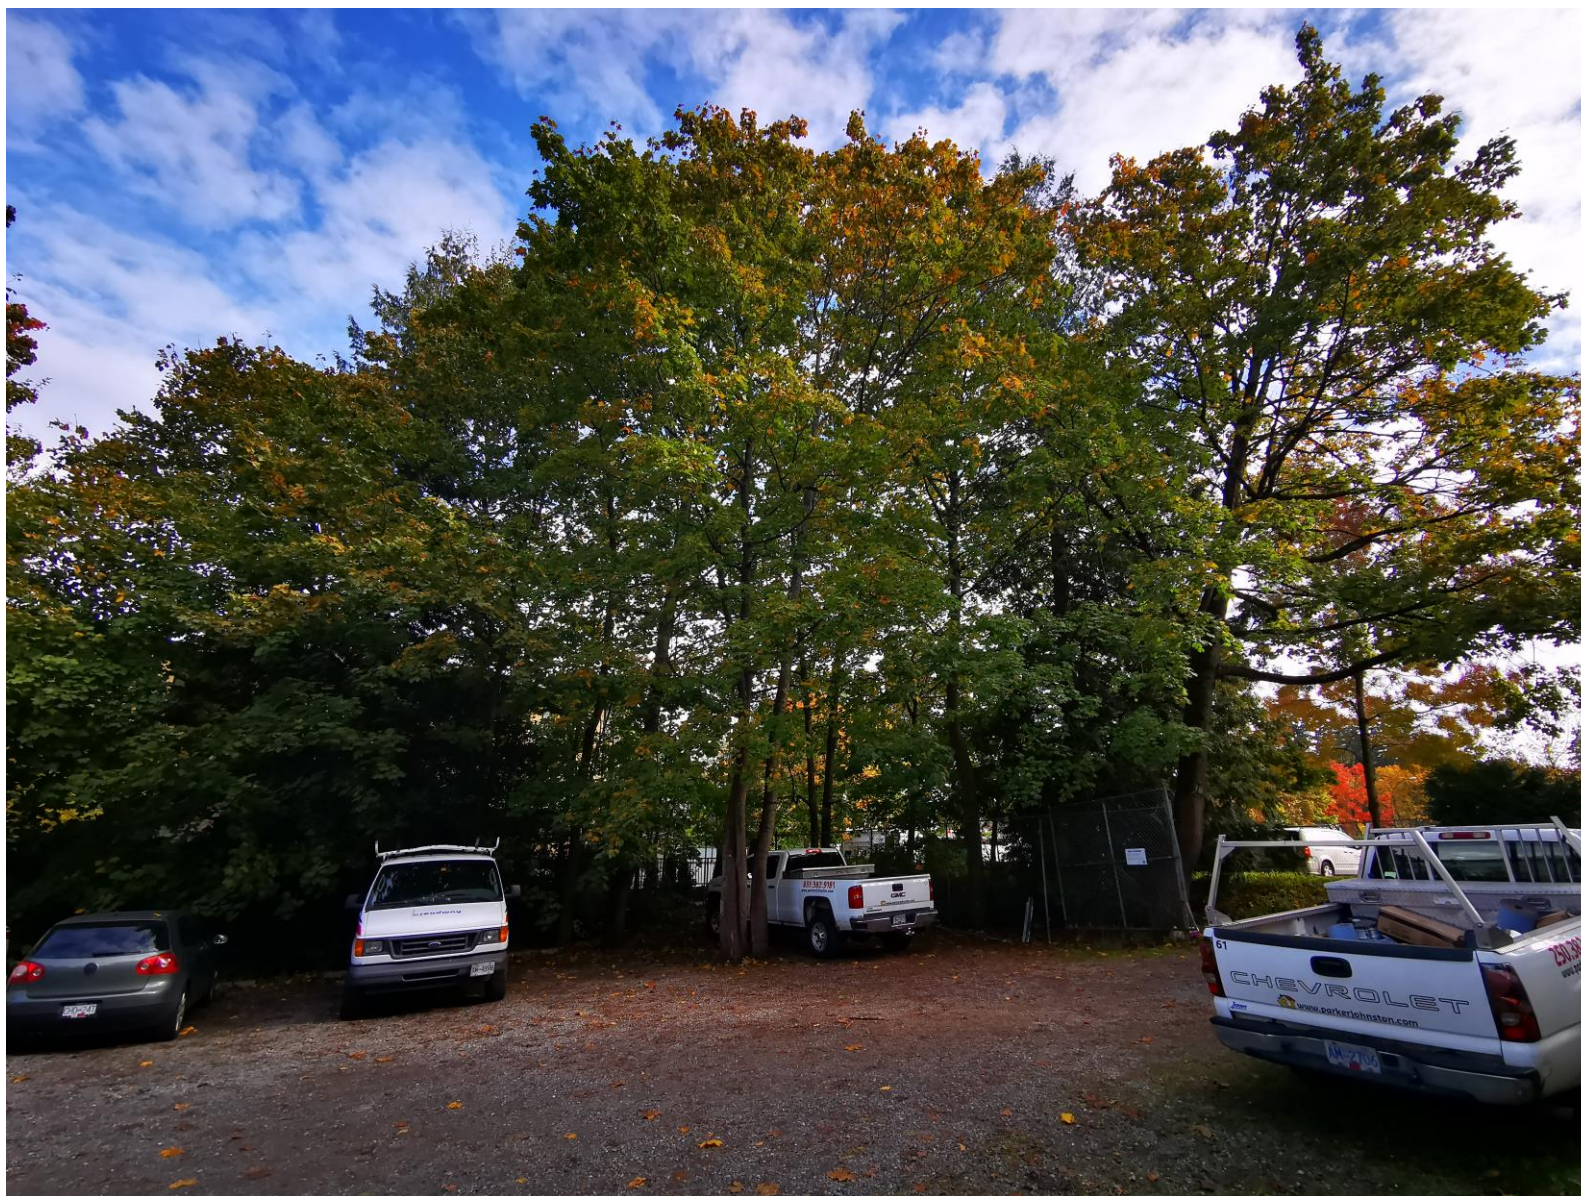
*Image 13 – Photograph of rear gravel parking lot with several Maple and Cedar Trees.*
