Project #: 322

Site Address: 5920 Iona Drive, Vancouver B.C.

Date: February 11, 2022

GOODE  
ARBORICULTURE CONSULTING  
*Tree Preservation Report*

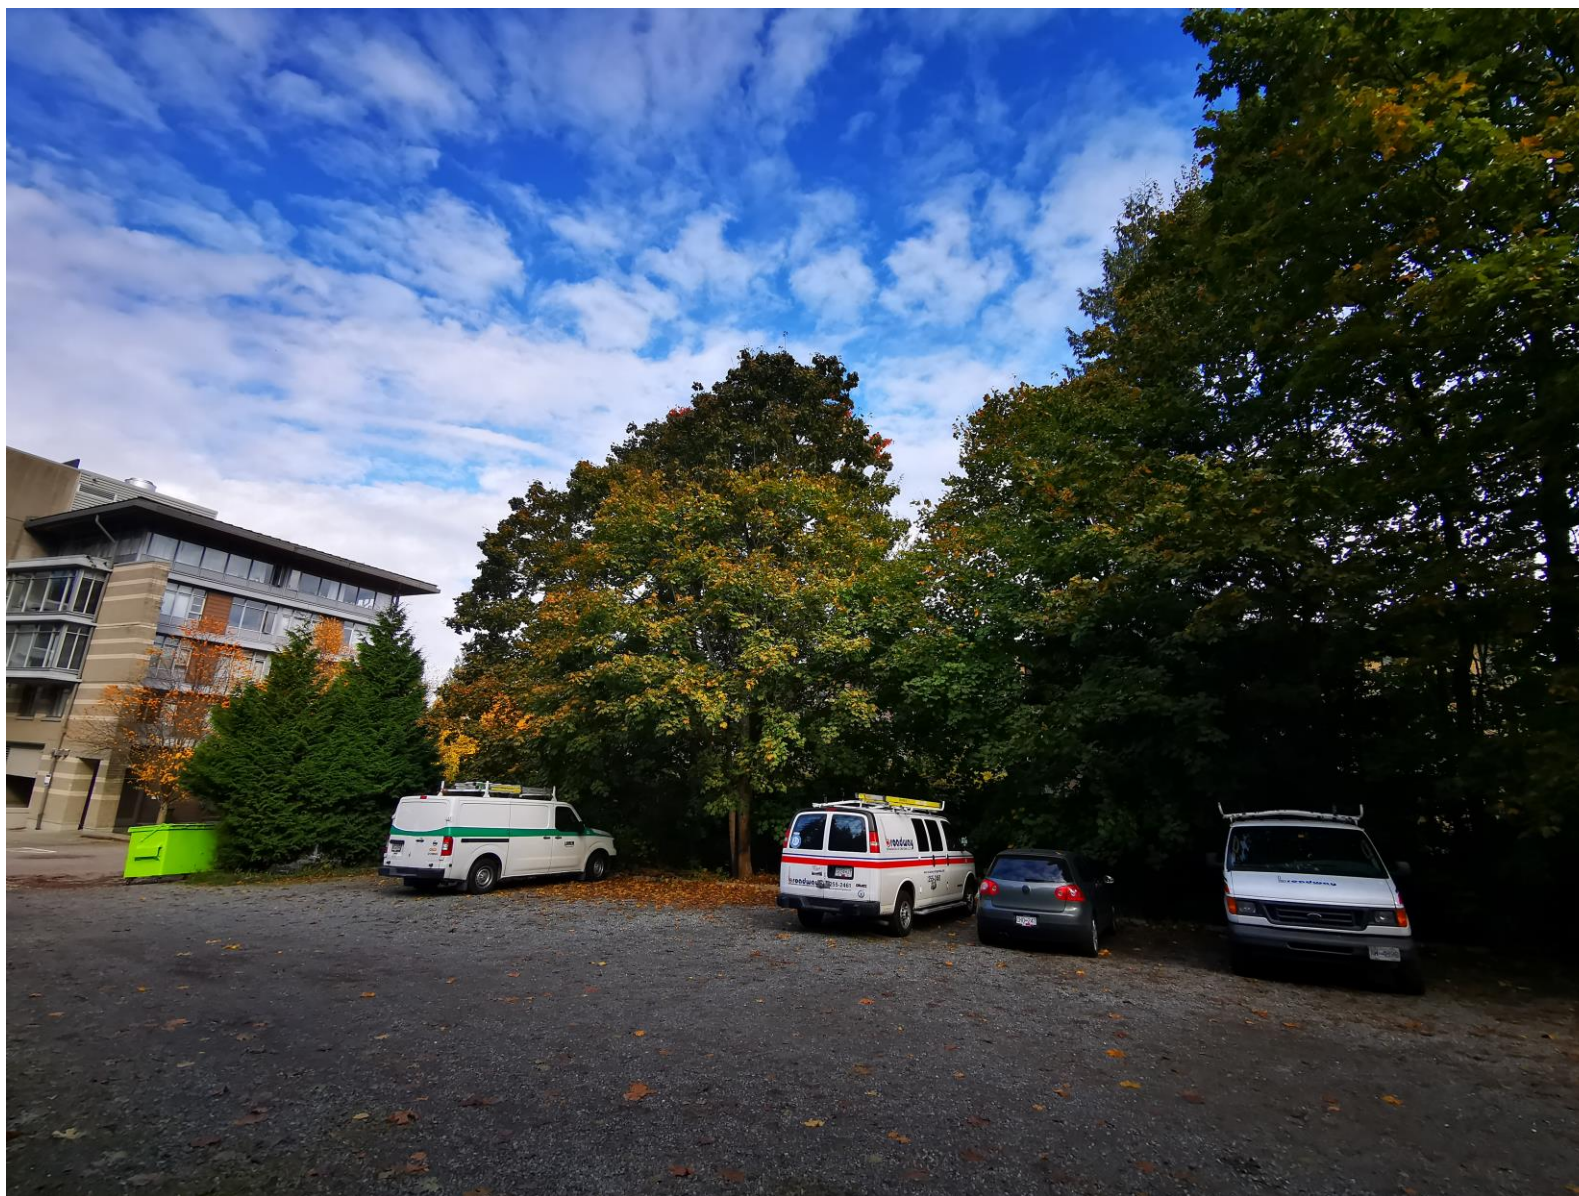
*Image 14 – Photograph of rear gravel parking lot with several Maple and Cedar Trees.*

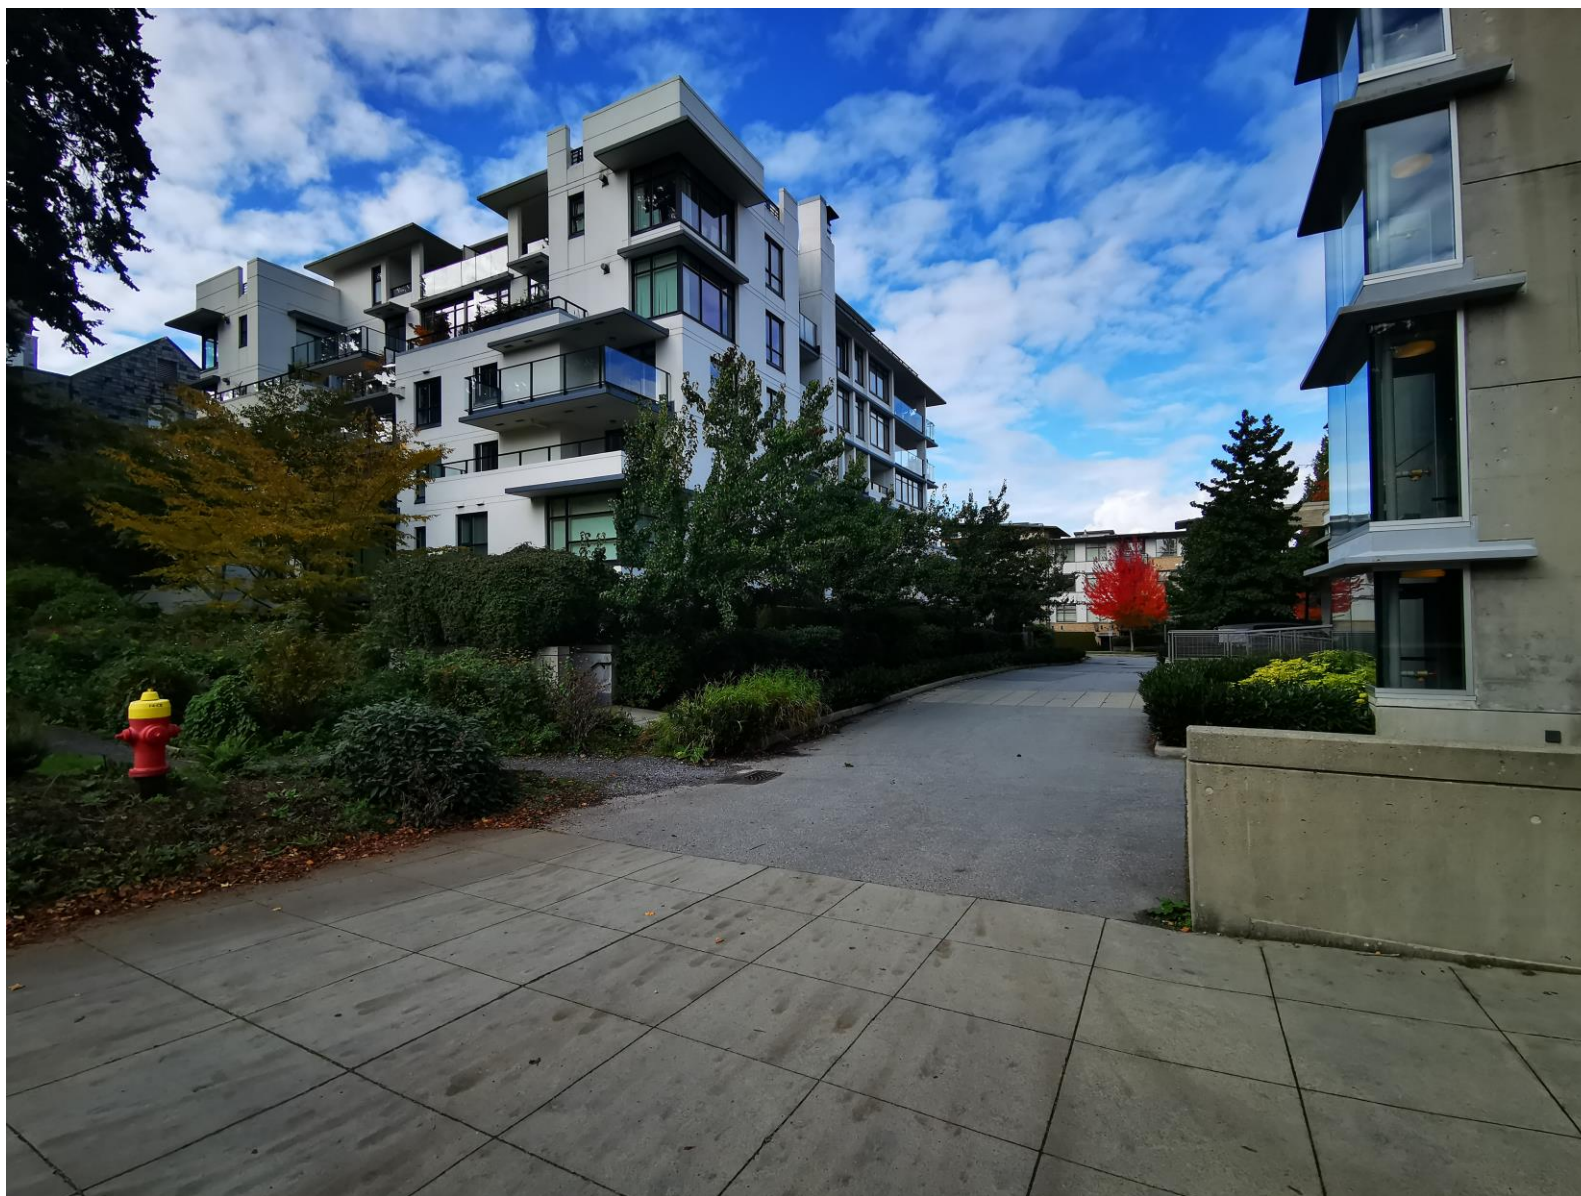
*Image 15 – Off-site Pear trees #1006-1008 on left of roadside.*

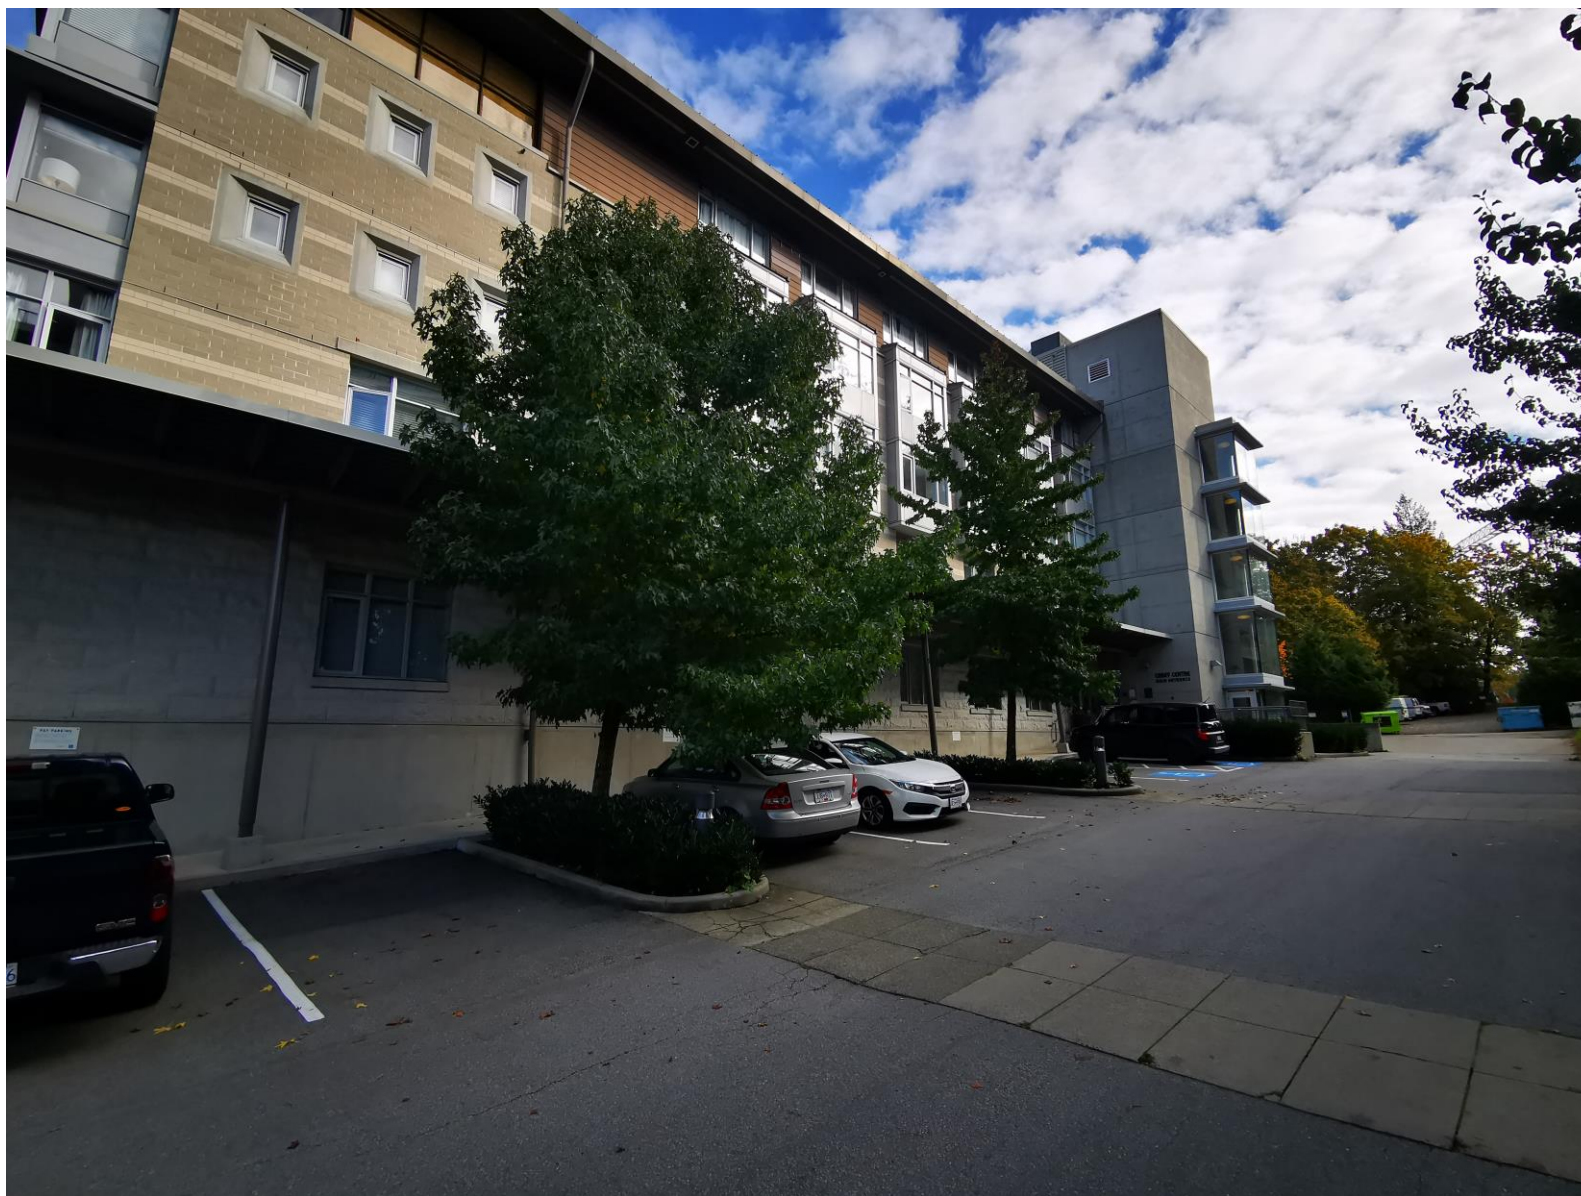
*Image 16 – Trees #1004-1005 in parking area.*
