Project #: 322

Site Address: 5920 Iona Drive, Vancouver B.C.

Date: February 11, 2022

Tree Preservation Report

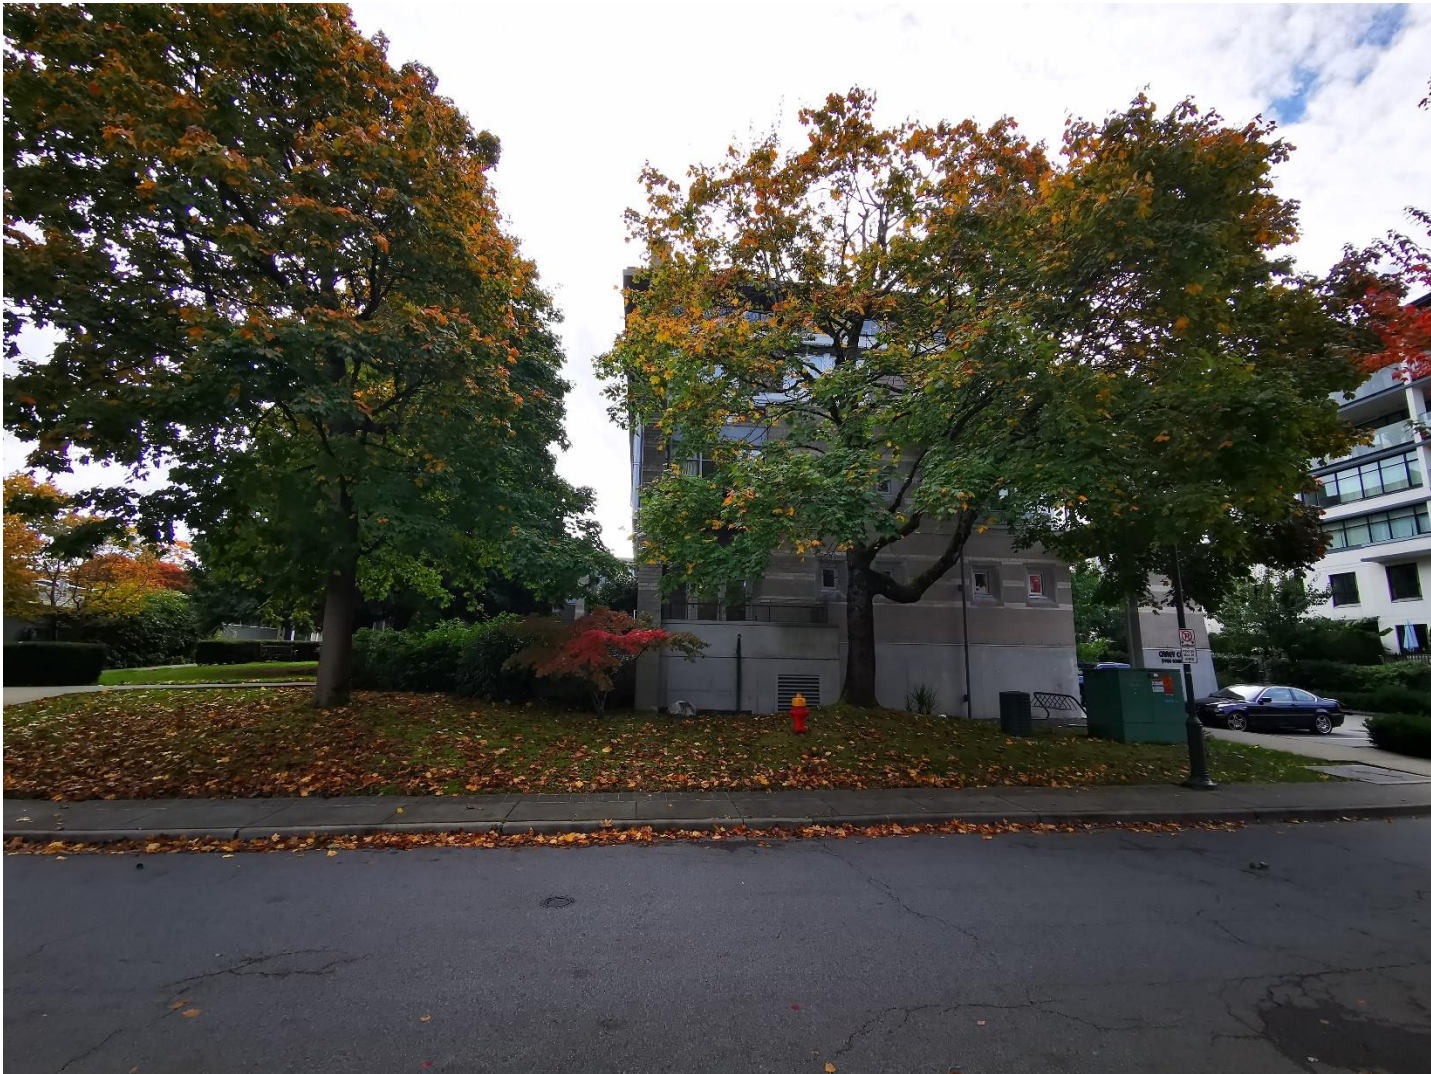
Image 2 – Trees #2523-2524 located along Iona Drive.

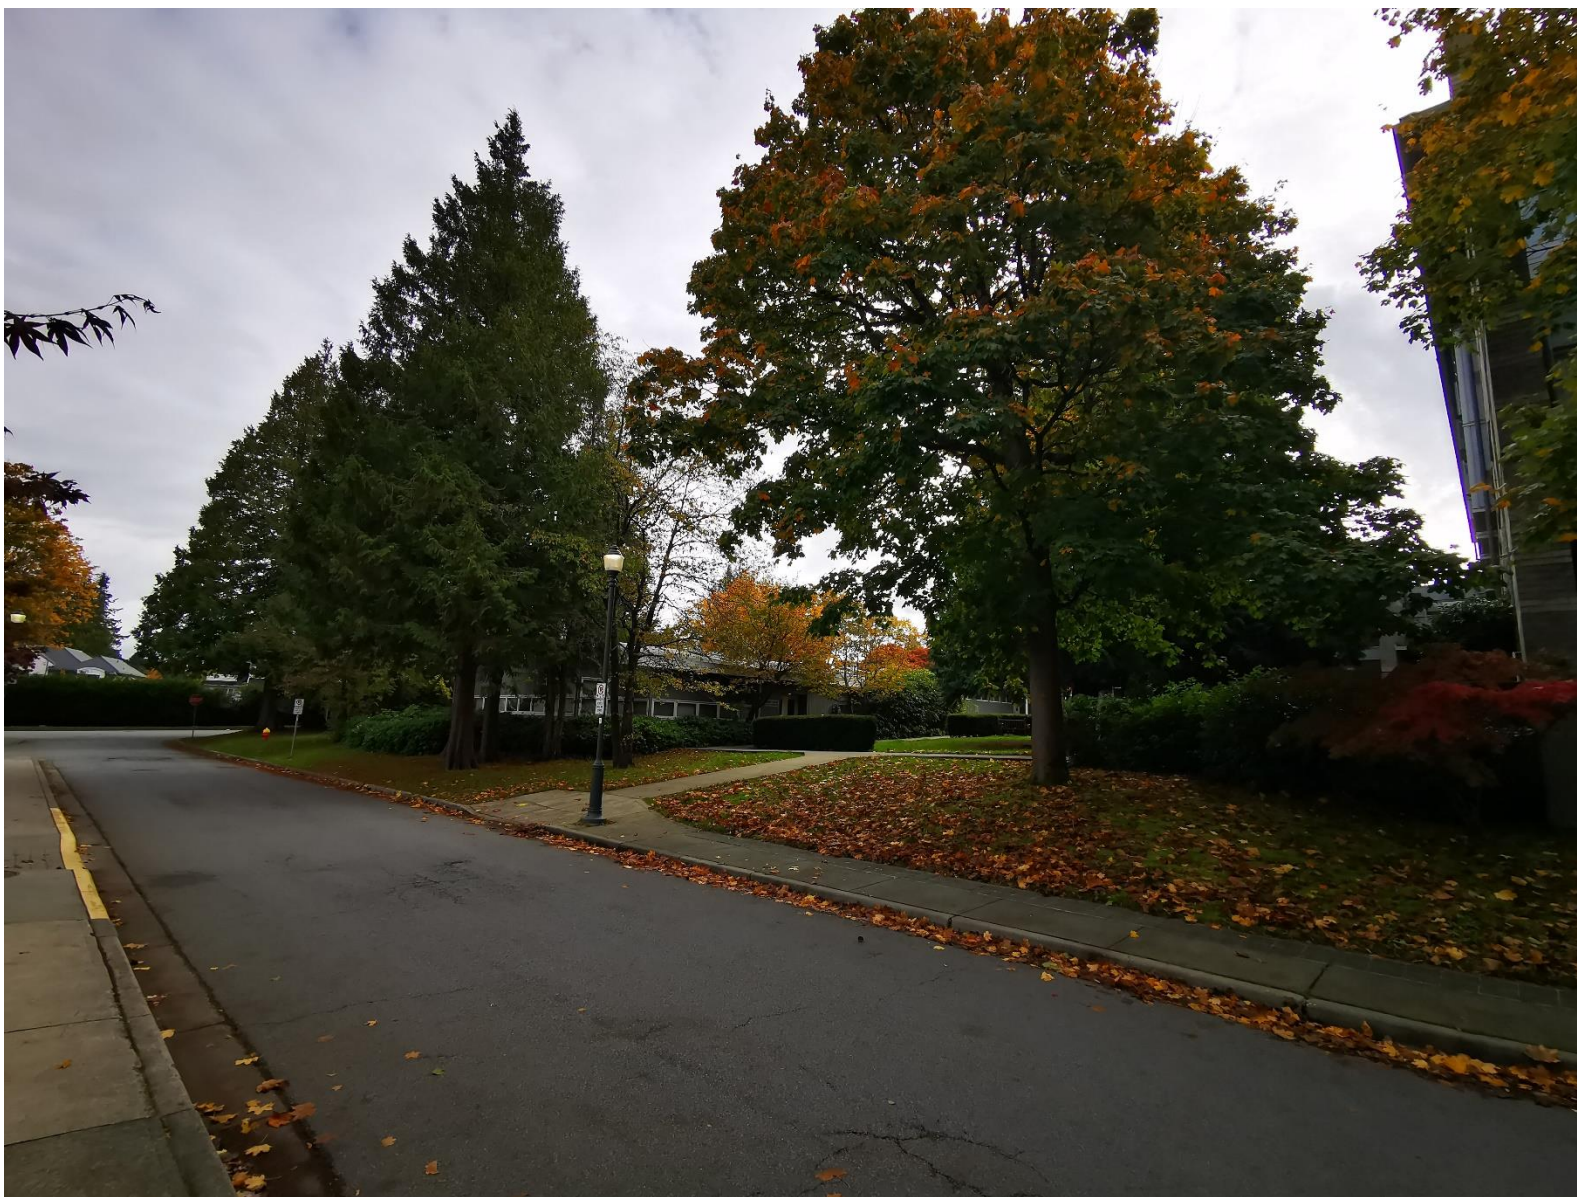
Image 3 – Photograph of Cedar tree along Iona Drive.

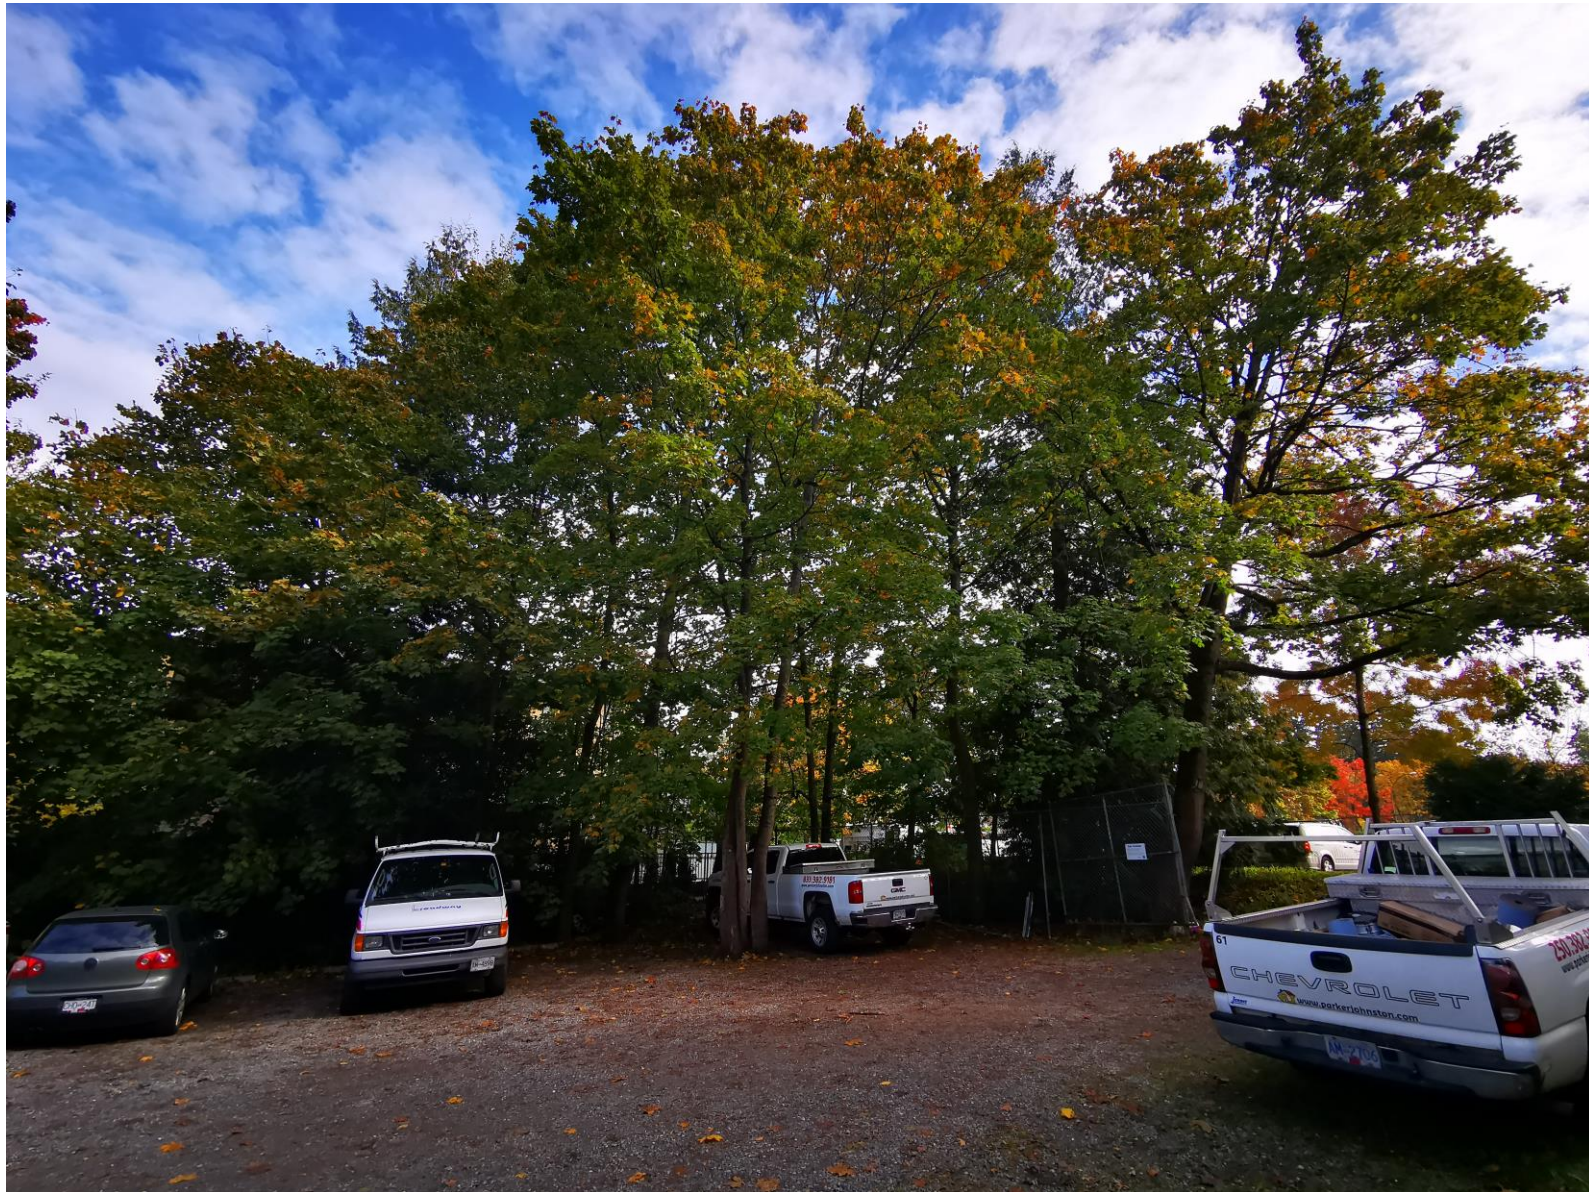
Image 13 – Photograph of rear gravel parking lot with several Maple and Cedar Trees.

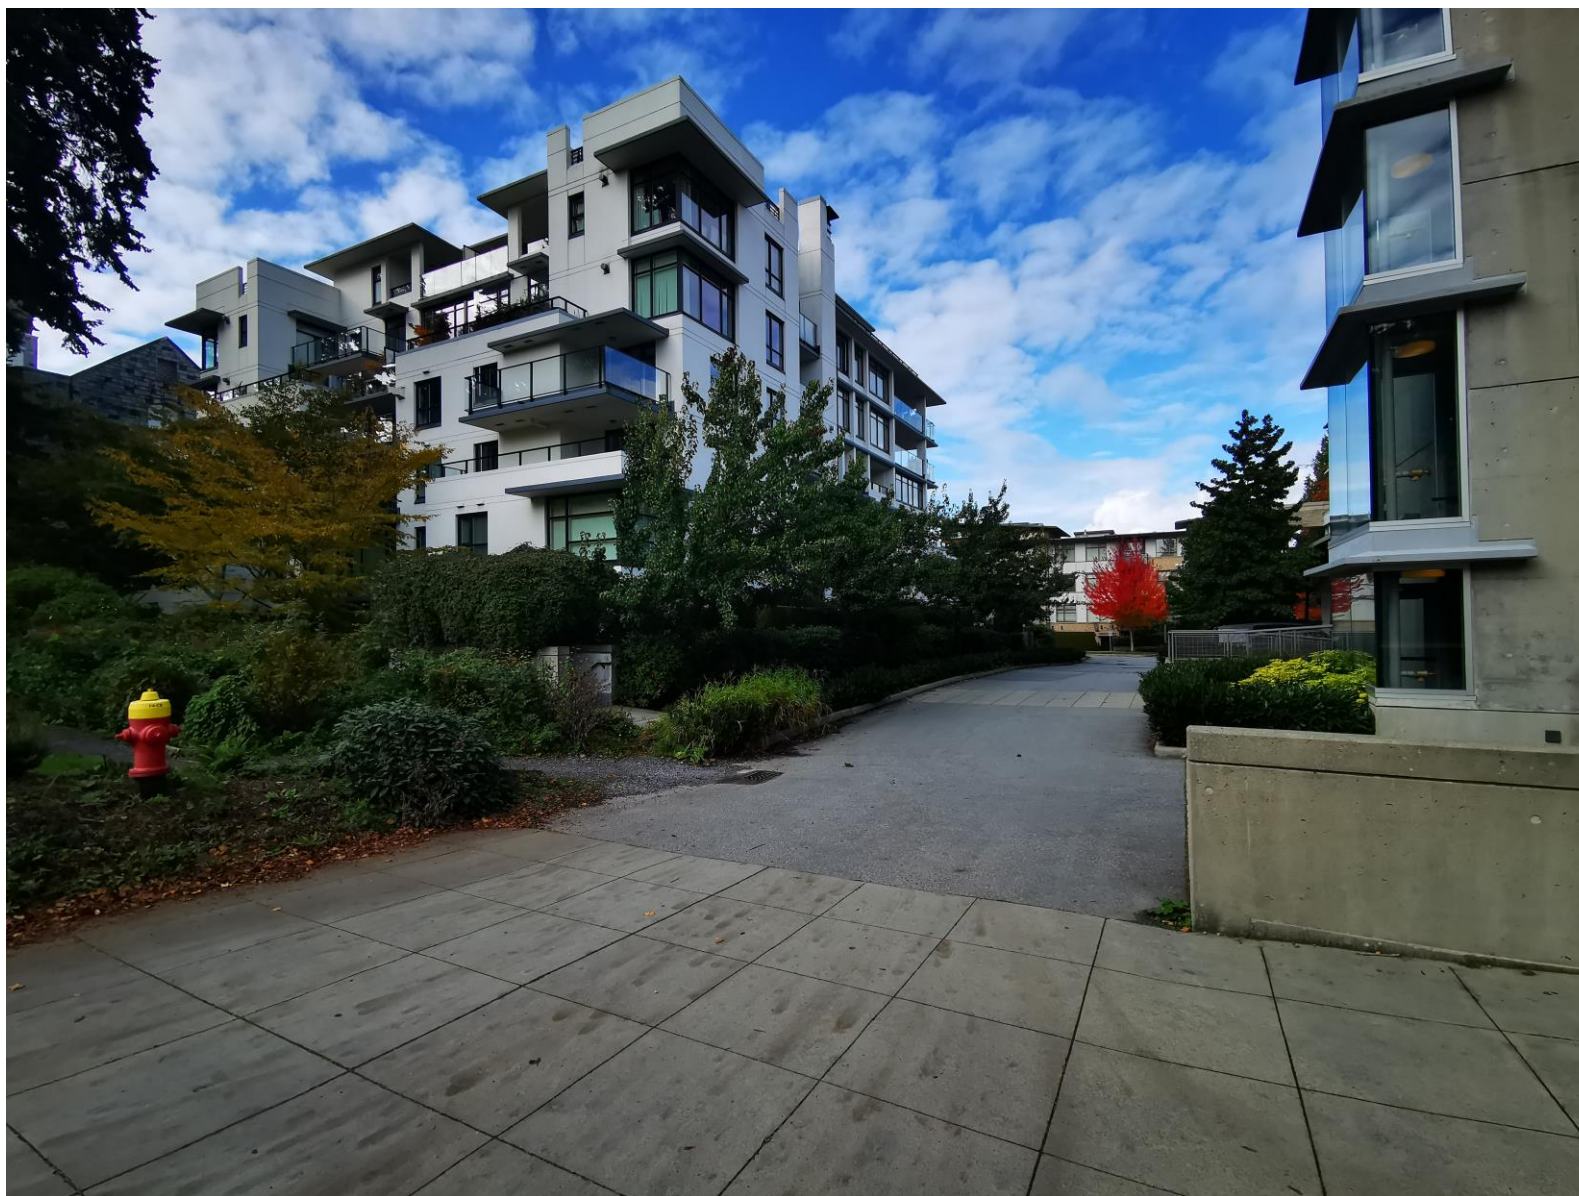
Image 15 – Off-site Pear trees #1006-1008 on left of roadside.
