Arboricultural Inventory and Report

UBC Campus Lot 26 – 5988 Gray Avenue,
Vancouver, BC

Date: May 16, 2023

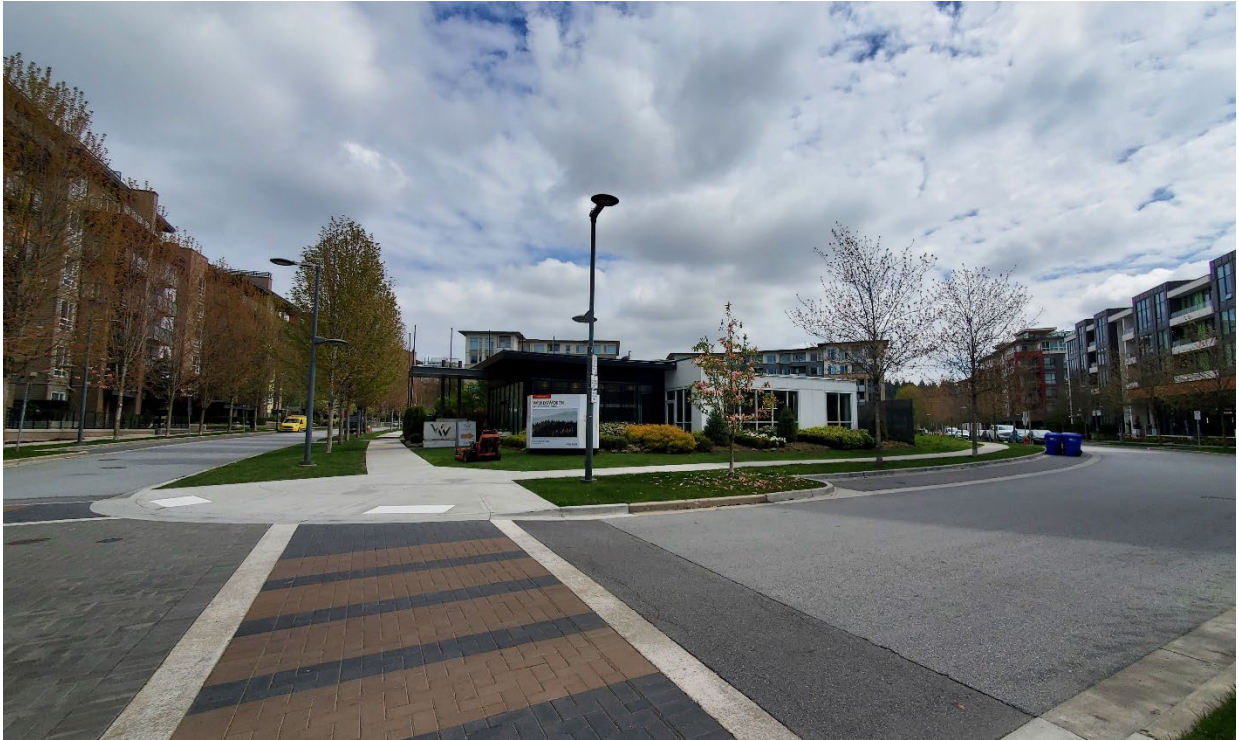
Photo 1. Overview of subject site. Viewing north.

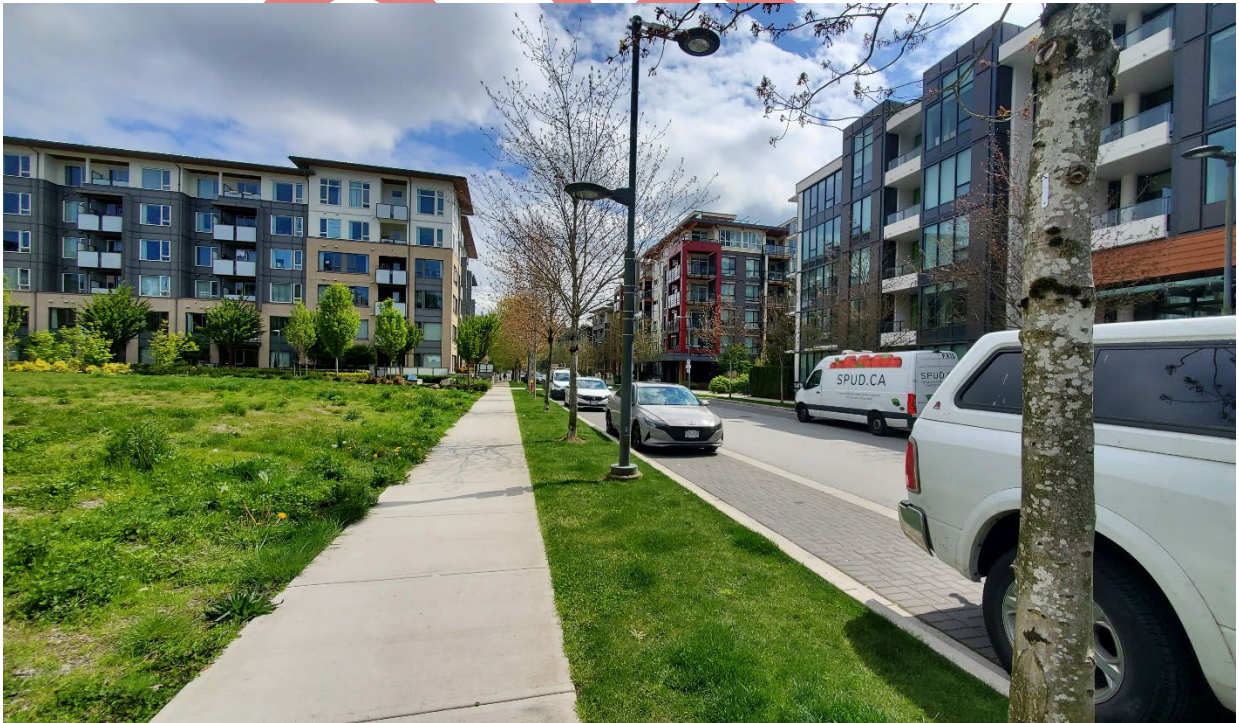
Photo 2. Boulevard trees #2010-2020 right in photo.

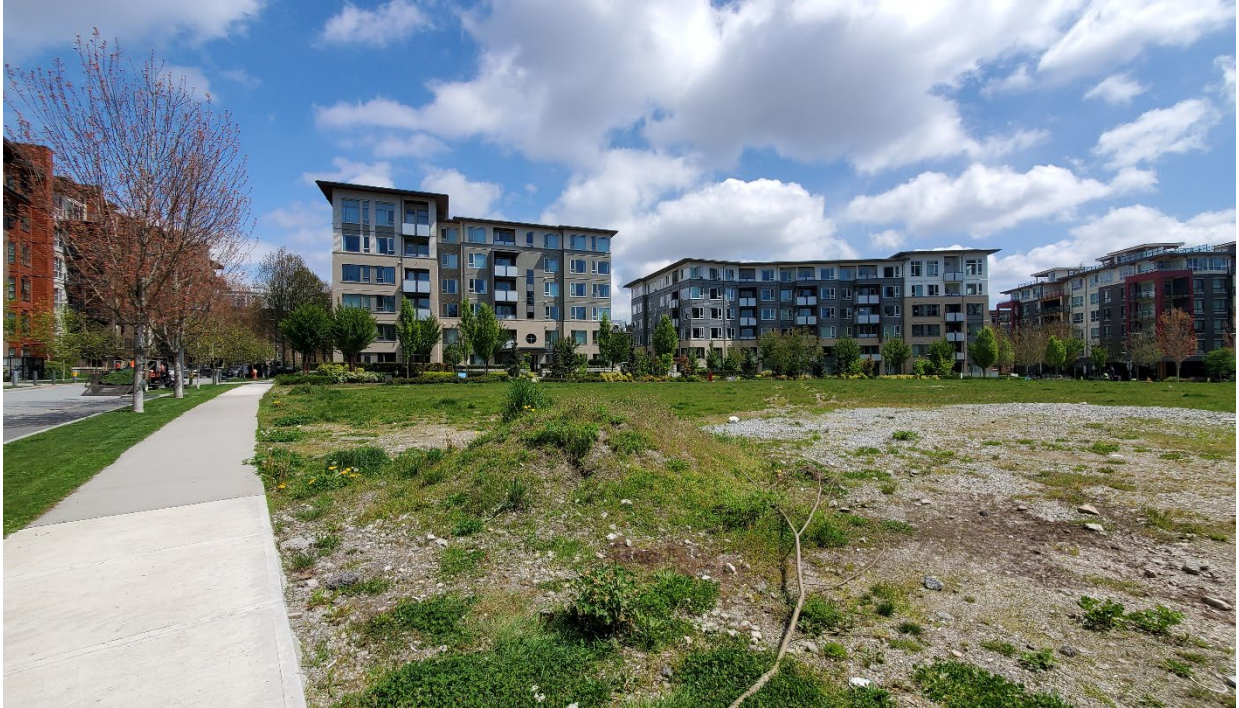
Photo 3. Overview of subject site. Viewing east.

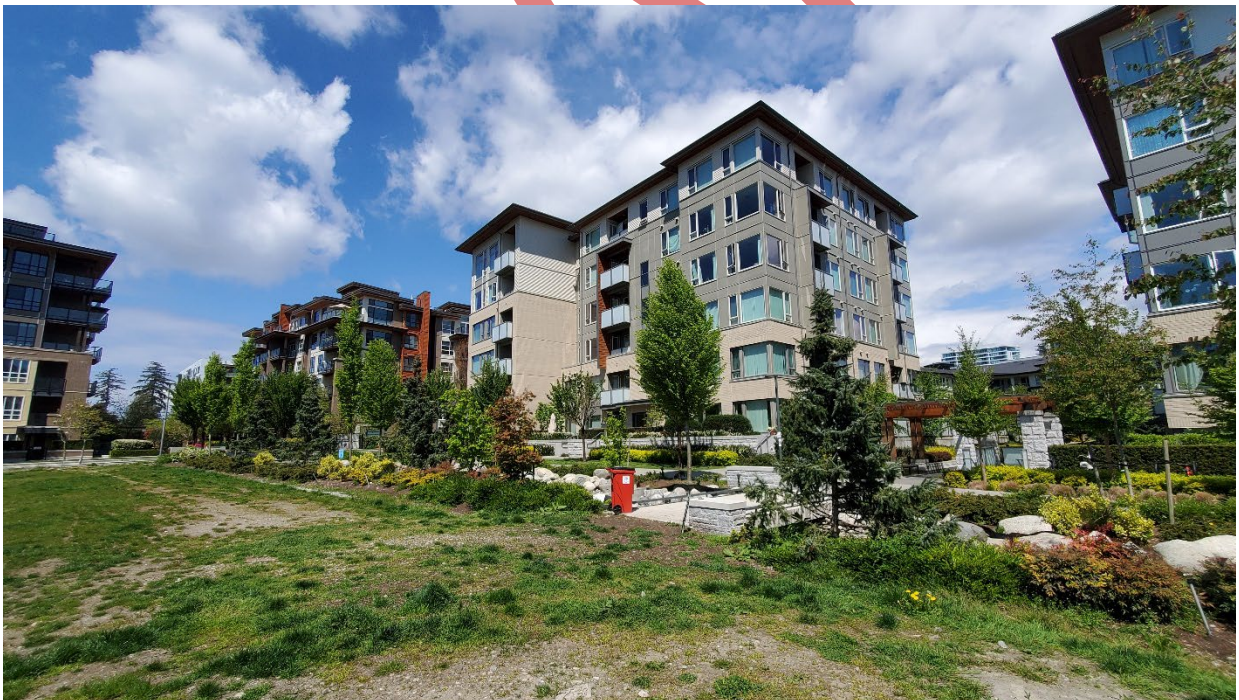
Photo 4. Landscape trees by water feature.

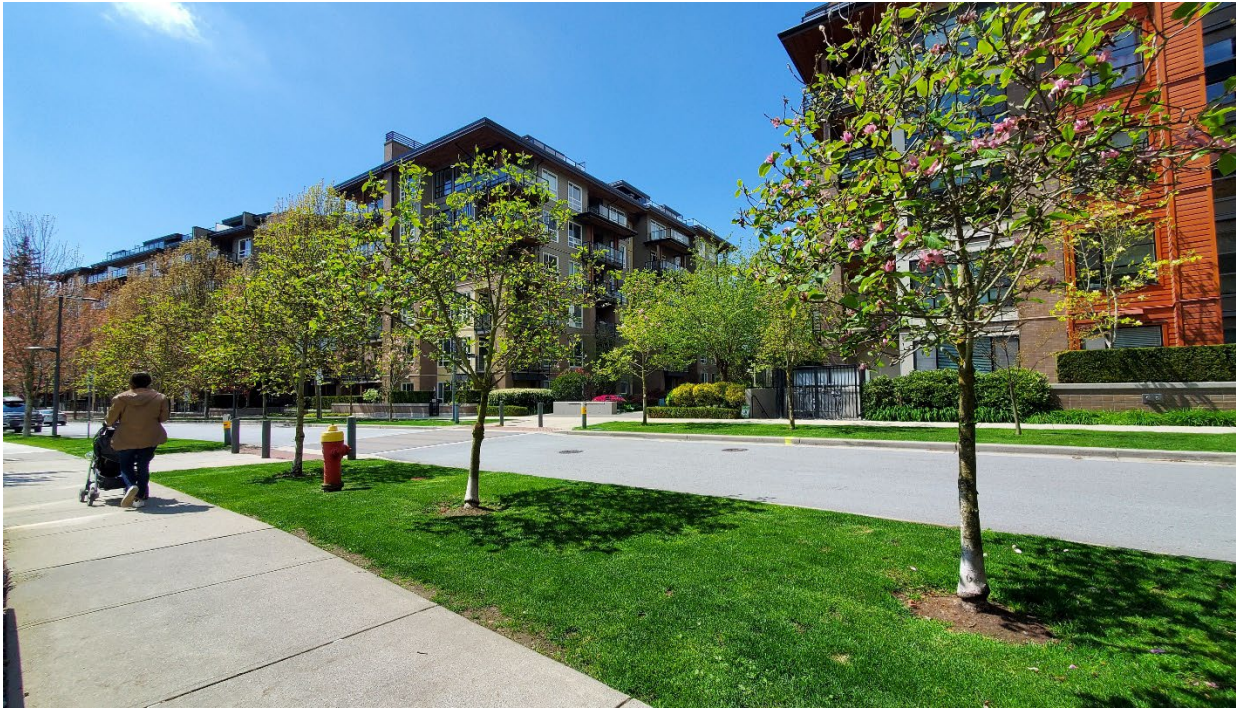
Photo 5. Boulevard trees #2073-2078.

- **UBC Owned trees # 2023 to 2038, 2041 to 2053, 2073 to 2080, and 2096:** retain and protect as required, per the associated tree management plan and arborist notes. The trees are outside the scope of the project and are not expected to be impacted by the proposed development.

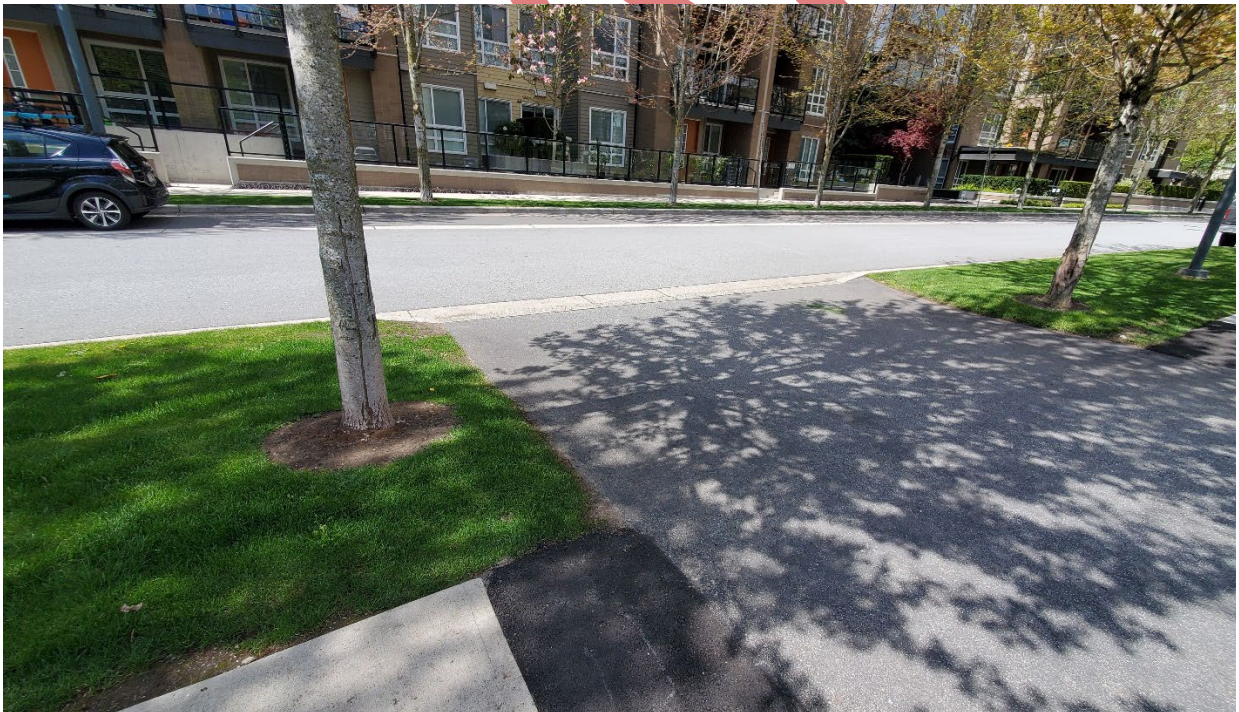
Y	2085	UBC owned	Magnolia	<i>Magnolia spp.</i>	24	12	4	Good	Tree planted on boulevard. Crown slightly encroaching light pole. Roots restricted by concrete sidewalk and road. Minor sunscald damage on trunk but tree still has good vigour.	High	Remove	In conflict with the proposed parking along the curbside.	2
Y	2086	UBC owned	Red Maple	<i>Acer rubrum</i>	24	12	4	Moderate	Tree planted on boulevard. Root zone on south side recently paved over. Roots restricted by concrete sidewalk and road. Historical sunscald damage that has been sealed.	Medium	Remove	In conflict with the proposed parking along the curbside.	2

Photo 6. Trees #2084-2085 with new paved access within their root zones.
