Arboricultural Inventory and Report

Anthropology and Sociology Building (ANSO)

6303 NW Marine Drive

Date: September 18, 2024

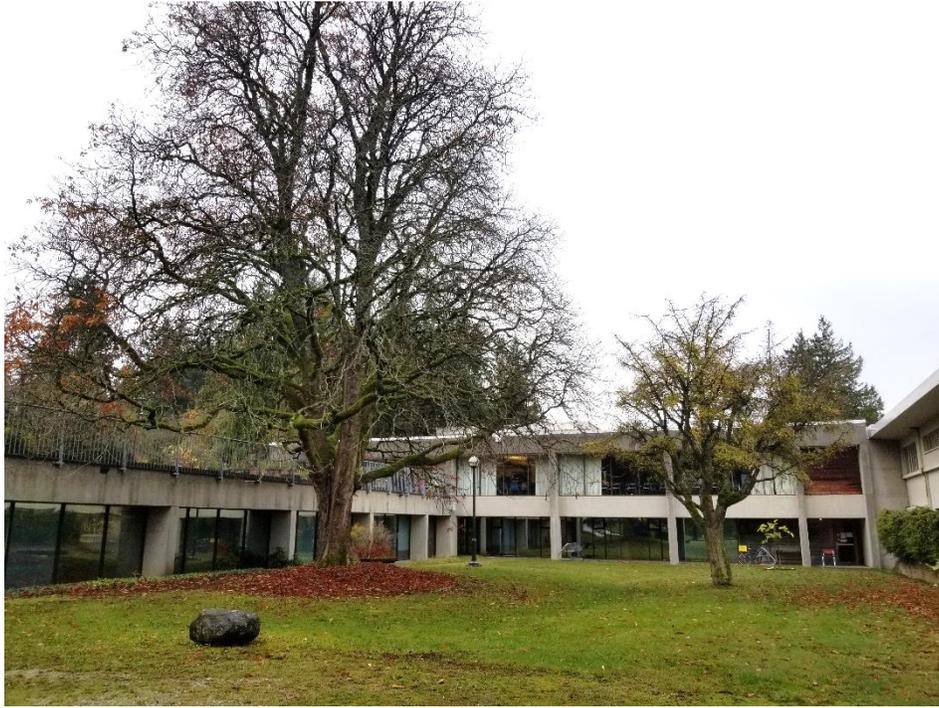
Photo 1. Trees #6018 and #6110, trees are within courtyard, viewing east.

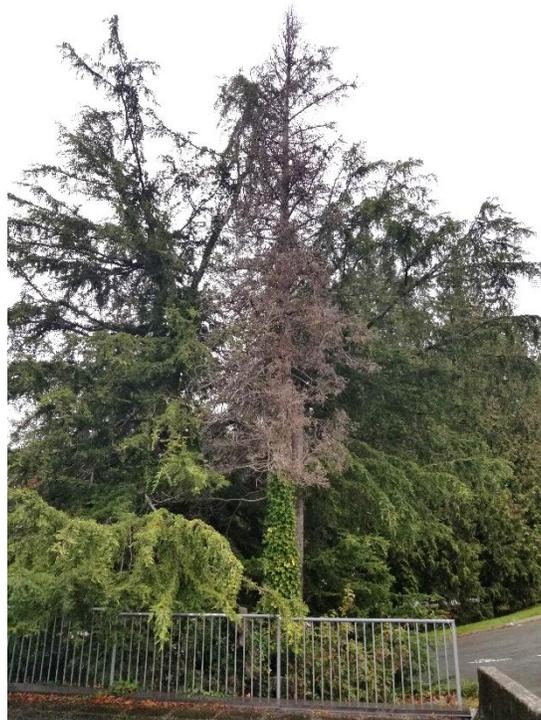
Photo 2. Dead tree #3997, viewing west

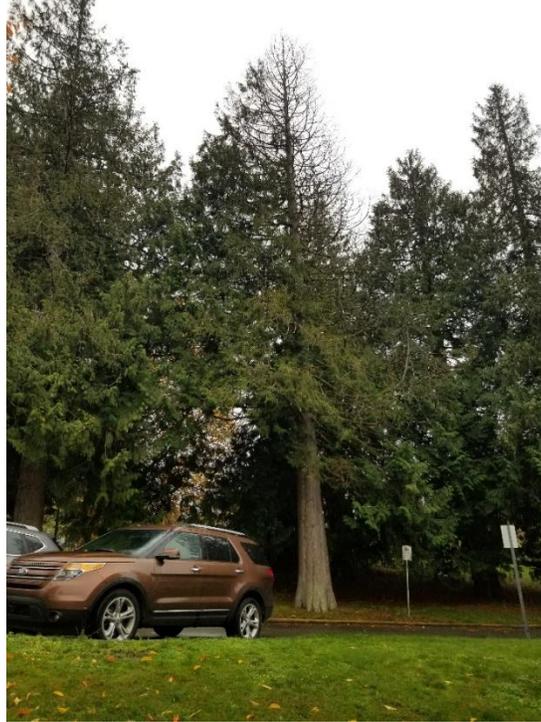
Photo 3. Dying tree # 6121, viewing south..

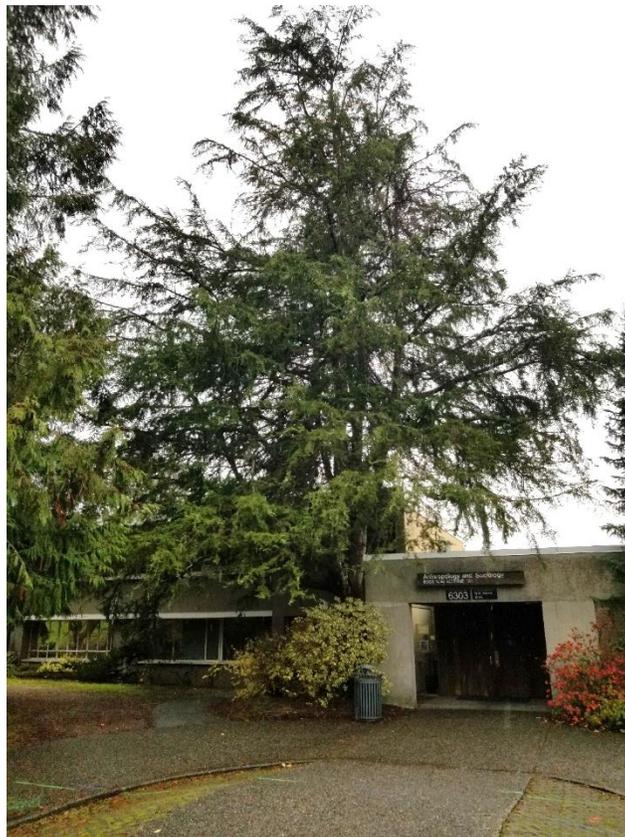
Photo 4. Tree #1707, Tree planted right against existing building. Viewing northwest.

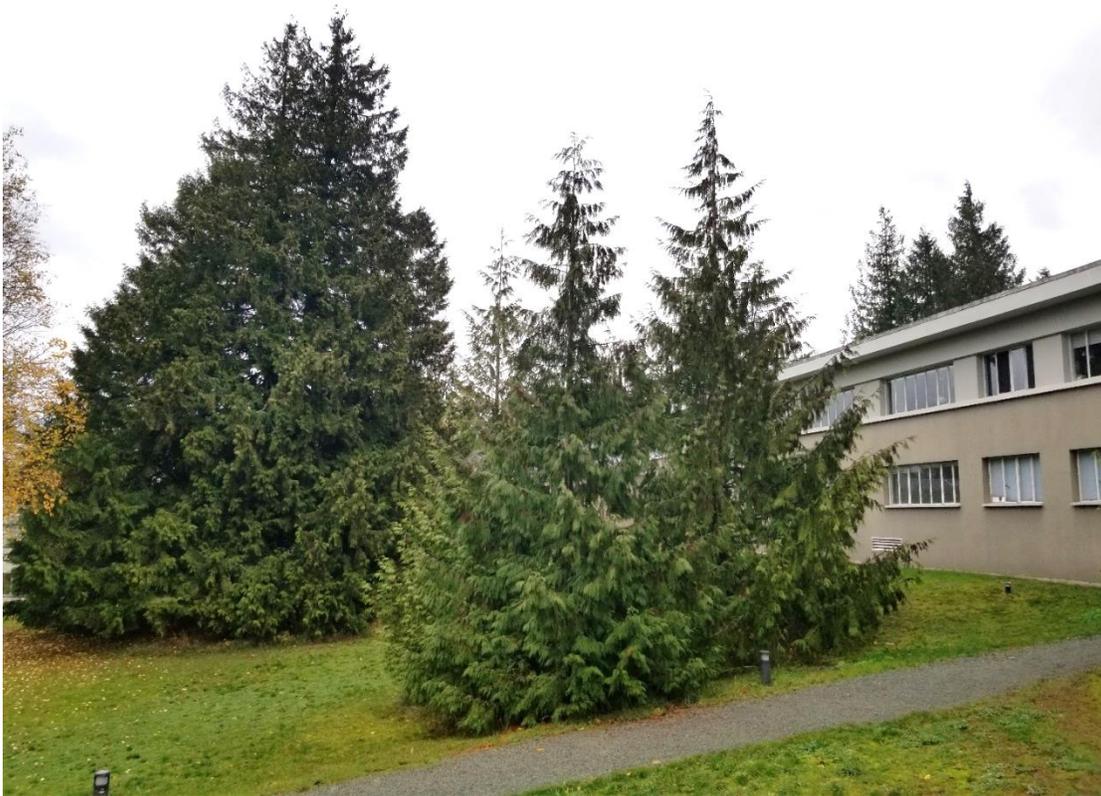
Photo 5. Trees # 6302, 8301-8303, viewing east.
