# UBC Ponderosa Commons | Development Review Committee Application

**DRAFT -Arborist Report  
Student Housing  
Complex at Ponderosa Centre**

January 6, 2010

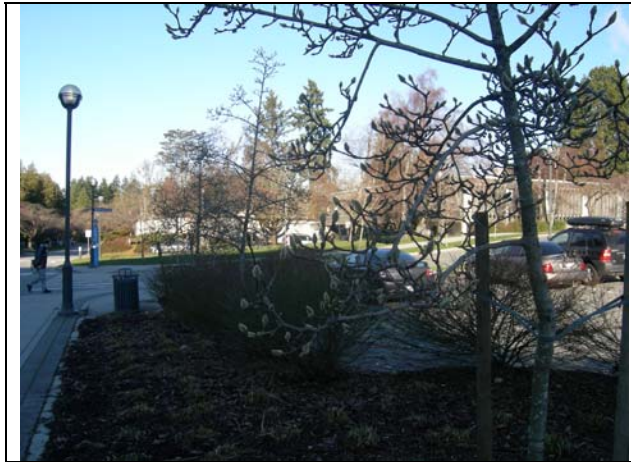
Photo 1. View of the magnolias in the planting bed off of lower mall.

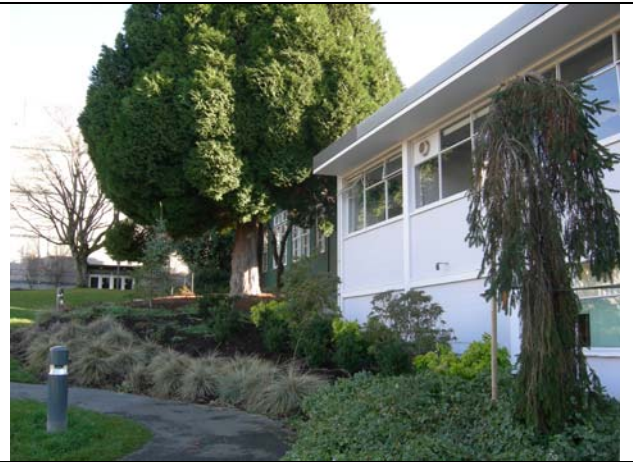
Photo 2. Looking at the weeping spruce and cypress outside of the Botany annex. Note the large maple in the background. All three are significant trees.

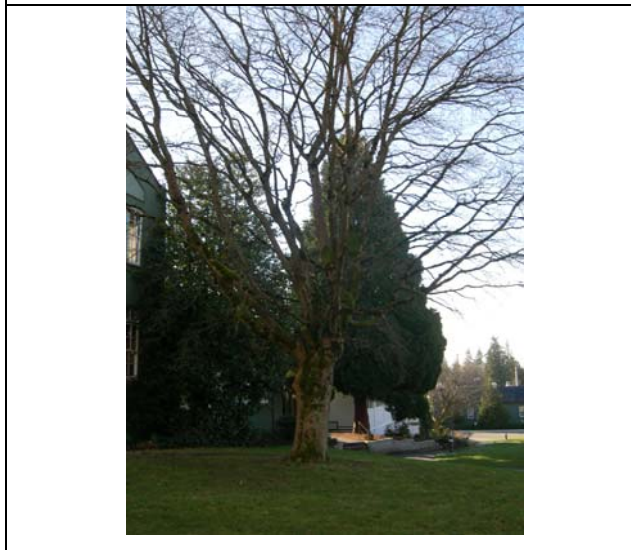
Photo 3. View of the large *Acer Campestris* near the Botany and Film building

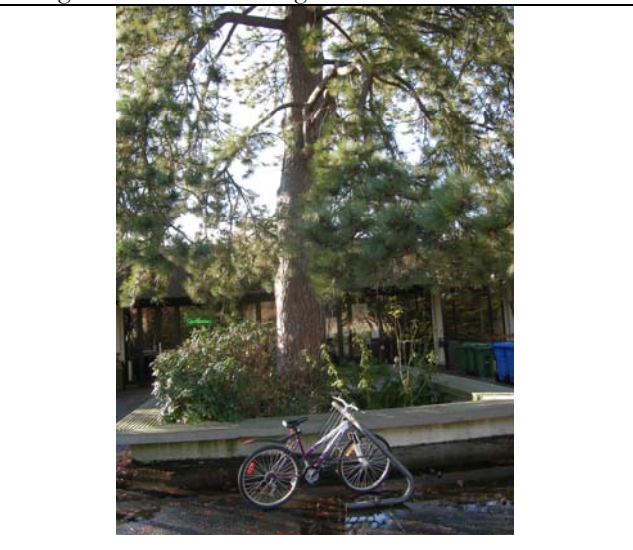
Photo 4. Photo of the large ponderosa pine outside of the ponderosa building.
