Arborist Report

University of British Columbia Properties Trust

Wesbrook Community Centre

December 18, 2018

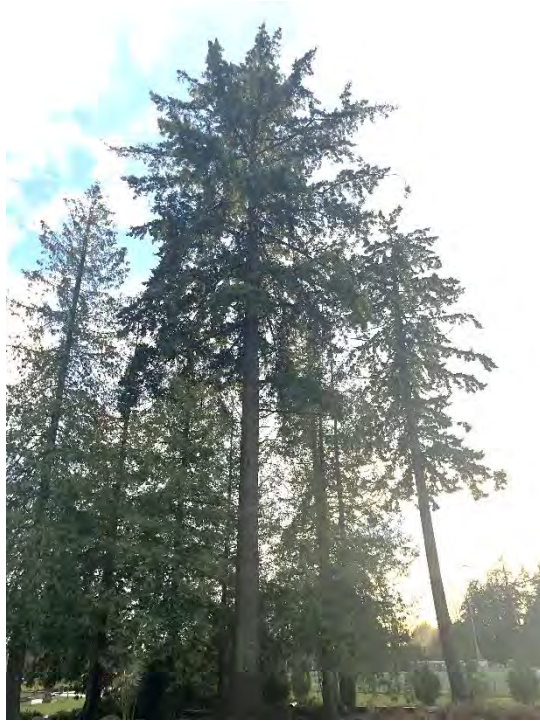
Photo 1. Looking southwest. Tree 8867 in the center with tree 6681 (western redcedar with a thinning crown) to the left and 8893 to the right of it (another large Douglas-fir. The smaller trees are amongst these three larger trees.

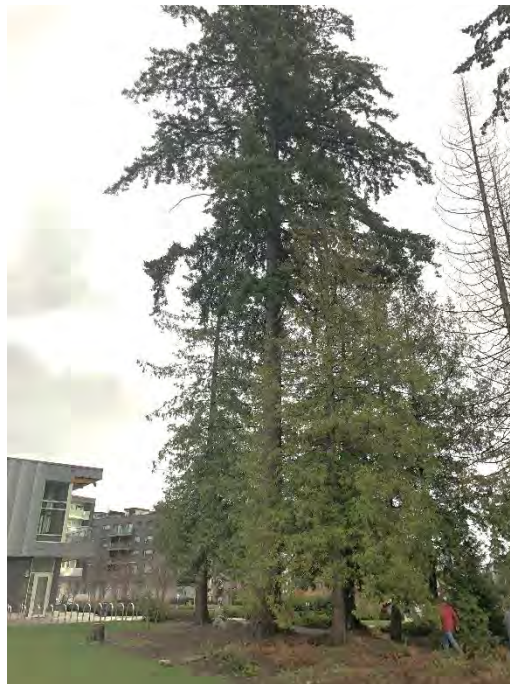
Photo 2. Looking northeast at tree 8893 with some of the dying cedars to the right (8879, 8883)

Trees 8879, 8883, 8880, 6681 and 6319 are proposed for removal. It is understood that all these trees may have large stumps left in place, so they can be used for play structures.

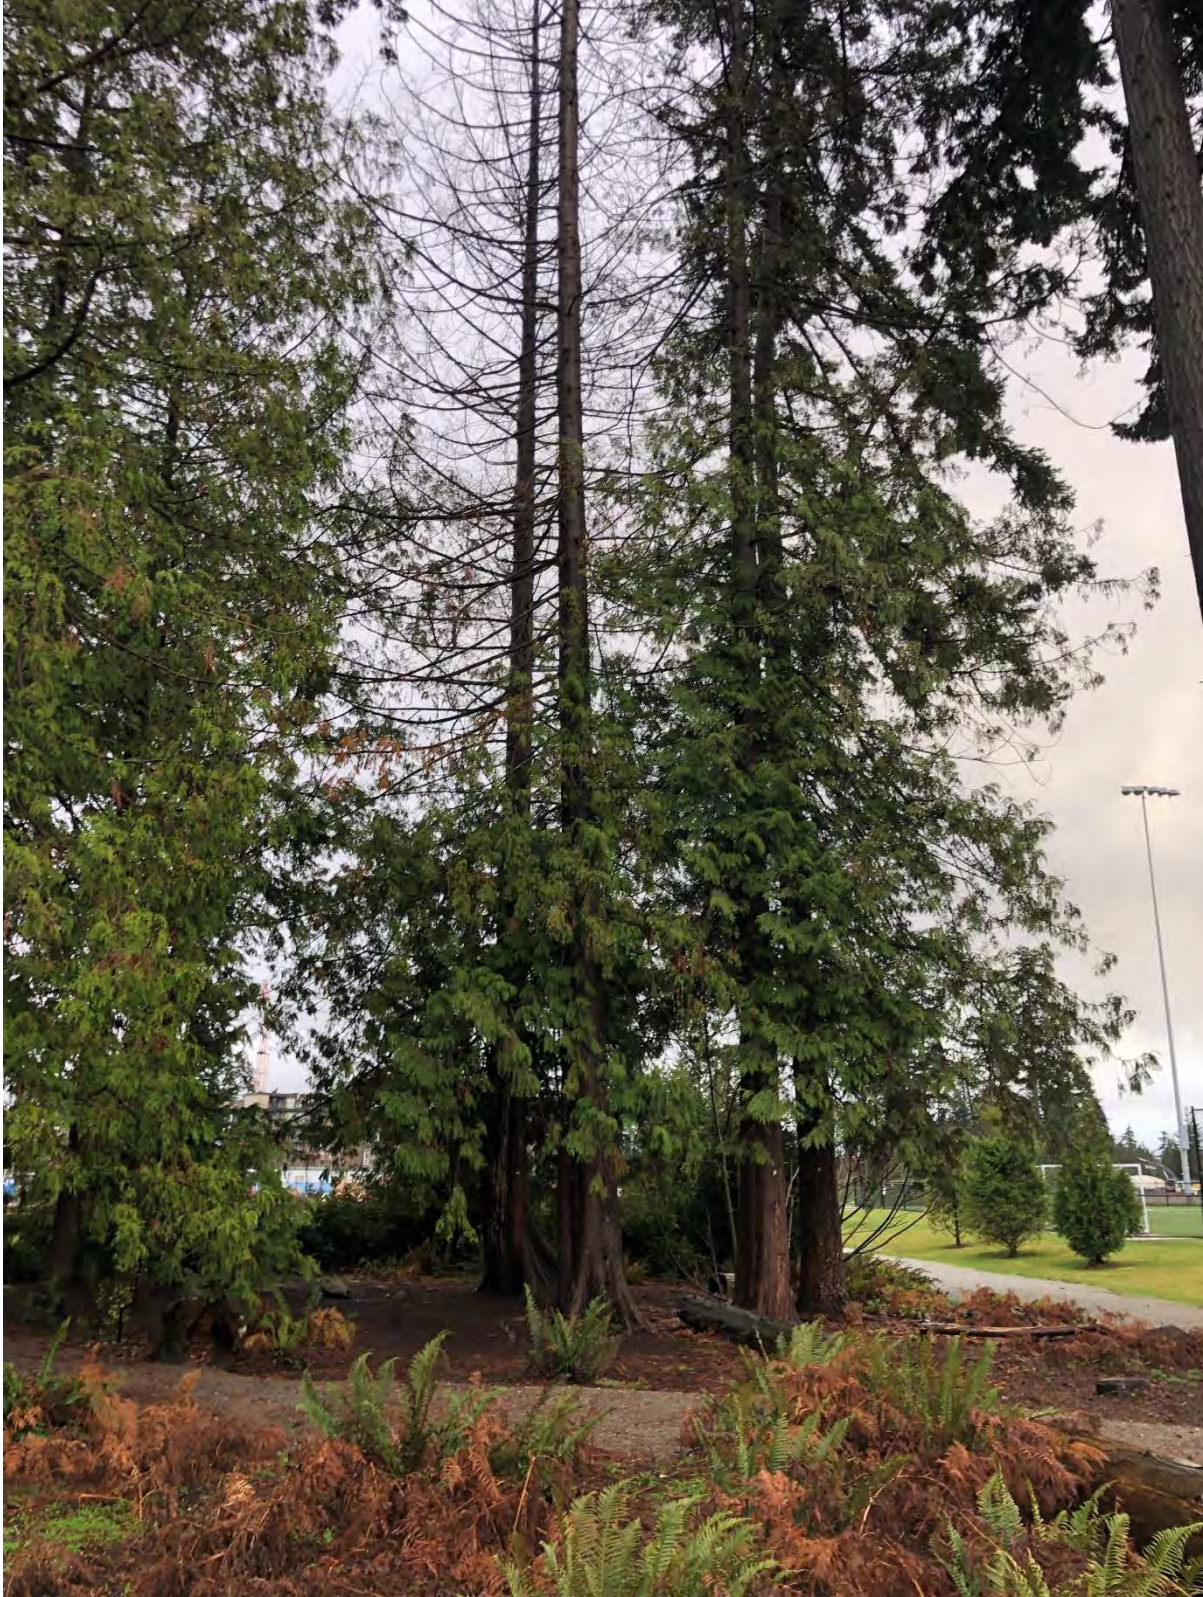
One tree 6319 has a defect in its stem and is leaning to the south. This tree has a high height to diameter ratio and the combination of its lean, the kink in the stem makes it prone to failure. Tree Risk Assessment

There were no trees on this site that posed a *high* or *extreme* risk at the time of assessment. One tree (6319) has a defect in its stem and is leaning to the south. The combination of its high height to diameter ratio its lean and the kink in the stem makes it prone to failure. Tree 6681 has a codominant stem in the upper canopy which will become a larger risk in the future but at this time the parts are less than 15cm in diameter and may get hung up in the tree.

Photo 3. Looking south at trees 6319 (from the center left) with a dead top and tree 8883 and 8879 to its right with dead tops as well. Tree 8880 is to the far right and its kink and lean is somewhat noticeable from this angle.

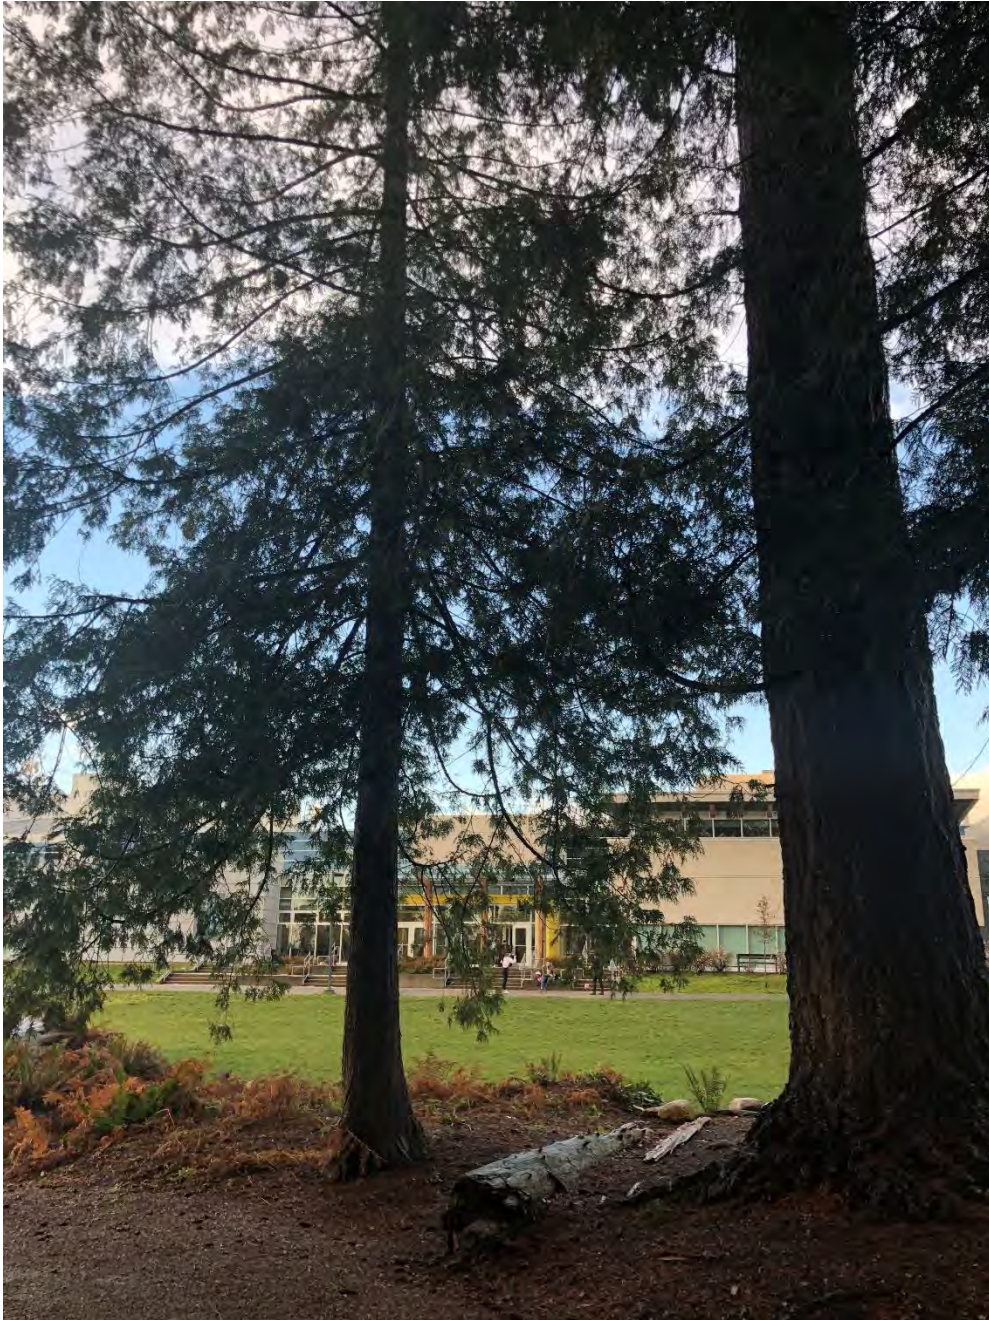
Photo 4. Looking north at tree 6316 with tree 8867 to its right.

Trees 8893, 6316, 8867, 6313, T1, 6322, 8862 are all proposed for retention. Care will be required in determining the extent of work to be conducted within the tree protection zone of these trees with the proposed child play area. Team meetings with the project landscape architect and playground specialist have occurred to discuss methods. Another tree protection plan will be prepared for this work once the design moves further into its detailed design stage.
