# Tree Protection Plan

**6085 Thunderbird Blvd**

**TEF3 Parking Lot**

**Bartlett Tree Experts**

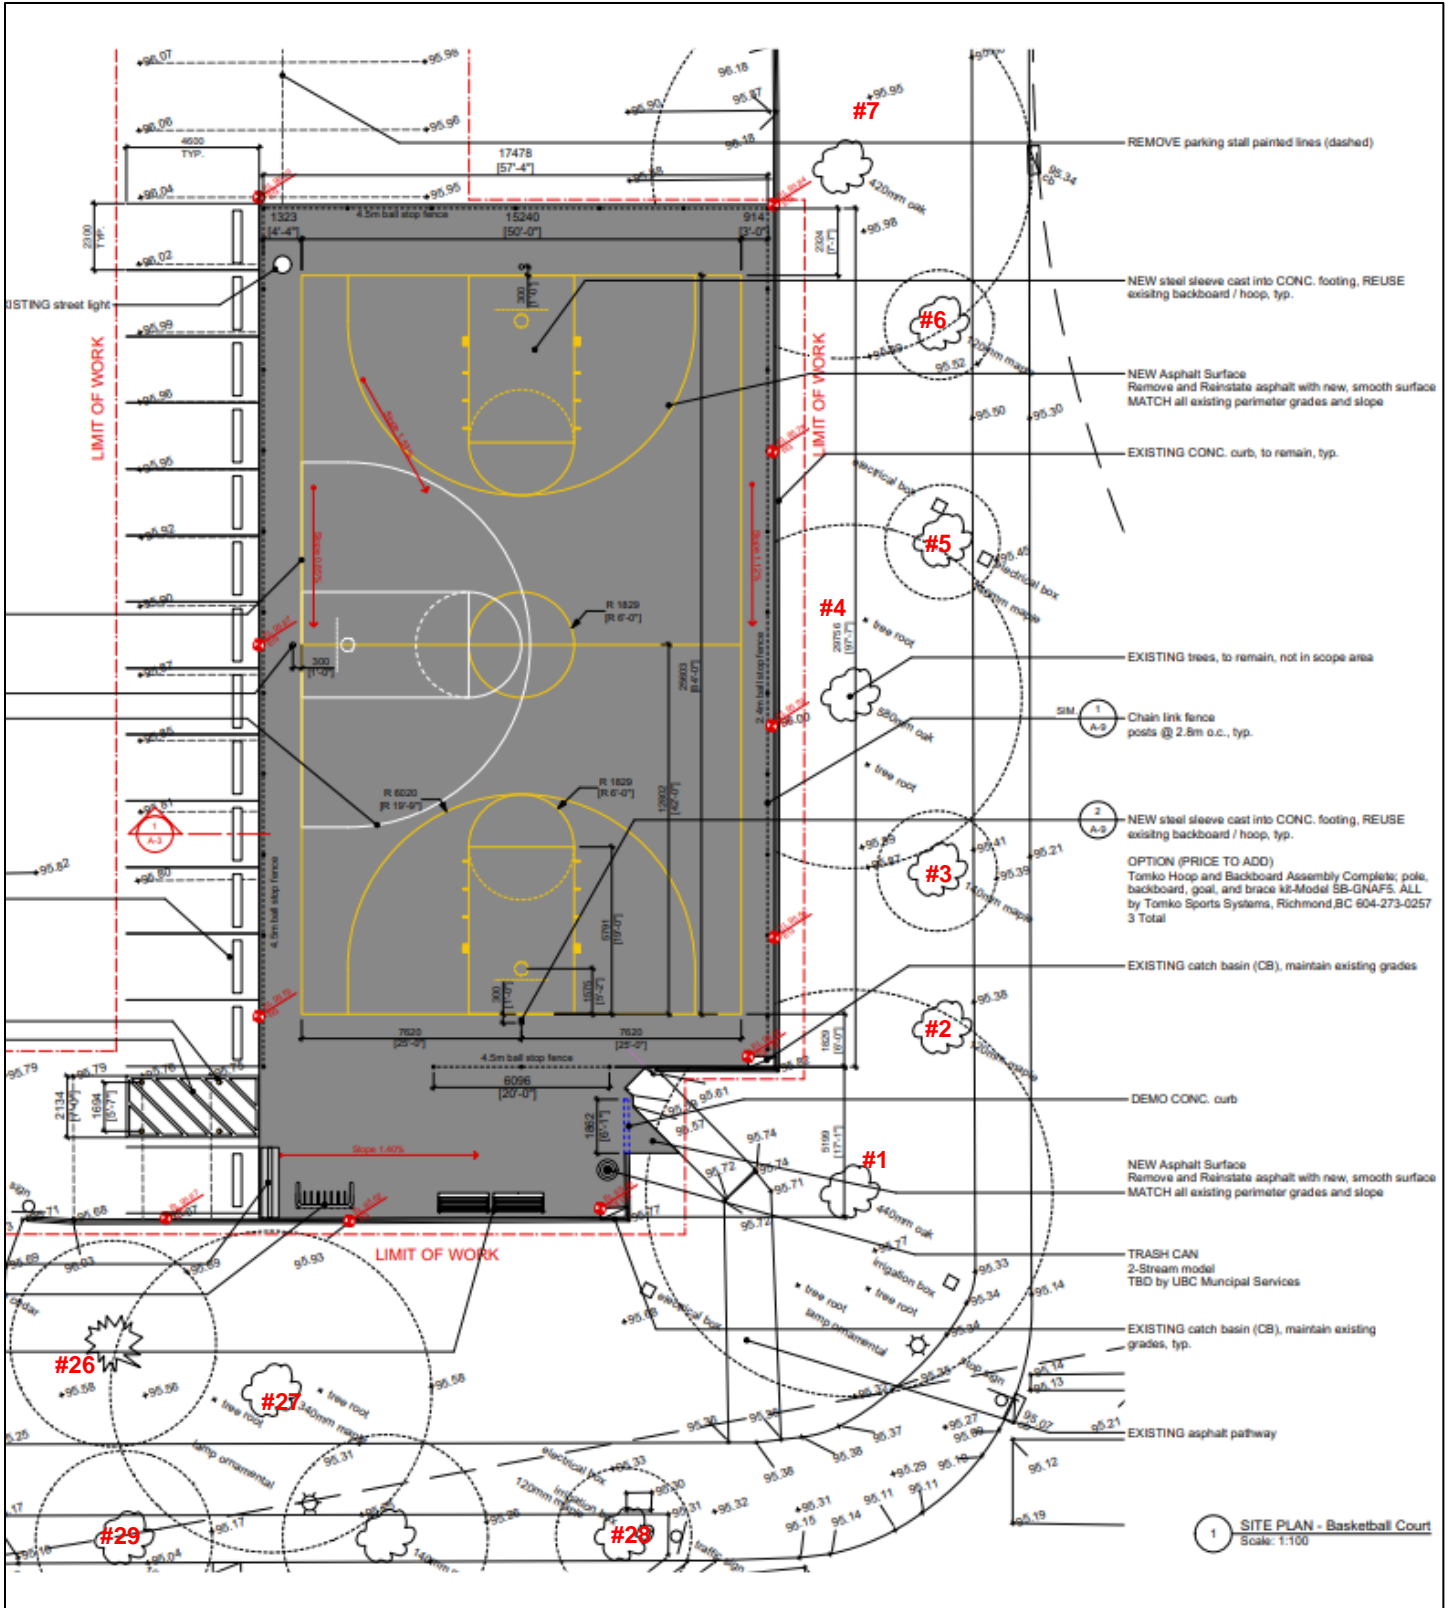
Trees in close proximity to the proposed development.

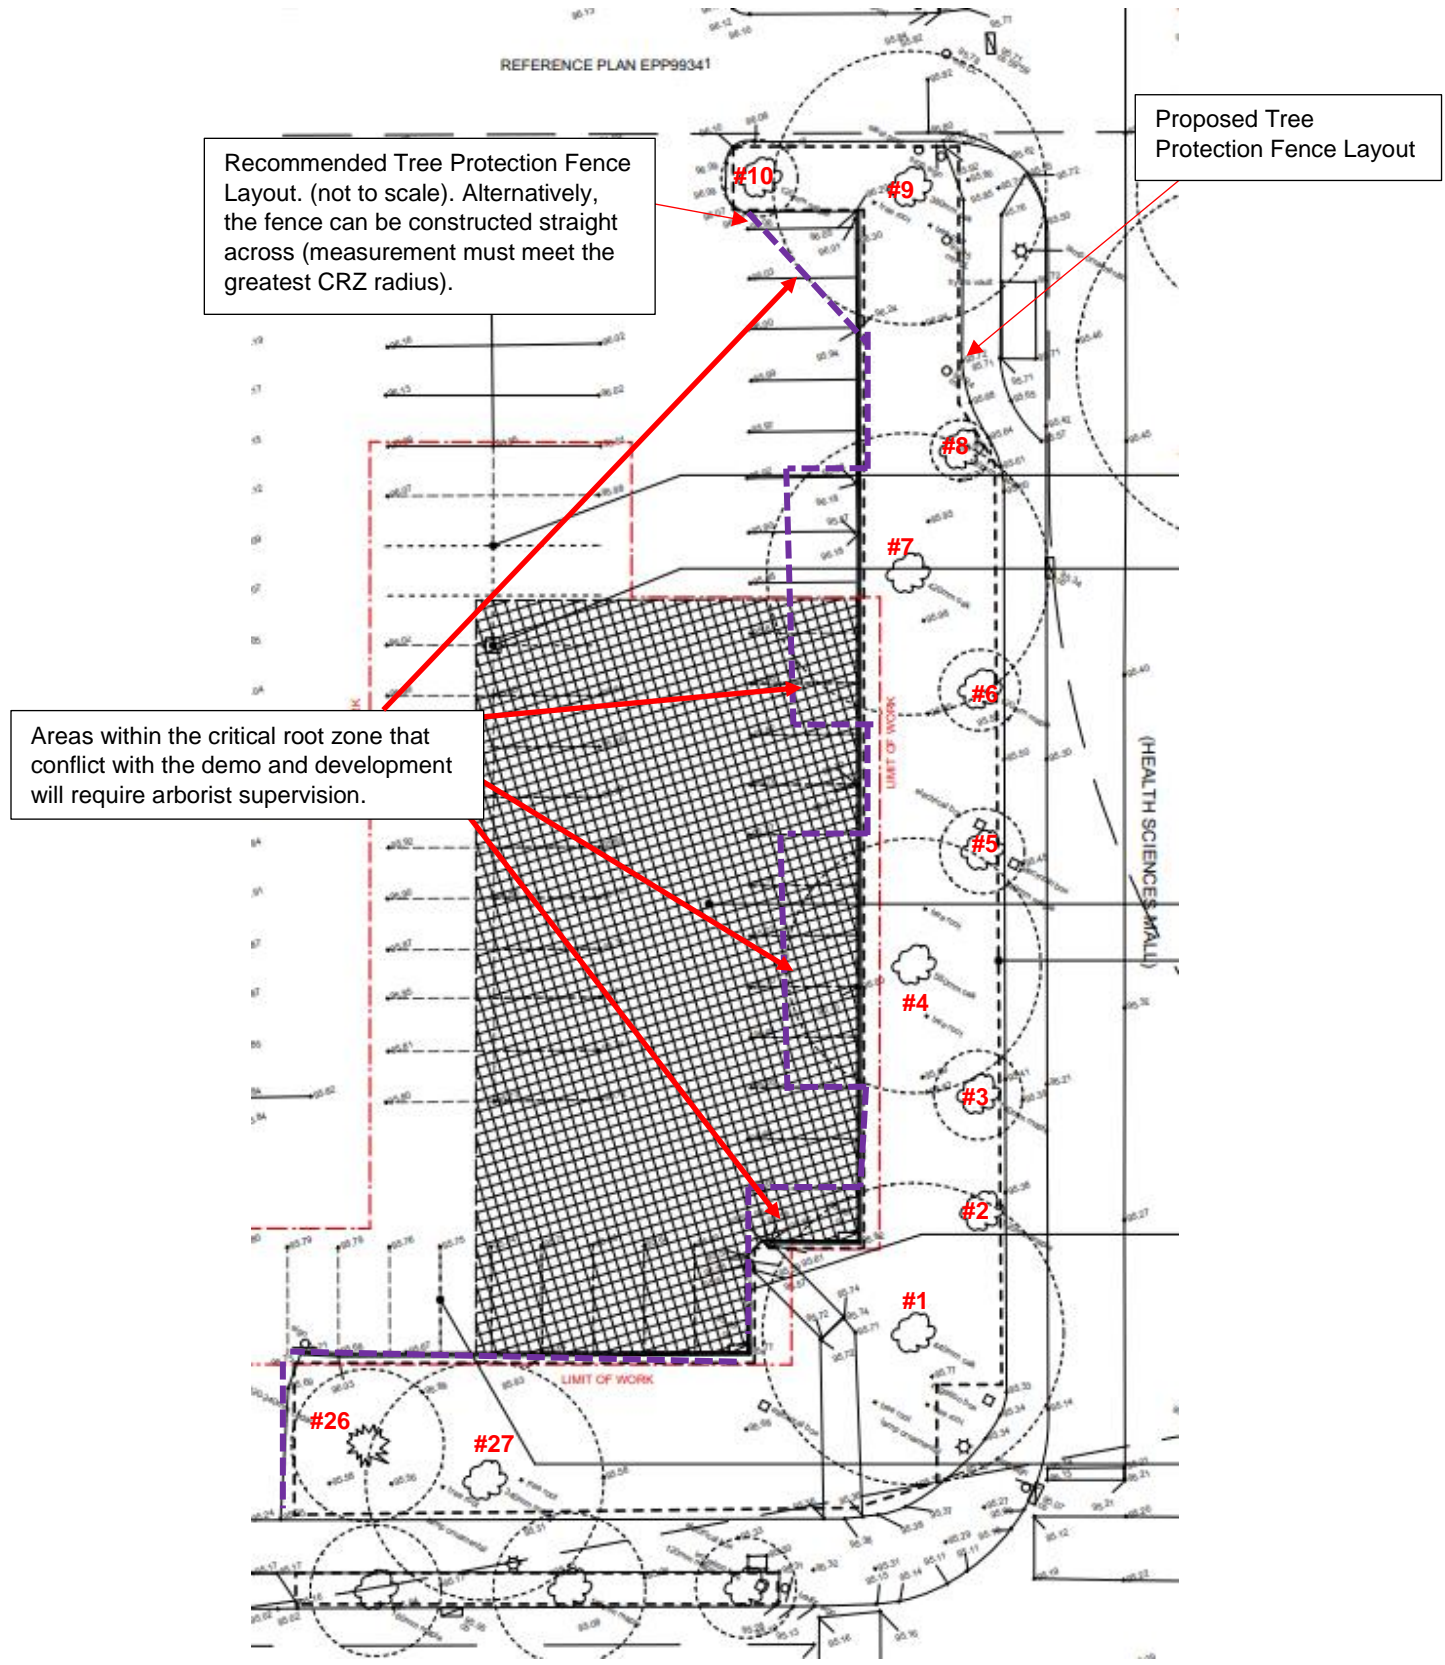
Demo plan and tree protection fence layout. (not to scale)

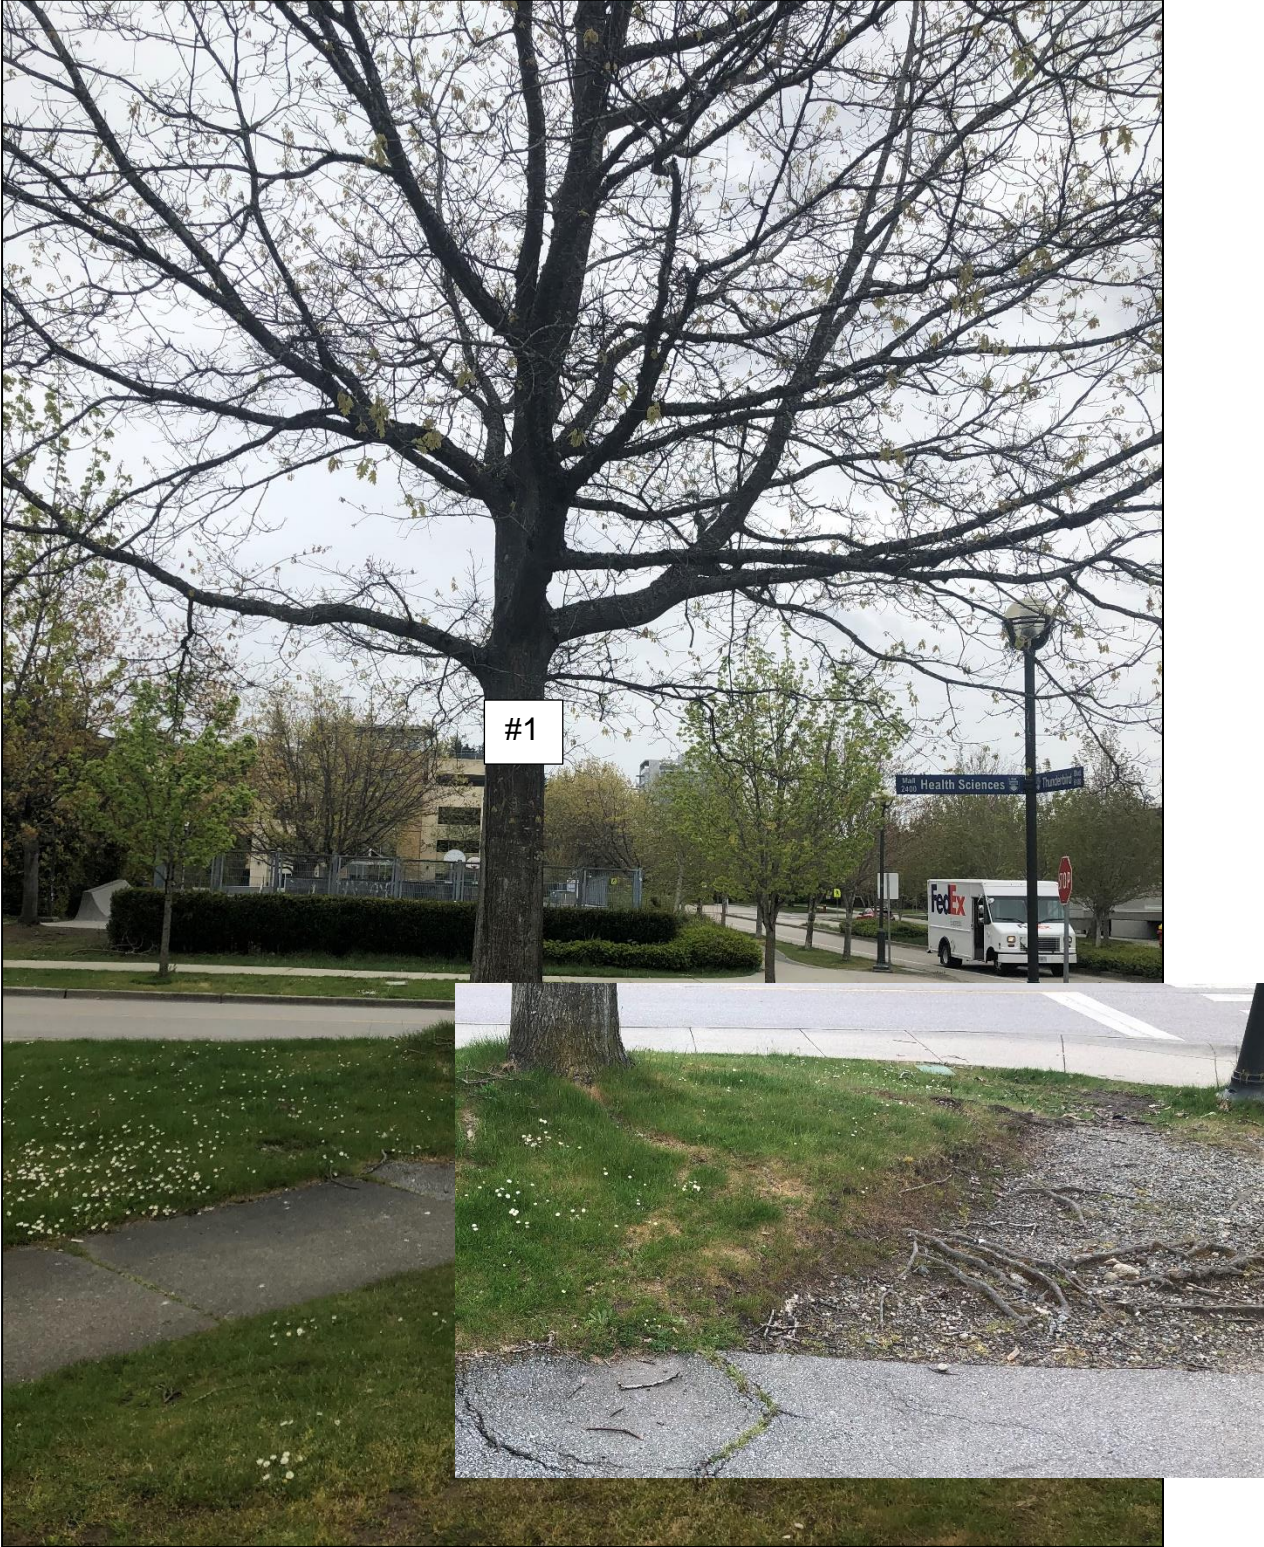
Figure 1: Tree #1, zoomed photo showing the exposed roots.

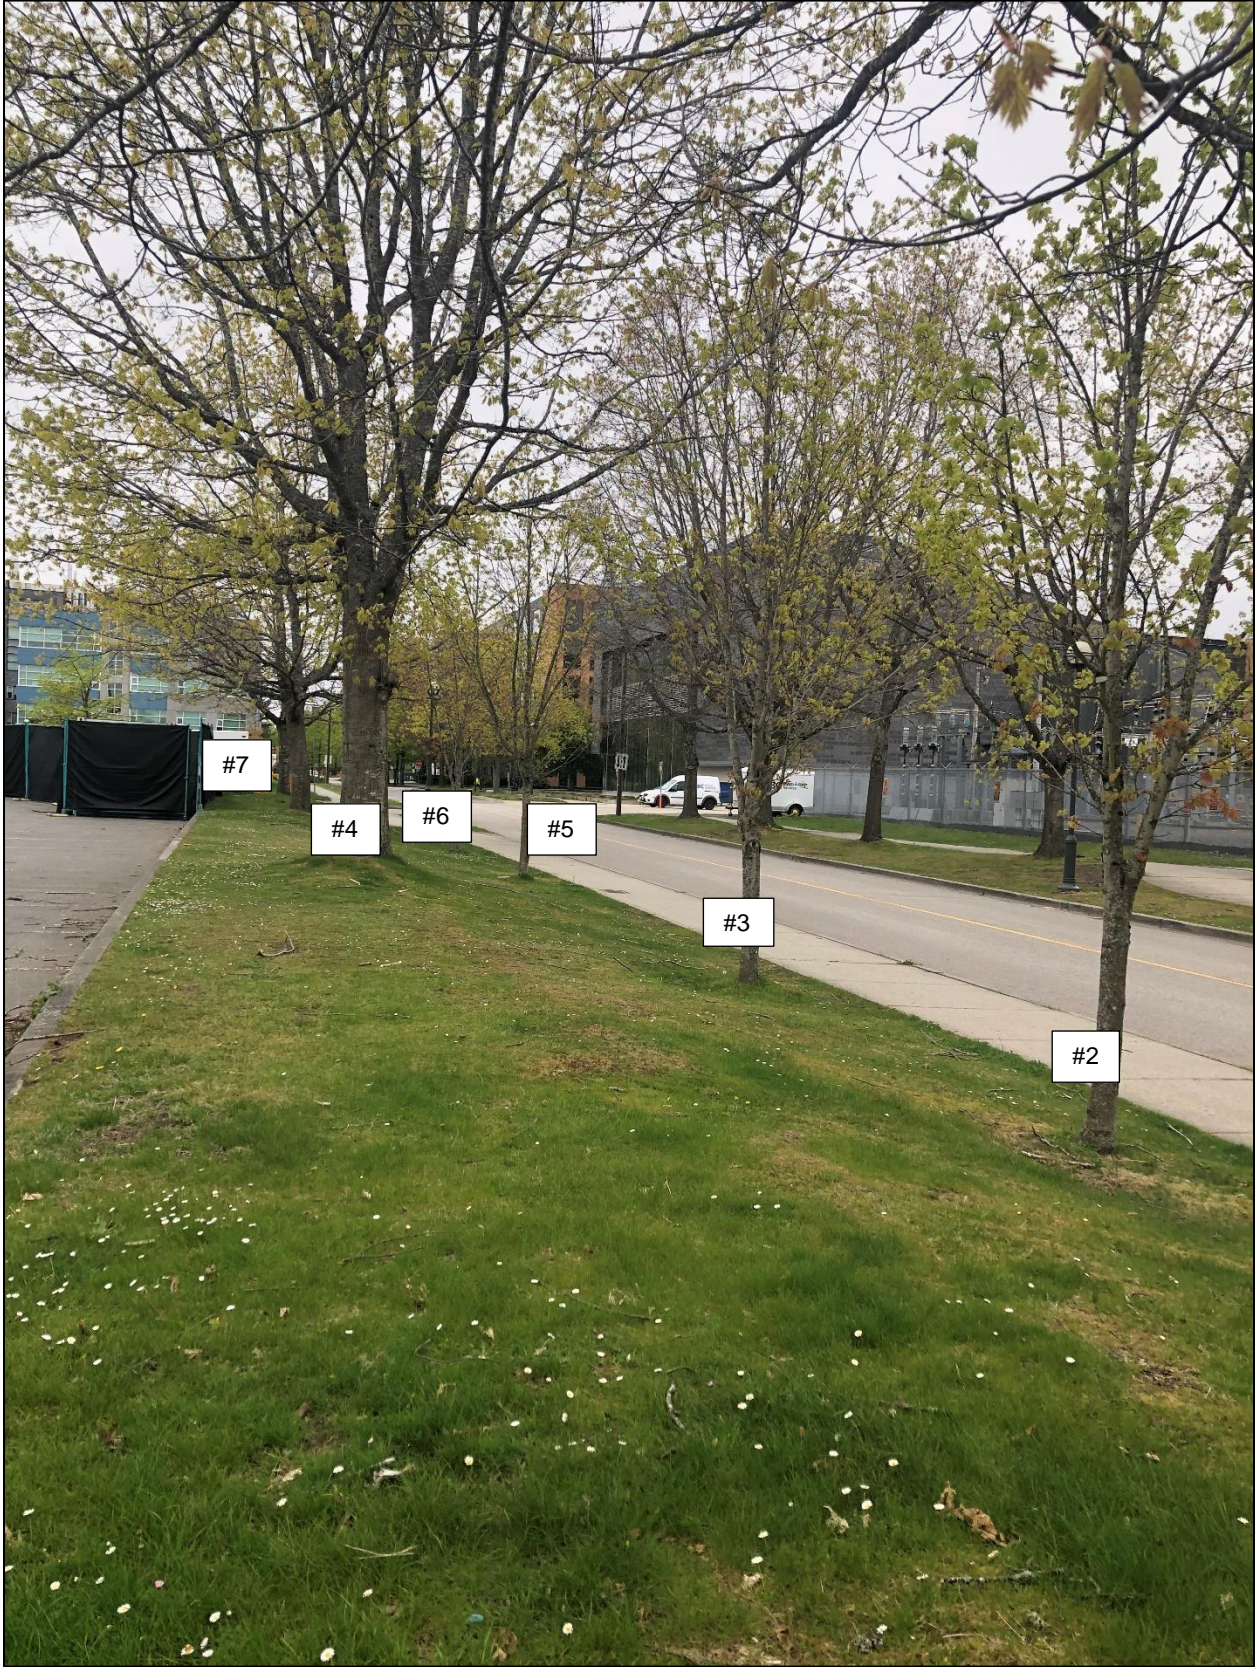
Figure 2: Trees at the east side of the site.

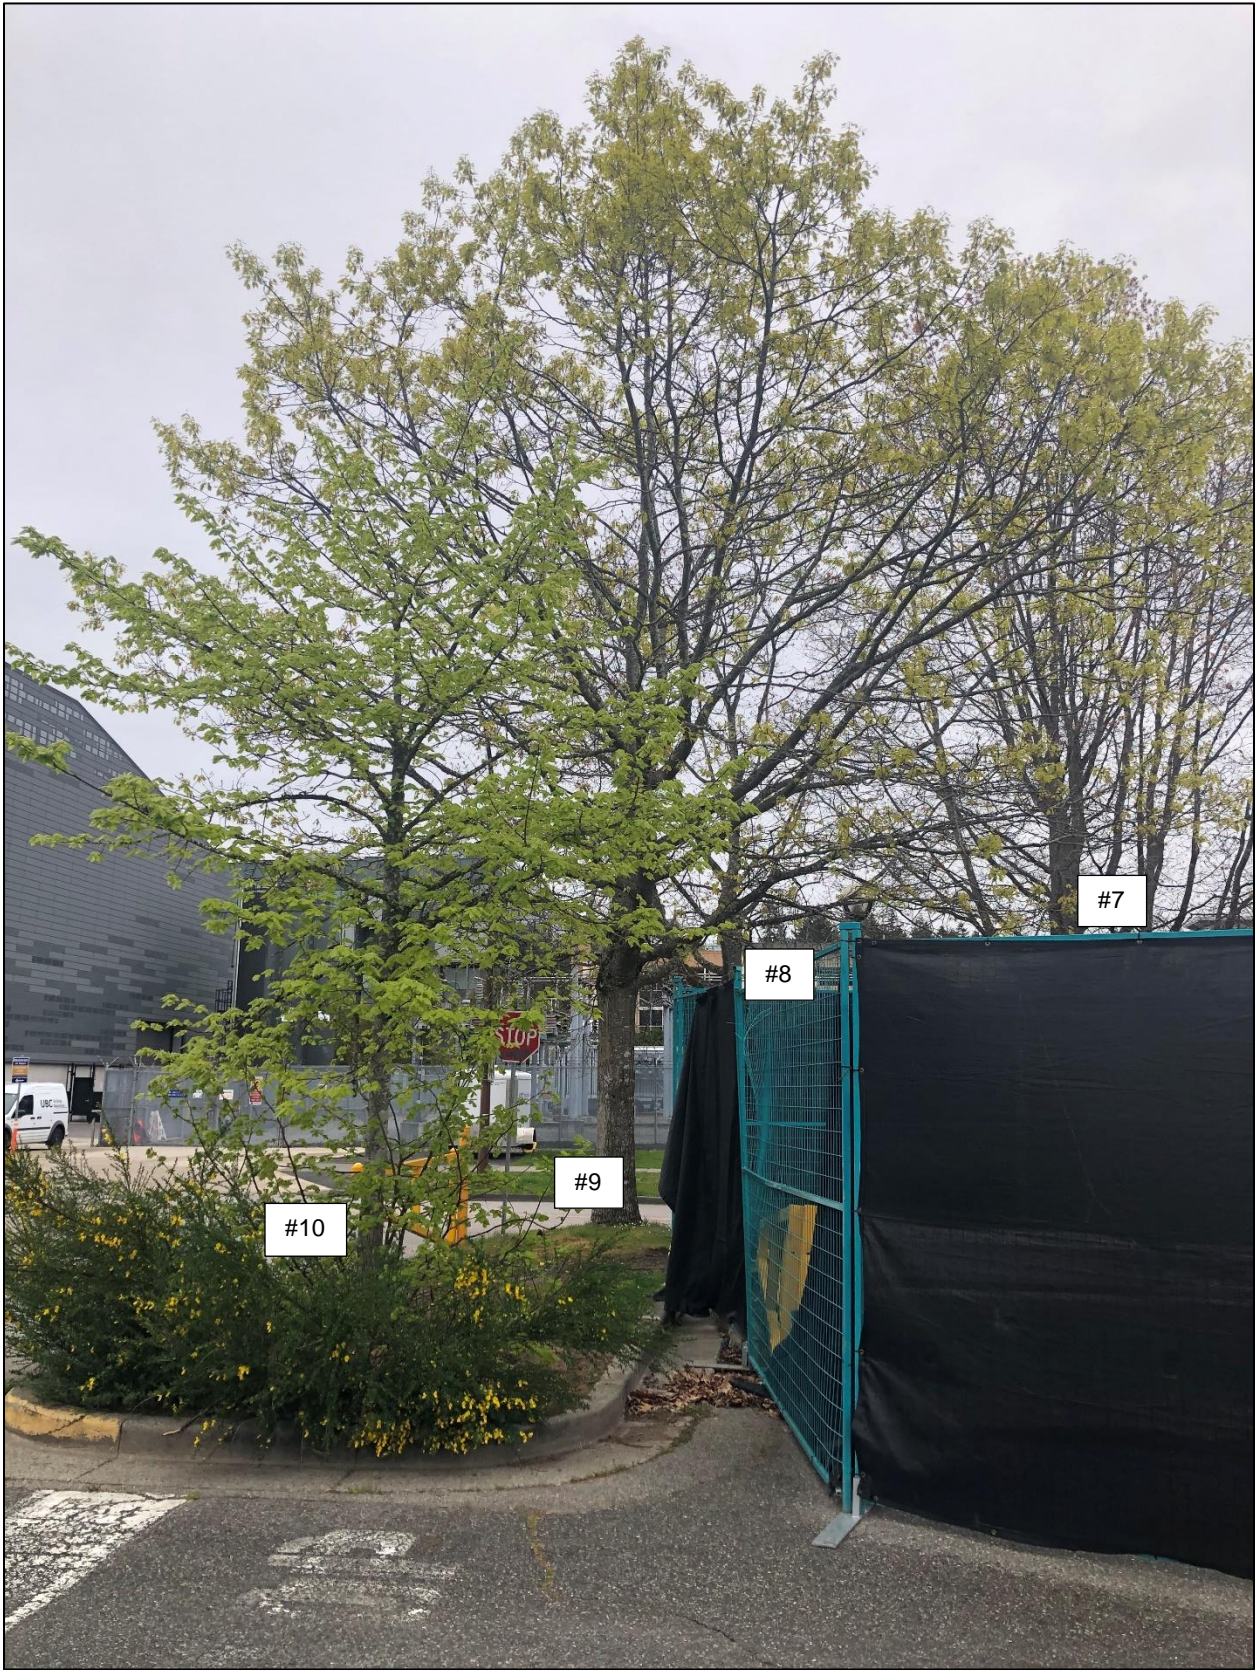
Figure 3: Trees at the north side of the site.

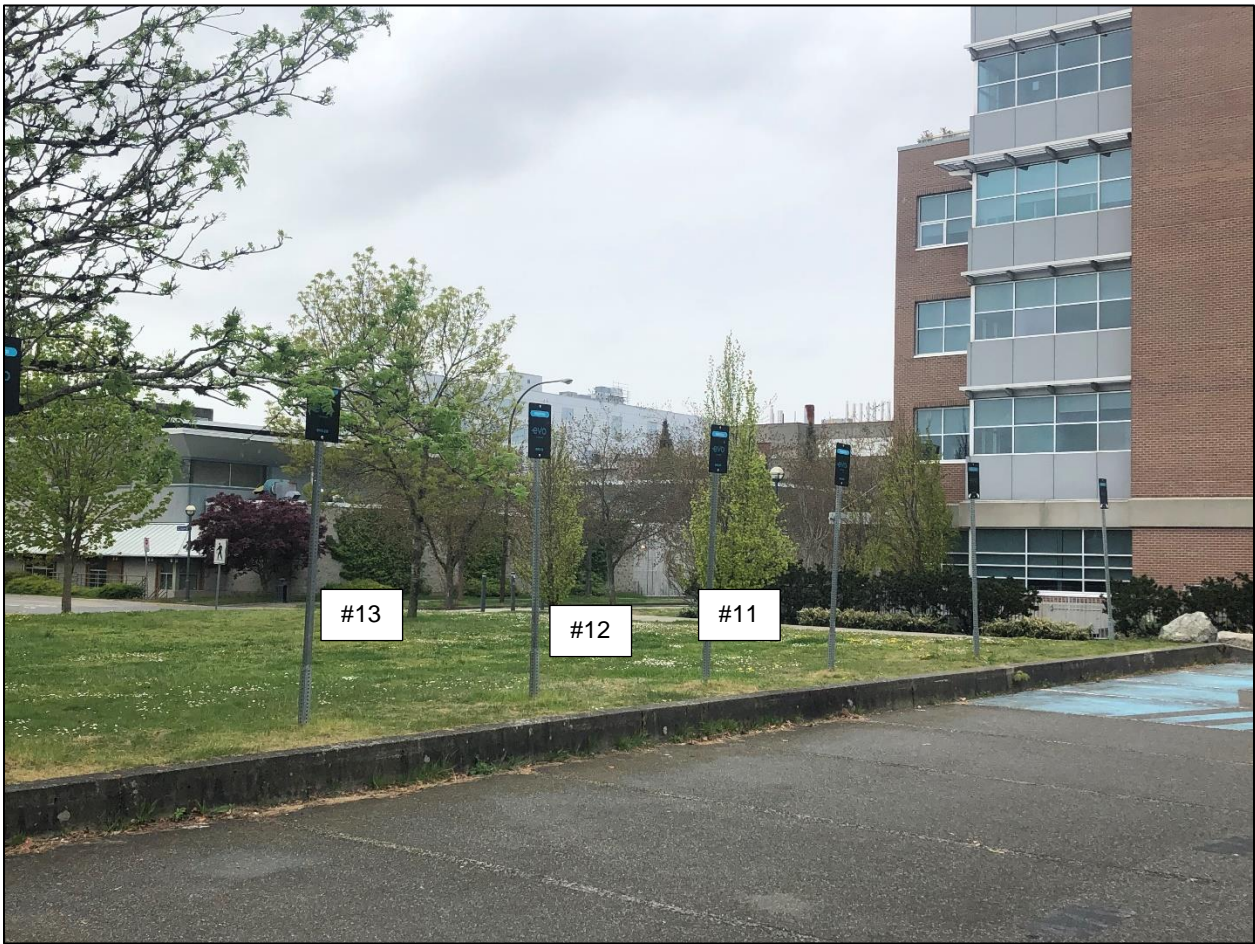
Figure 4: Trees on the northwest side of the site.

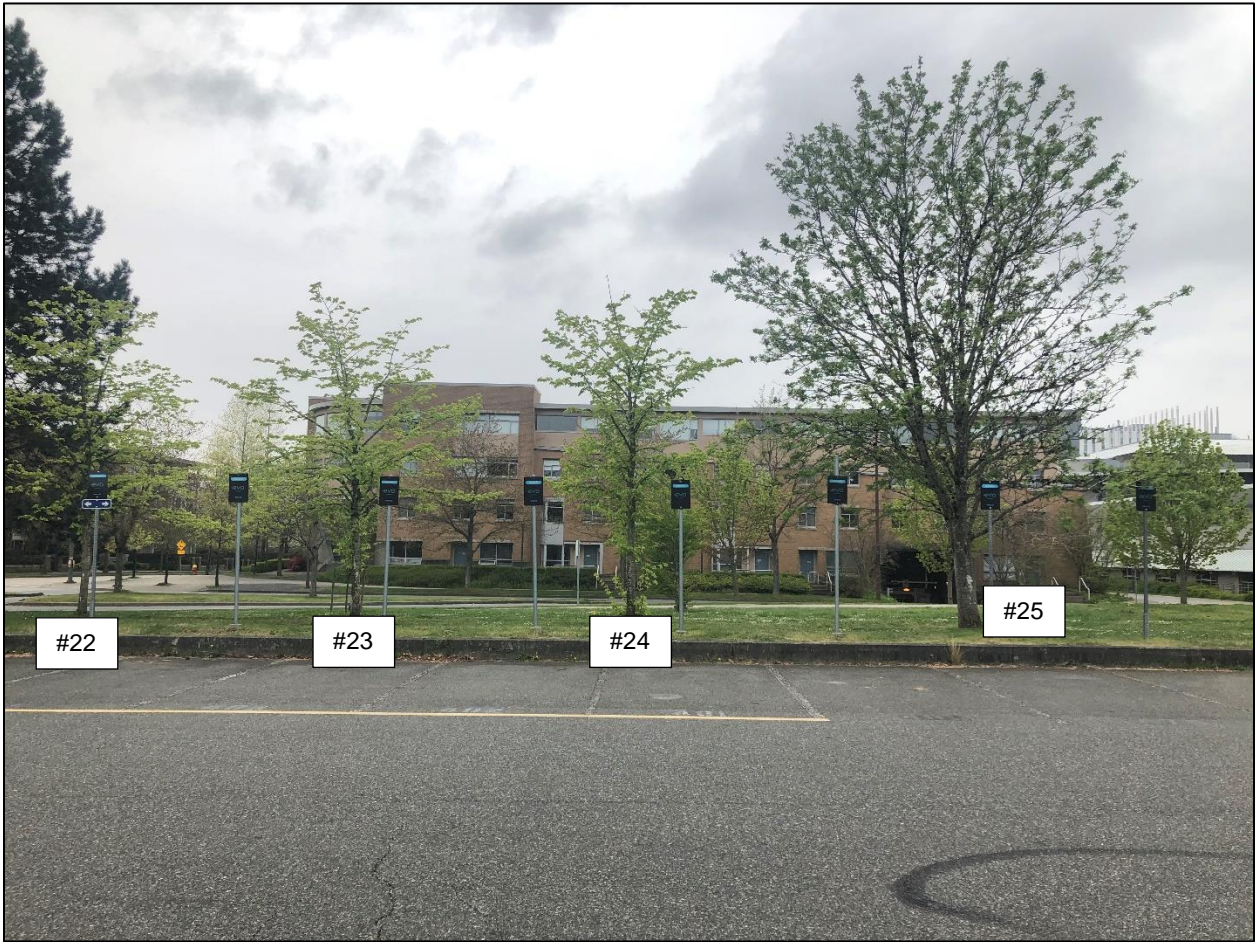
Figure 5: Trees to the west side of the site. Trees #14-#16 are situated behind trees #22-#25.

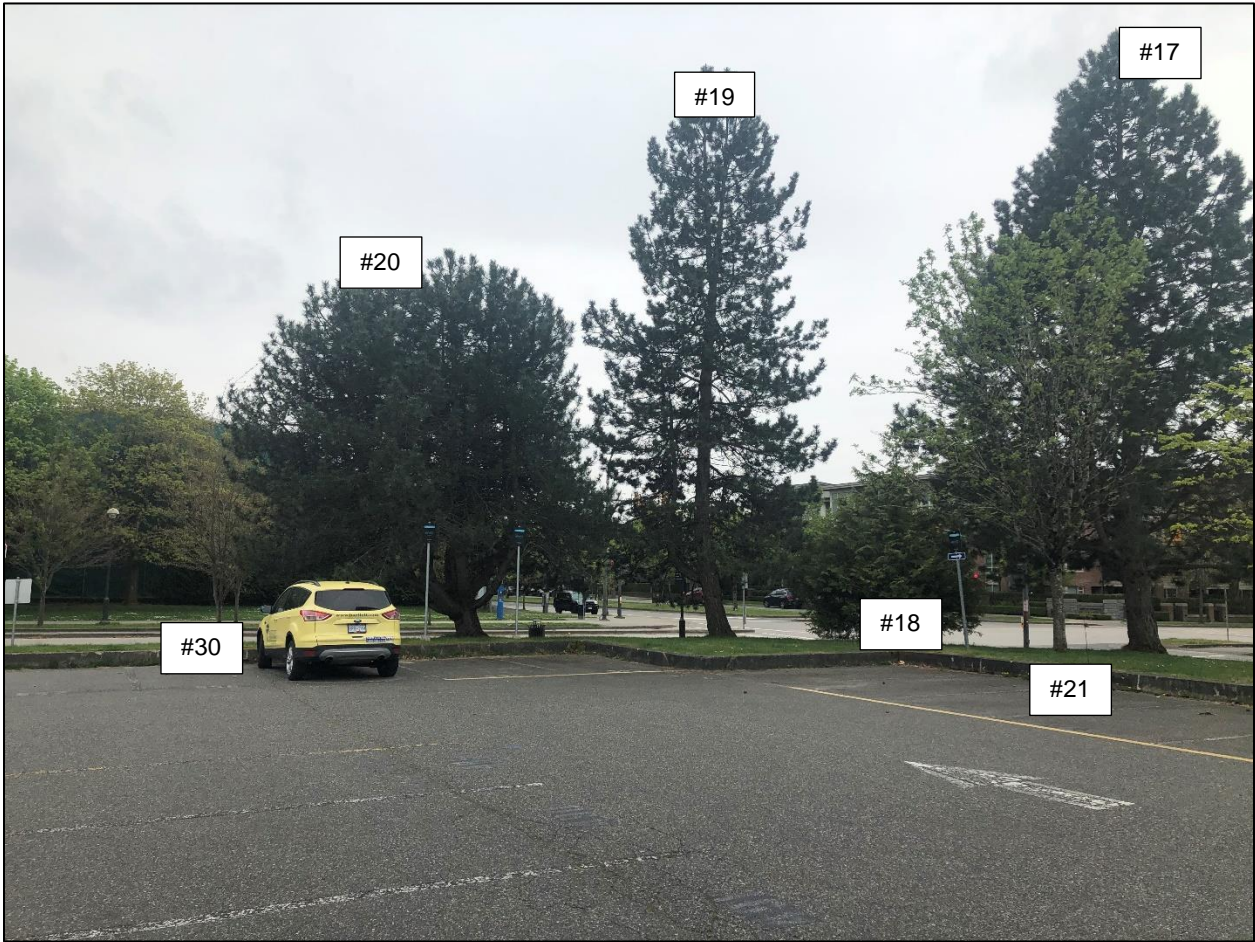
Figure 6: Trees on the southwest side of the site.

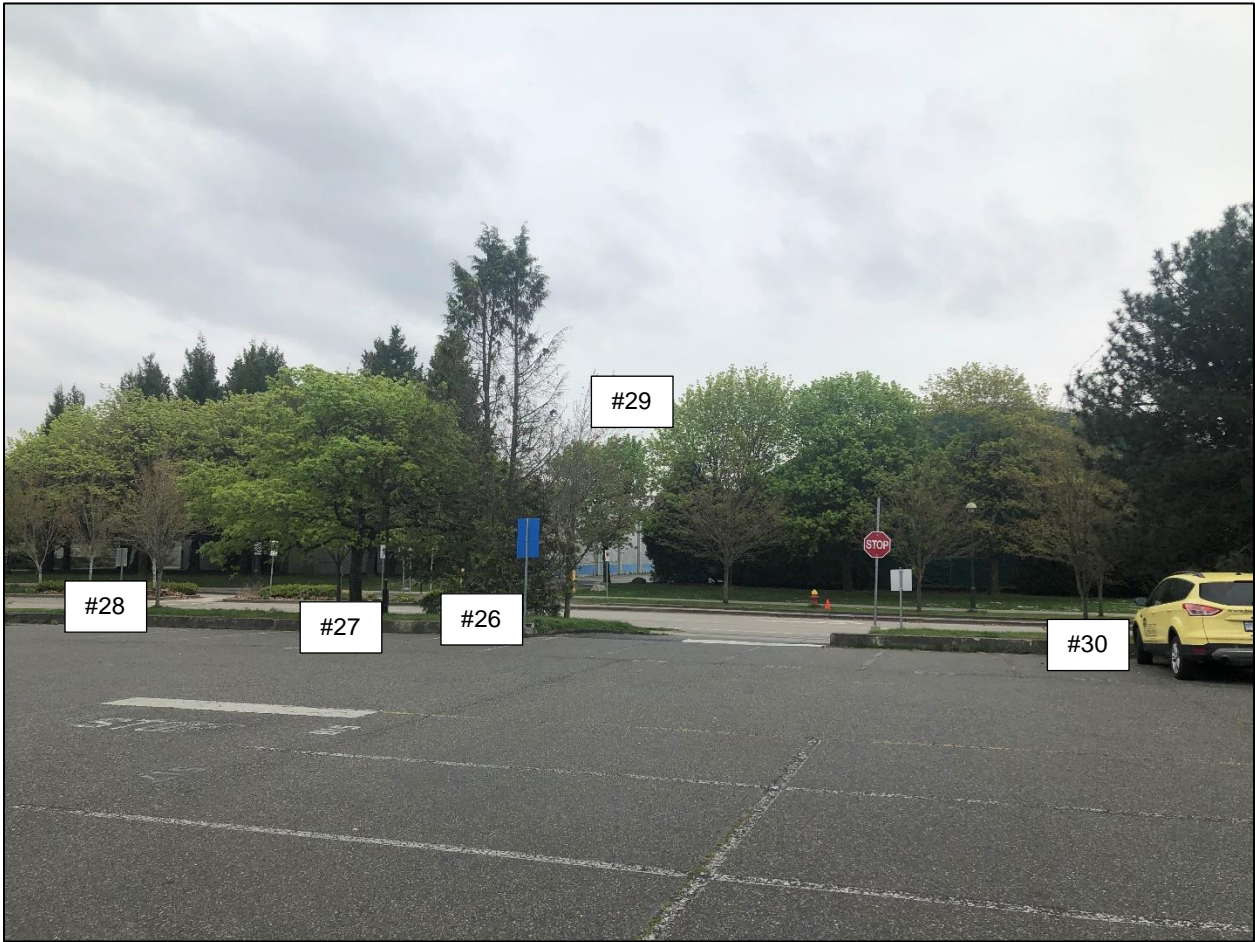
Figure 7: Trees on the south side of the site.
