Arboricultural Inventory and Report

UBC Properties Trust

**Hospital Lane – Food and Beverage Innovation
Centre**

Date: February 14, 2022

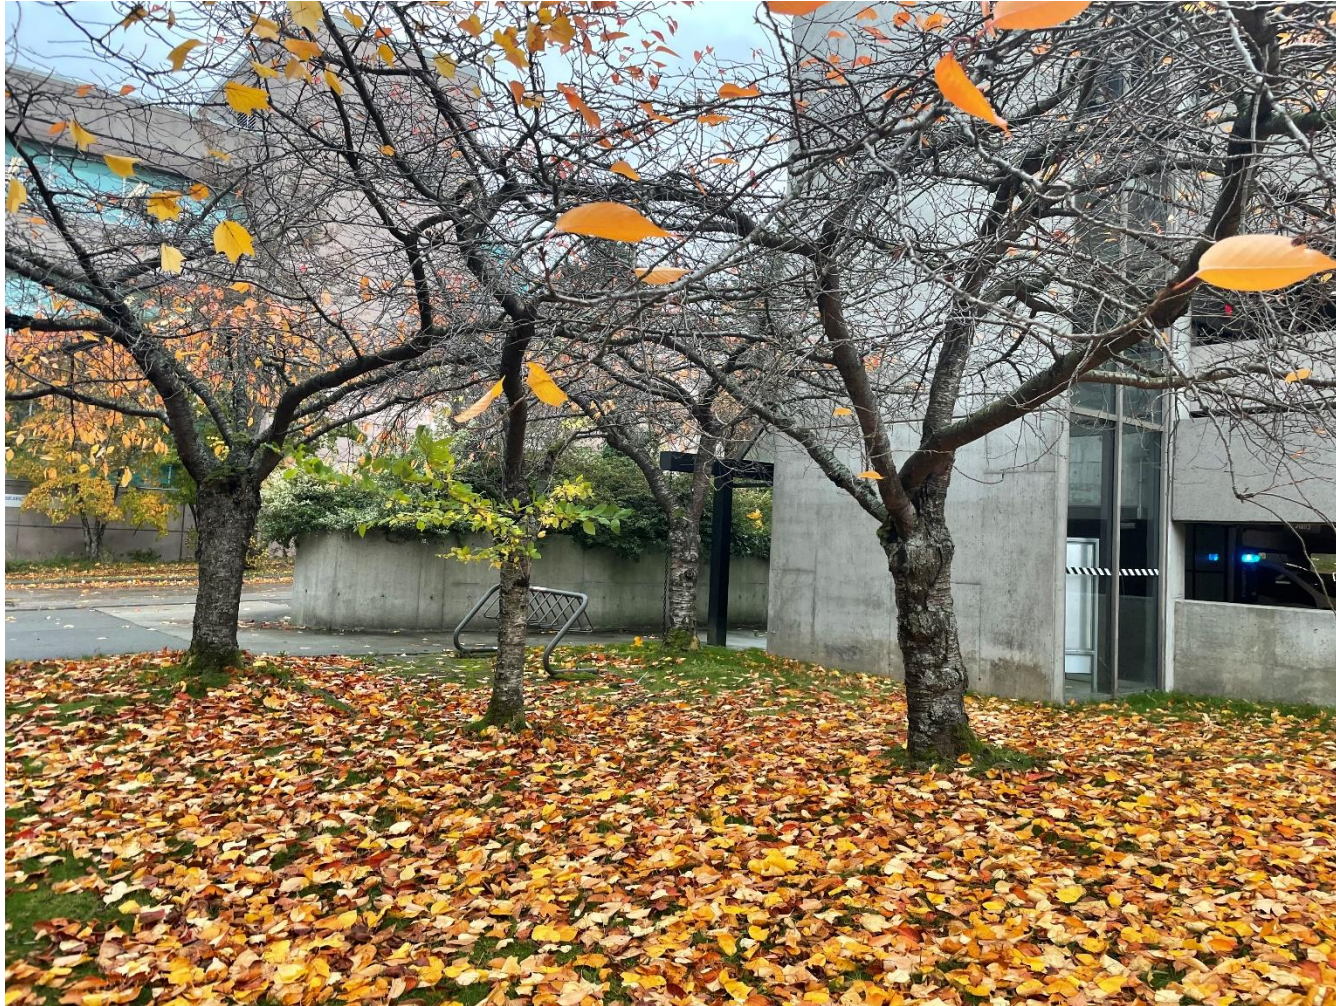
Photo 1. Group of cherry trees at the northeast corner of the site.

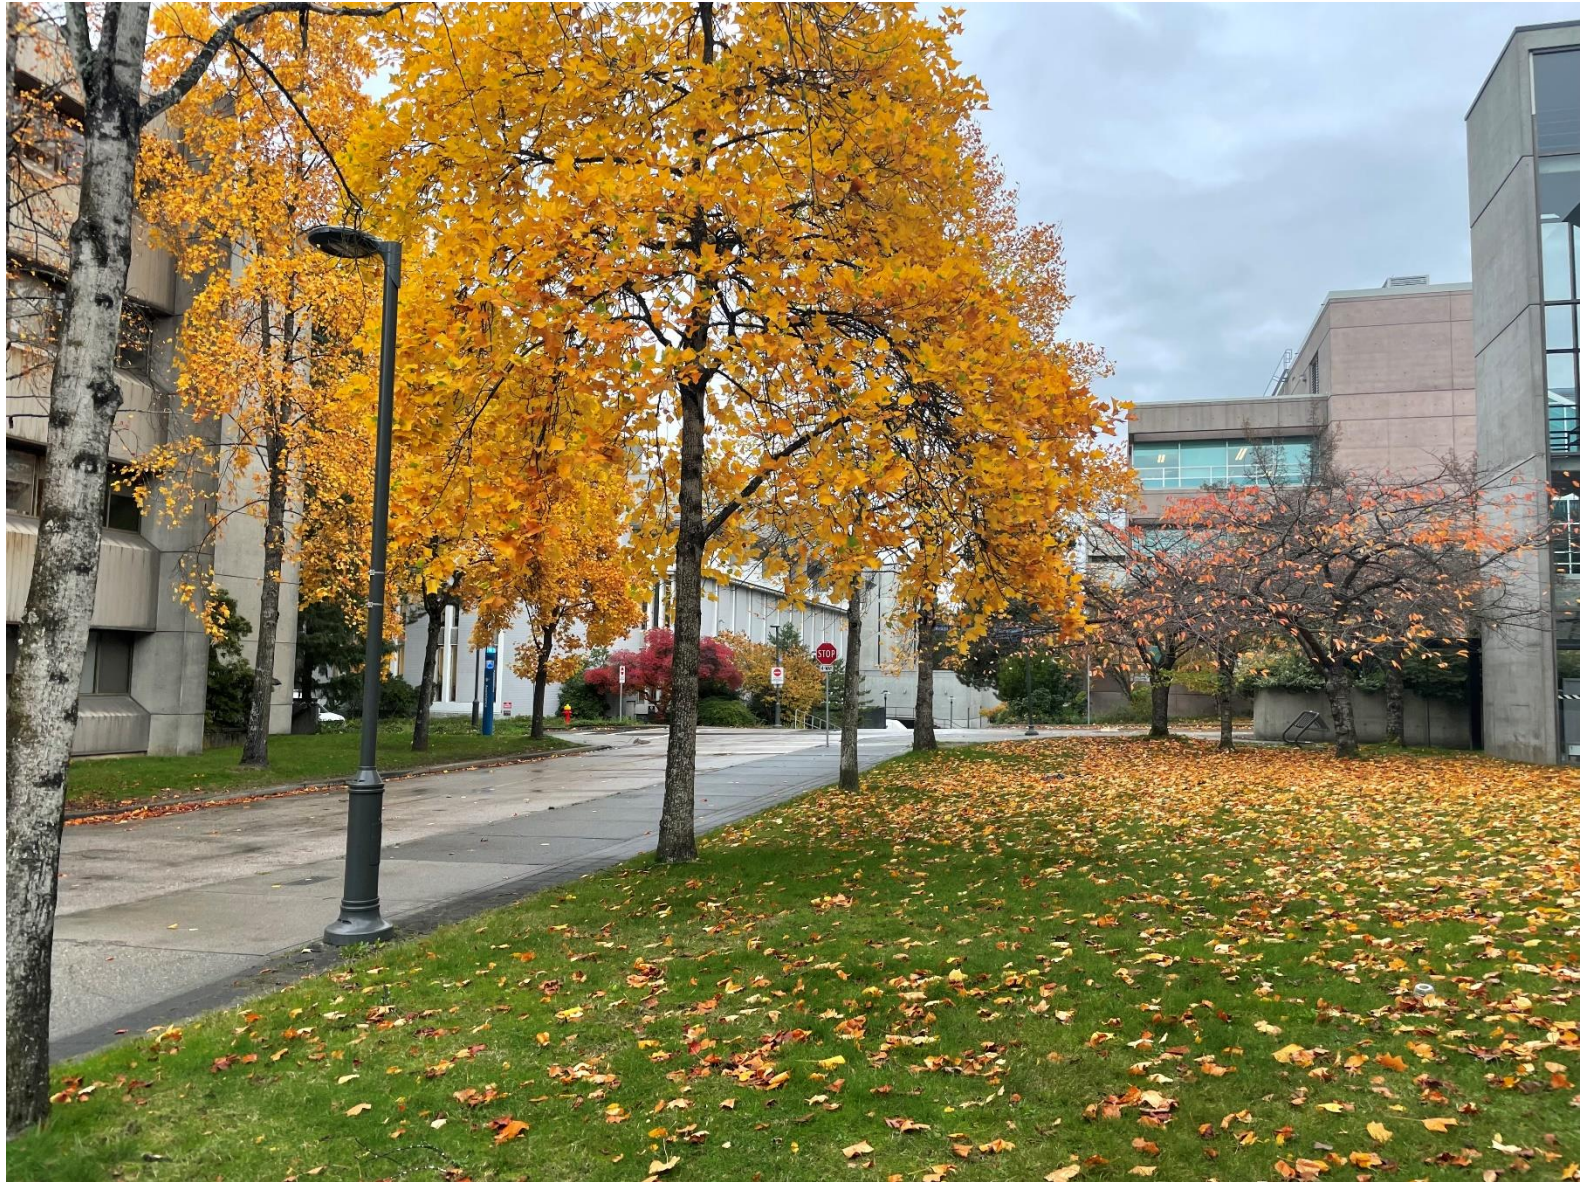
Photo 2: Showing the group of Tulip trees along the sidewalk at the north end of the site.

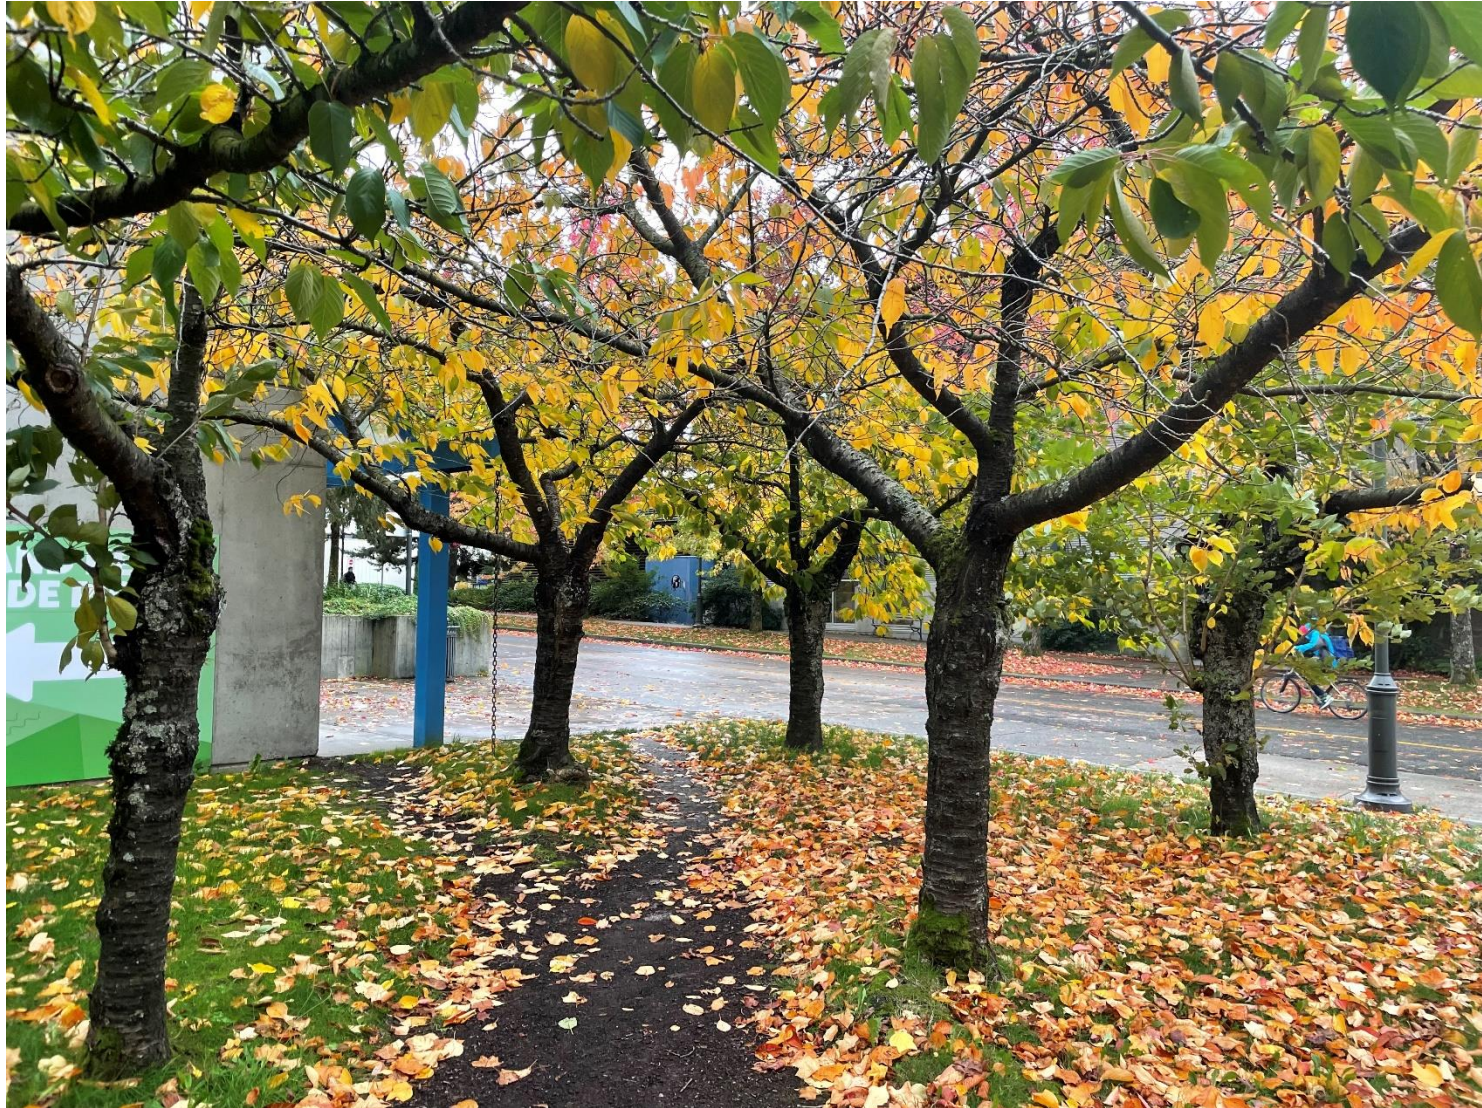
Photo 3. The cherry trees found at the west end of the site.

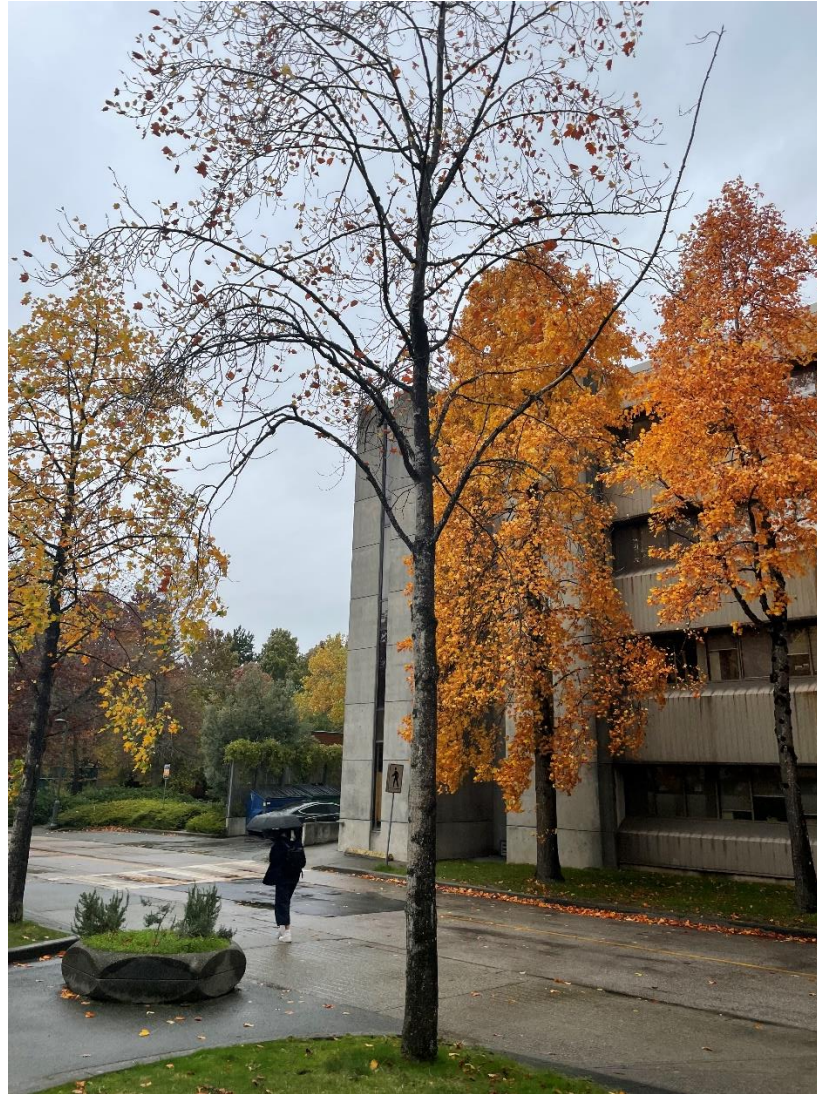
Photo 4. One of the tulip trees at the entrance to the parkade that is showing signs of stress. It is likely from the installation of the walkway.
