Drawing title: Tree Management Plan
Project address: UBC Lot 26 - 5988 Gray Avenue, Vancouver, BC
Client: Polygon Development 233 Ltd.

Arboricultural Inventory and Report

UBC Campus Lot 26 – 5988 Gray Avenue,
Vancouver, BC

Date: May 16, 2023

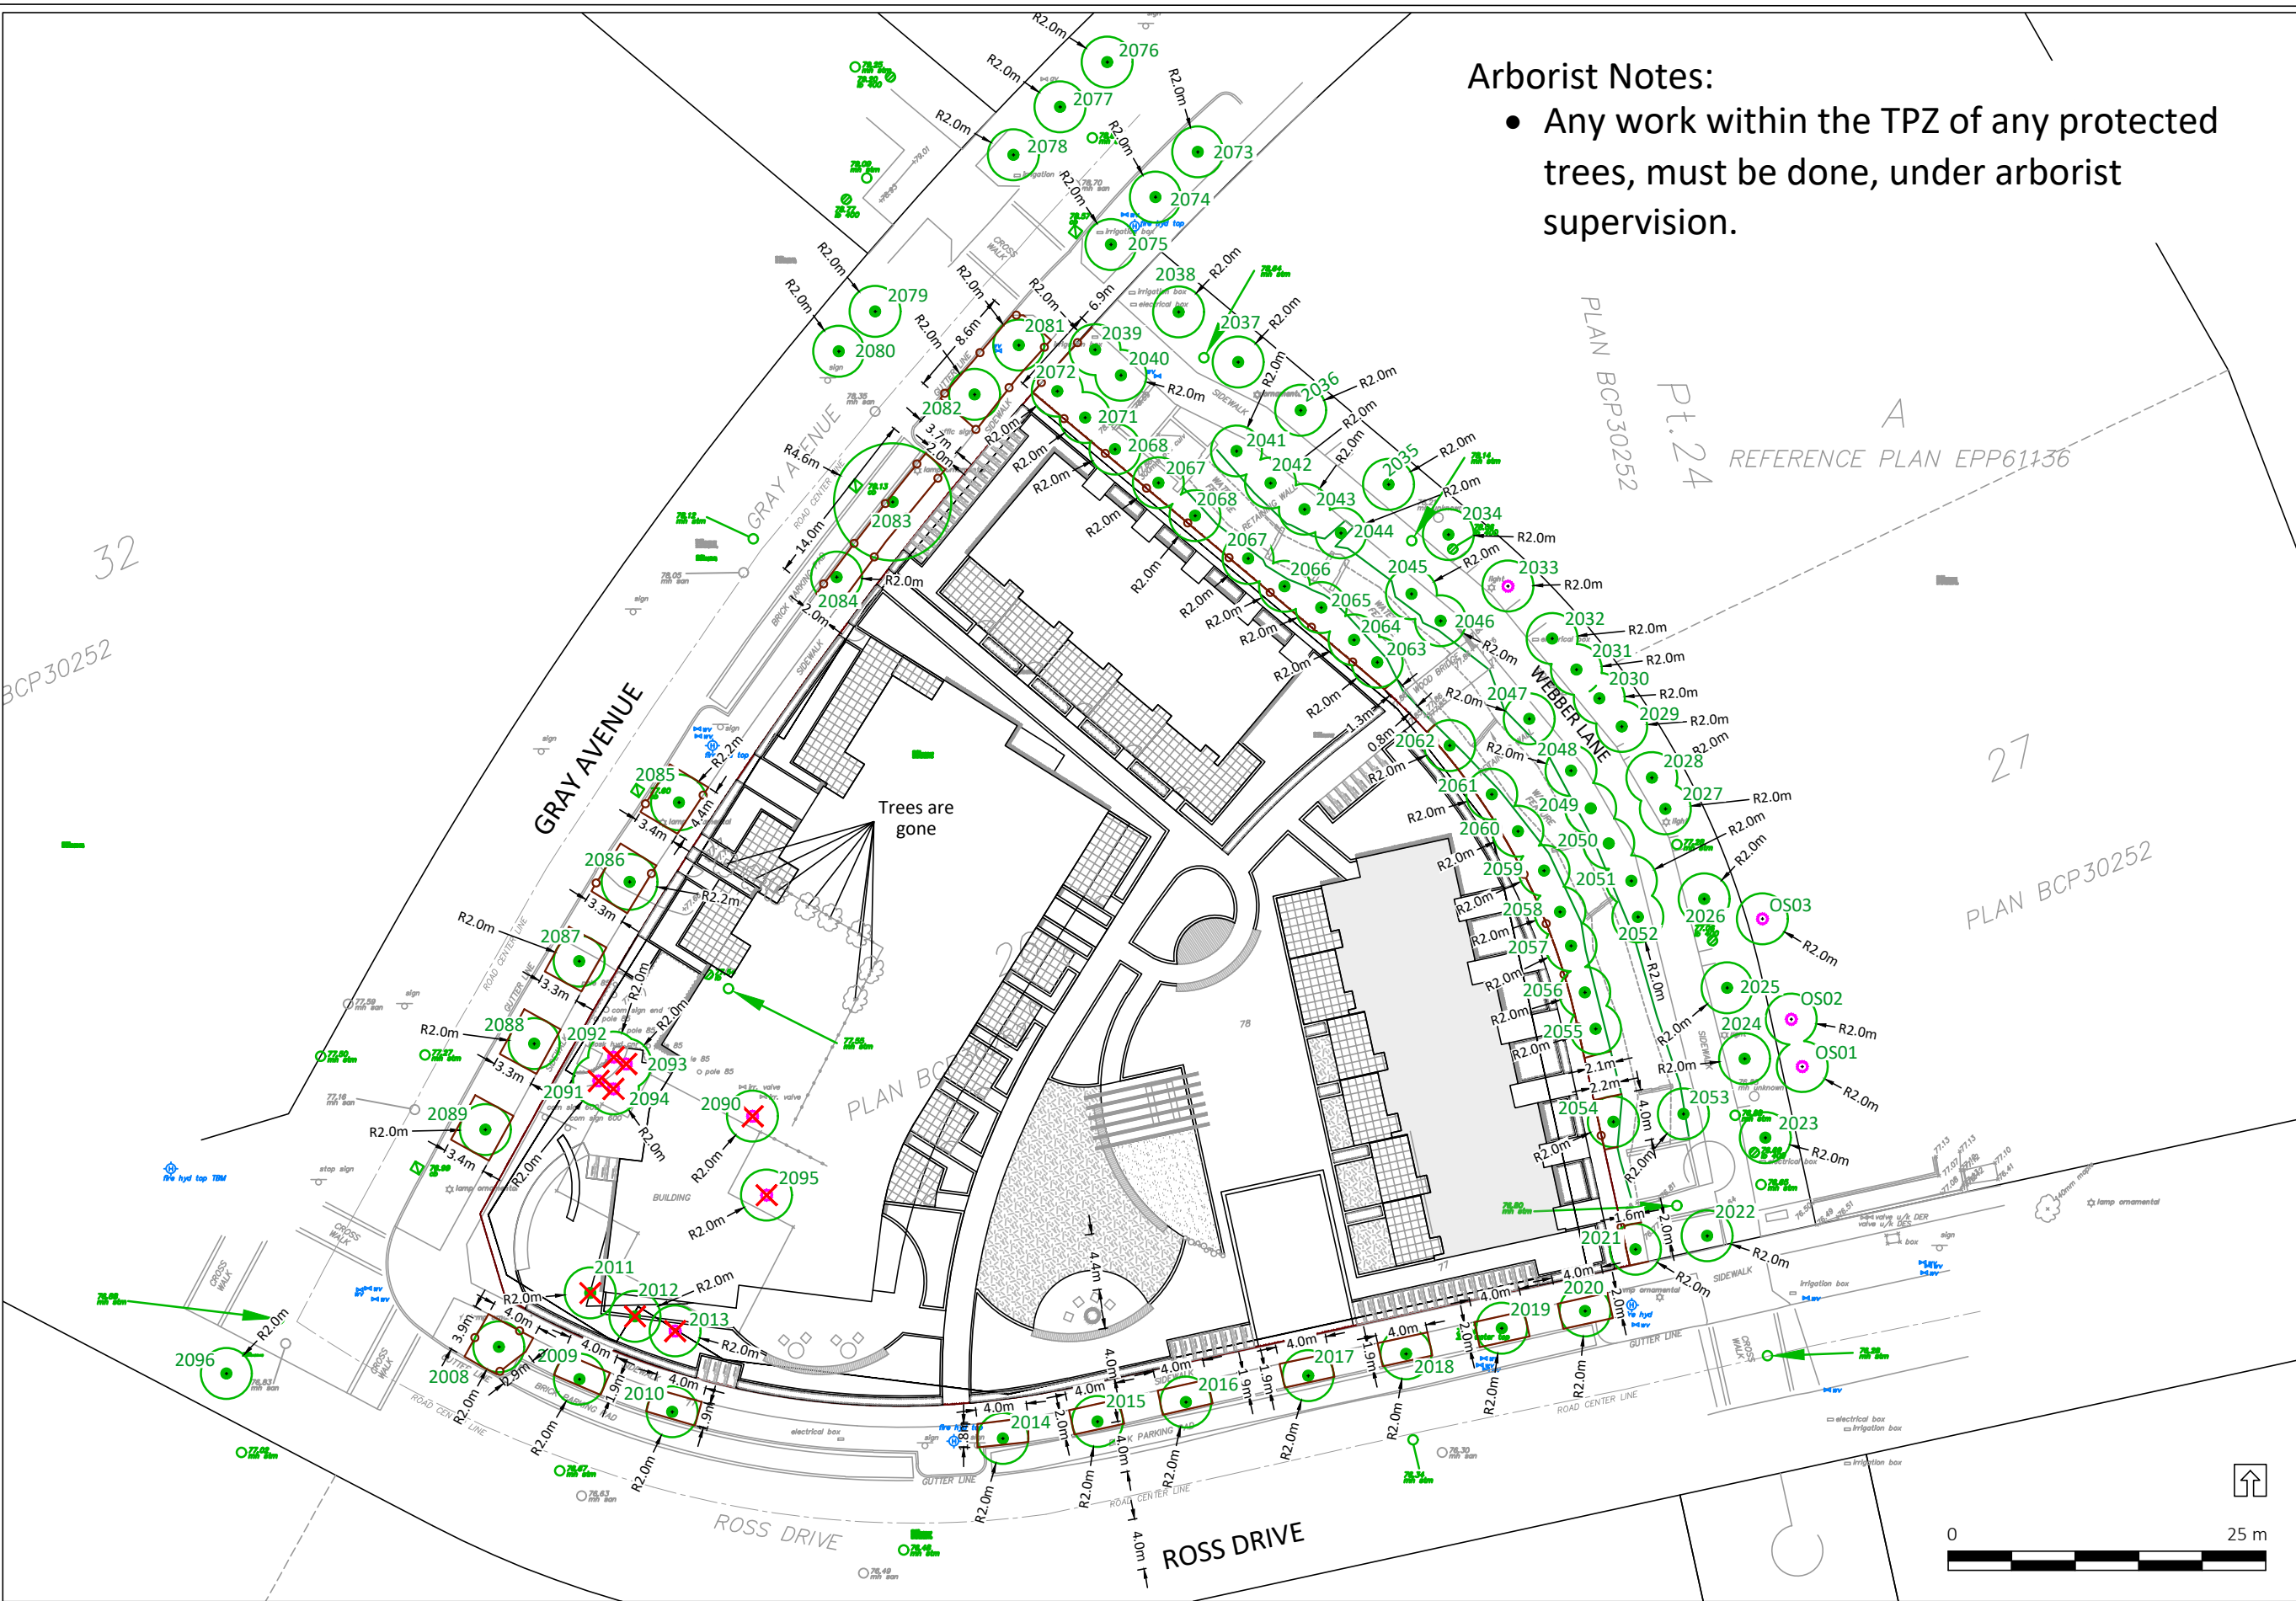
- On-Site trees # 2011 to 2013, 2090, and 2095: are recommended for removal due to conflicts with the proposed building's envelope.
- On-Site trees # 2091 to 2094: are recommended for removal due to conflict with the proposed landscaped and paved area. Retention would be possible if the landscaping was redesigned to accommodate these trees.

- Any work within the TPZ of any protected trees, must be done, under arborist supervision.

- UBC Owned Trees # 2021, 2054 to 2072, and 2083: retain and protect as required, per the associated tree management plan and arborist notes. Installation of tree protection fencing is required. Within the tree protection zone's, vertical excavation and shoring and low impact methods are to be used for the proposed building's foundation and the paved path, under arborist supervision.

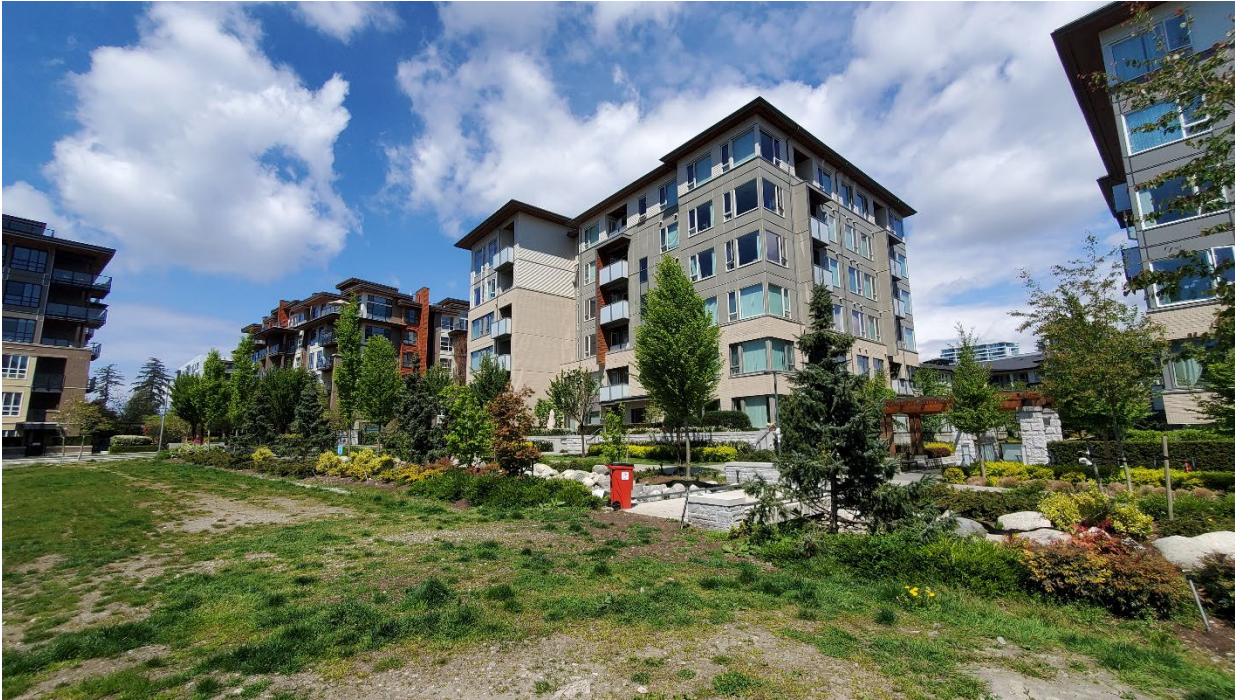
| Surveyed? Y/N | Tag # | Location | Species Common Name | Botanical Name | DBH (cm) | Height (m) | Dripline Radius (m) | Health and Structure Rating | Comments | Retention Value Rating | Retain/ Remove | Retention/TPZ Comments | *TPZ (m) |
|---|---|---|---|---|---|---|---|---|---|---|---|---|---|
| Y | 2054 | UBC Owned | Hornbeam | <i>Carpinus betulus</i> | 6 | 5 | 1 | Moderate | Tree planted in landscape area by open field and water feature. Roots restricted by water feature. Thinning crown. | Medium | Retain | Within TPZ, vertical excavation and shoring, and low-impact methods are to be used for the proposed building foundation and paved path, under arborist supervision. | 2 |

| Surveyed? Y/N | Tag # | Location | Species Common Name | Botanical Name | DBH (cm) | Height (m) | Dripline Radius (m) | Health and Structure Rating | Comments | Retention Value Rating | Retain/ Remove | Retention/TPZ Comments | *TPZ (m) |
|---|---|---|---|---|---|---|---|---|--|---|---|---|---|
| Y | 2057 | UBC Owned | Hornbeam | <i>Carpinus betulus</i> | 4 | 6 | 1 | Poor | Tree planted in landscape area by open field and water feature. Roots restricted by water feature. Very thin crown. Epicormic growth on trunk indicating stress. | Low | Retain | Within TPZ, vertical excavation and shoring, and low-impact methods are to be used for the proposed building foundation and paved path, under arborist supervision. | 2 |

Photo 4. Landscape trees by water feature.

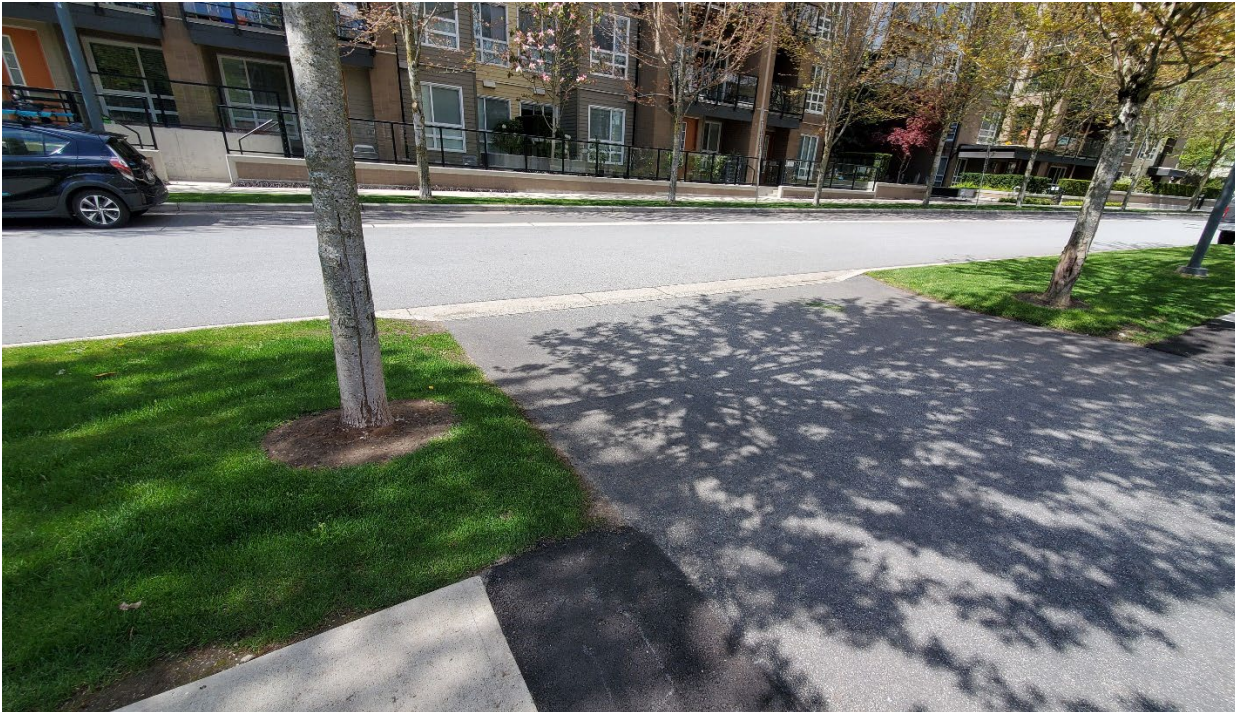
| Surveyed? Y/N | Tag # | Location | Species Common Name | Botanical Name | DBH (cm) | Height (m) | Dripline Radius (m) | Health and Structure Rating | Comments | Retention Value Rating | Retain/ Remove | Retention/TPZ Comments | *TPZ (m) |
|---|---|---|---|---|---|---|---|---|--|---|---|---|---|
| Y | 2085 | UBC Owned | Magnolia | <i>Magnolia spp.</i> | 24 | 12 | 4 | Good | Tree planted on boulevard. Crown slightly encroaching light pole. Roots restricted by concrete sidewalk and road. Minor sunscald damage on trunk but tree still has good vigour. | High | Retain | Protect as required per associated TMP. | 2.2 |

Photo 6. Trees #2084-2085 with new paved access within their root zones.

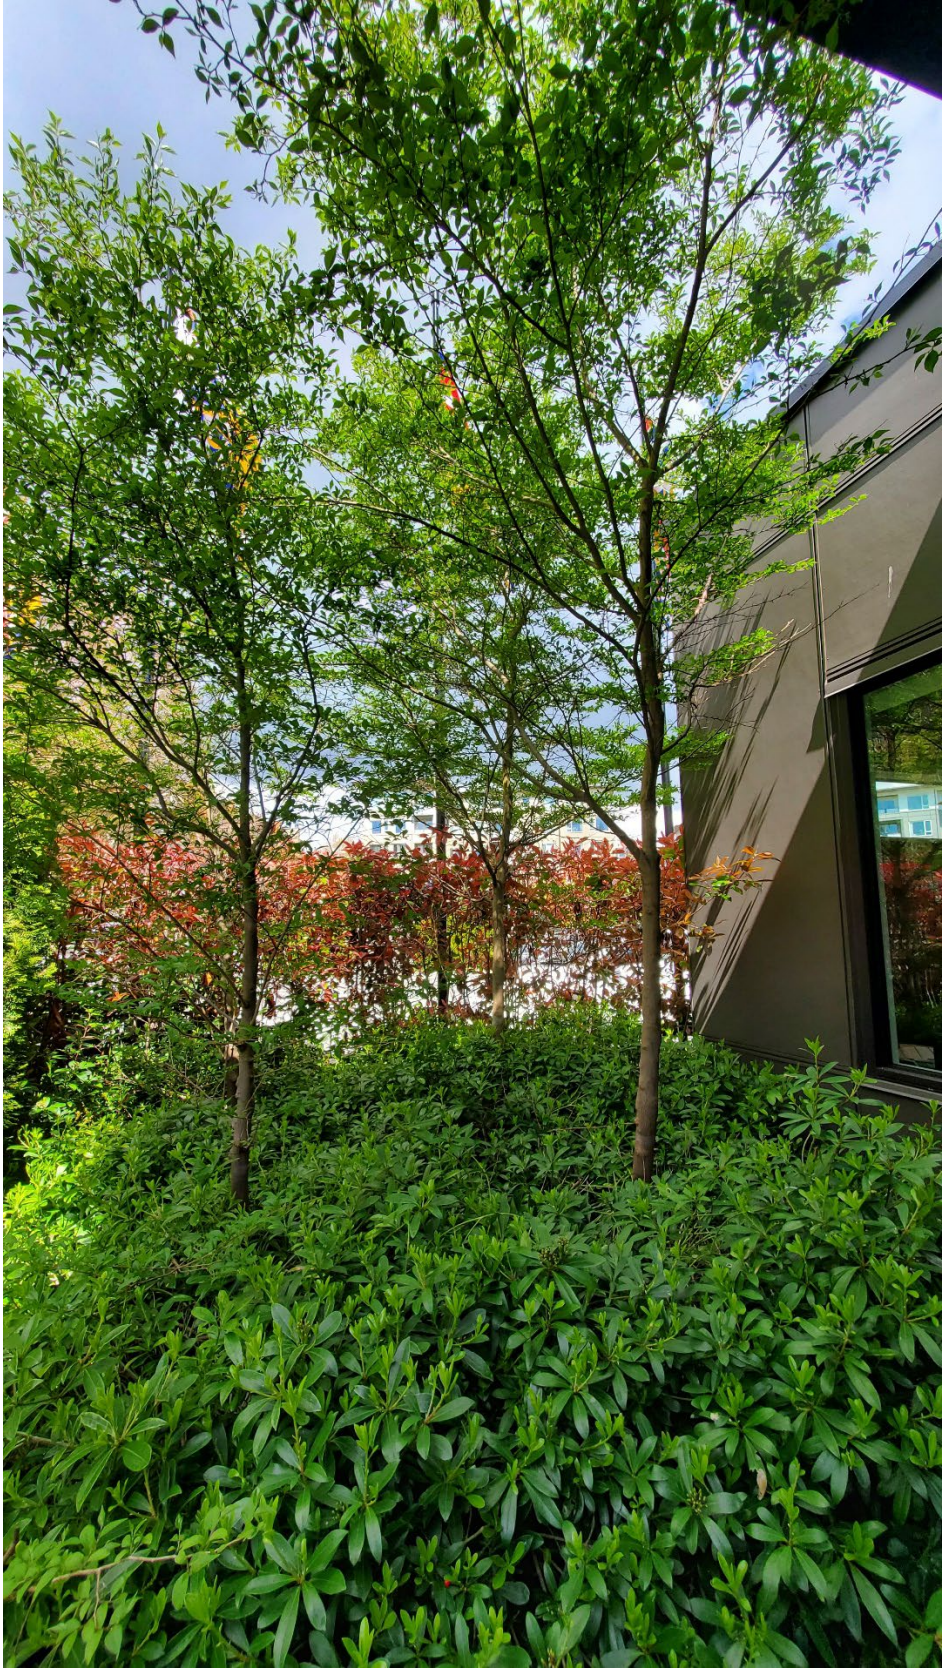
Photo 7. Trees #2091-2094.

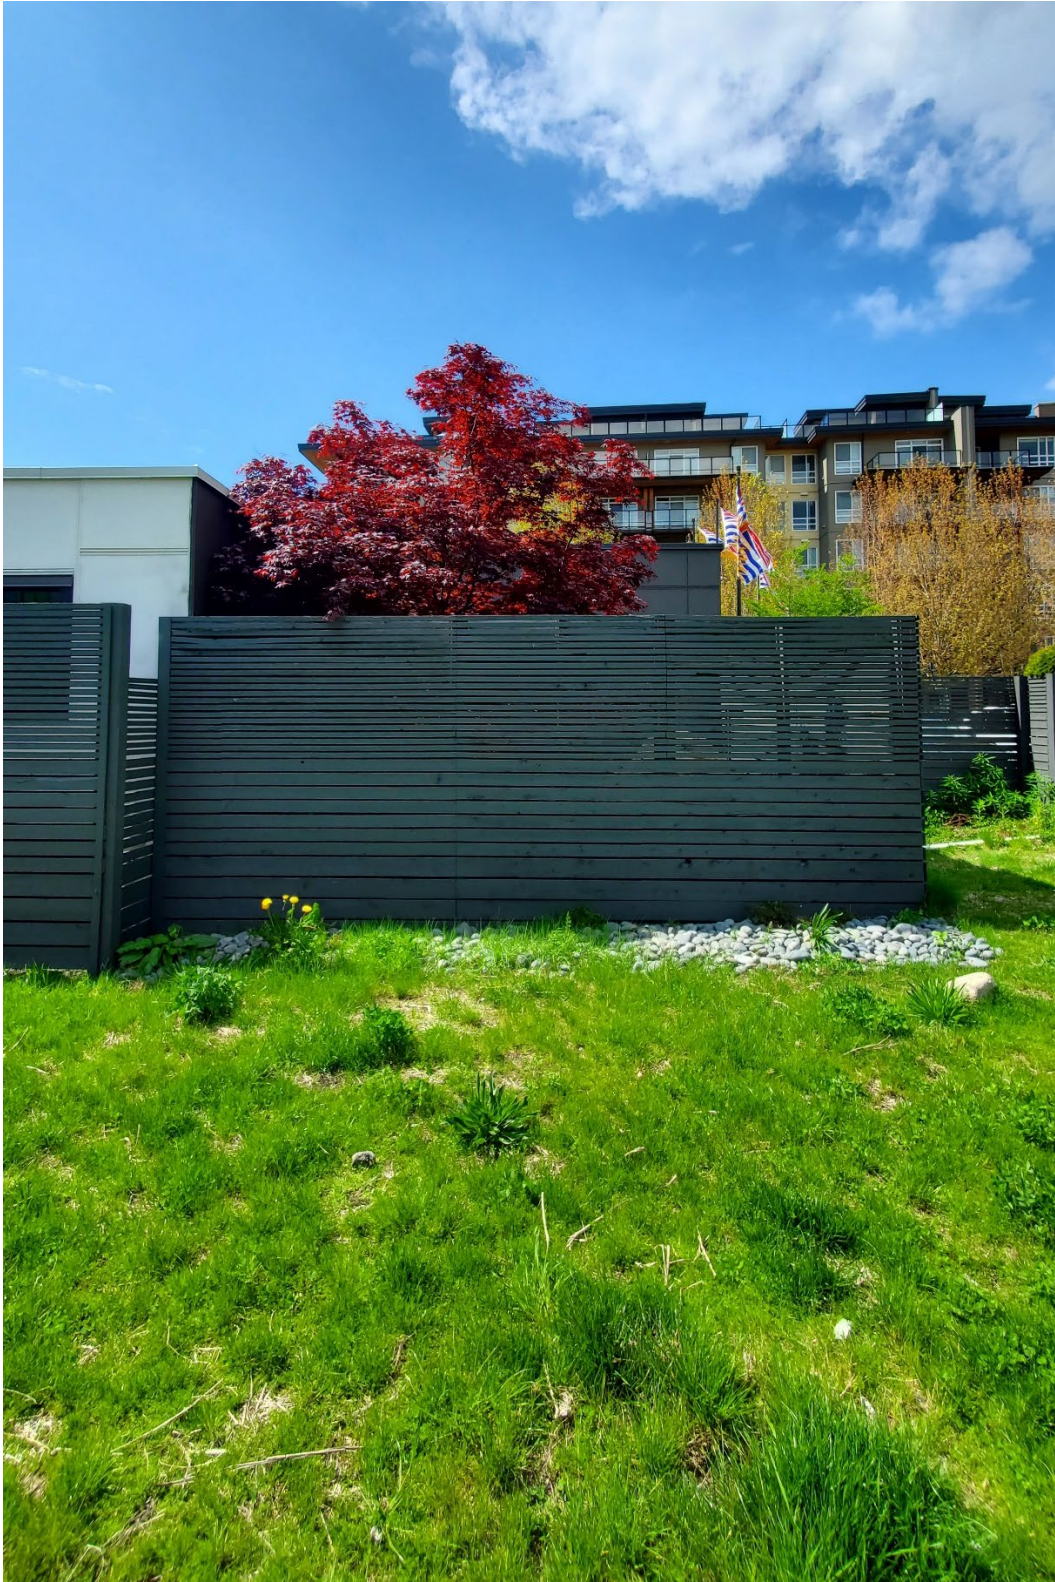
Photo 8. Tree #2095.
