Drawing title: Tree Management Plan
 Project address: Orchard Commons, UBC
 Client: UBC

Arborist Report

For:
UBCPT

Site Location:
Orchard Commons Daycare
University of British Columbia
Vancouver, BC

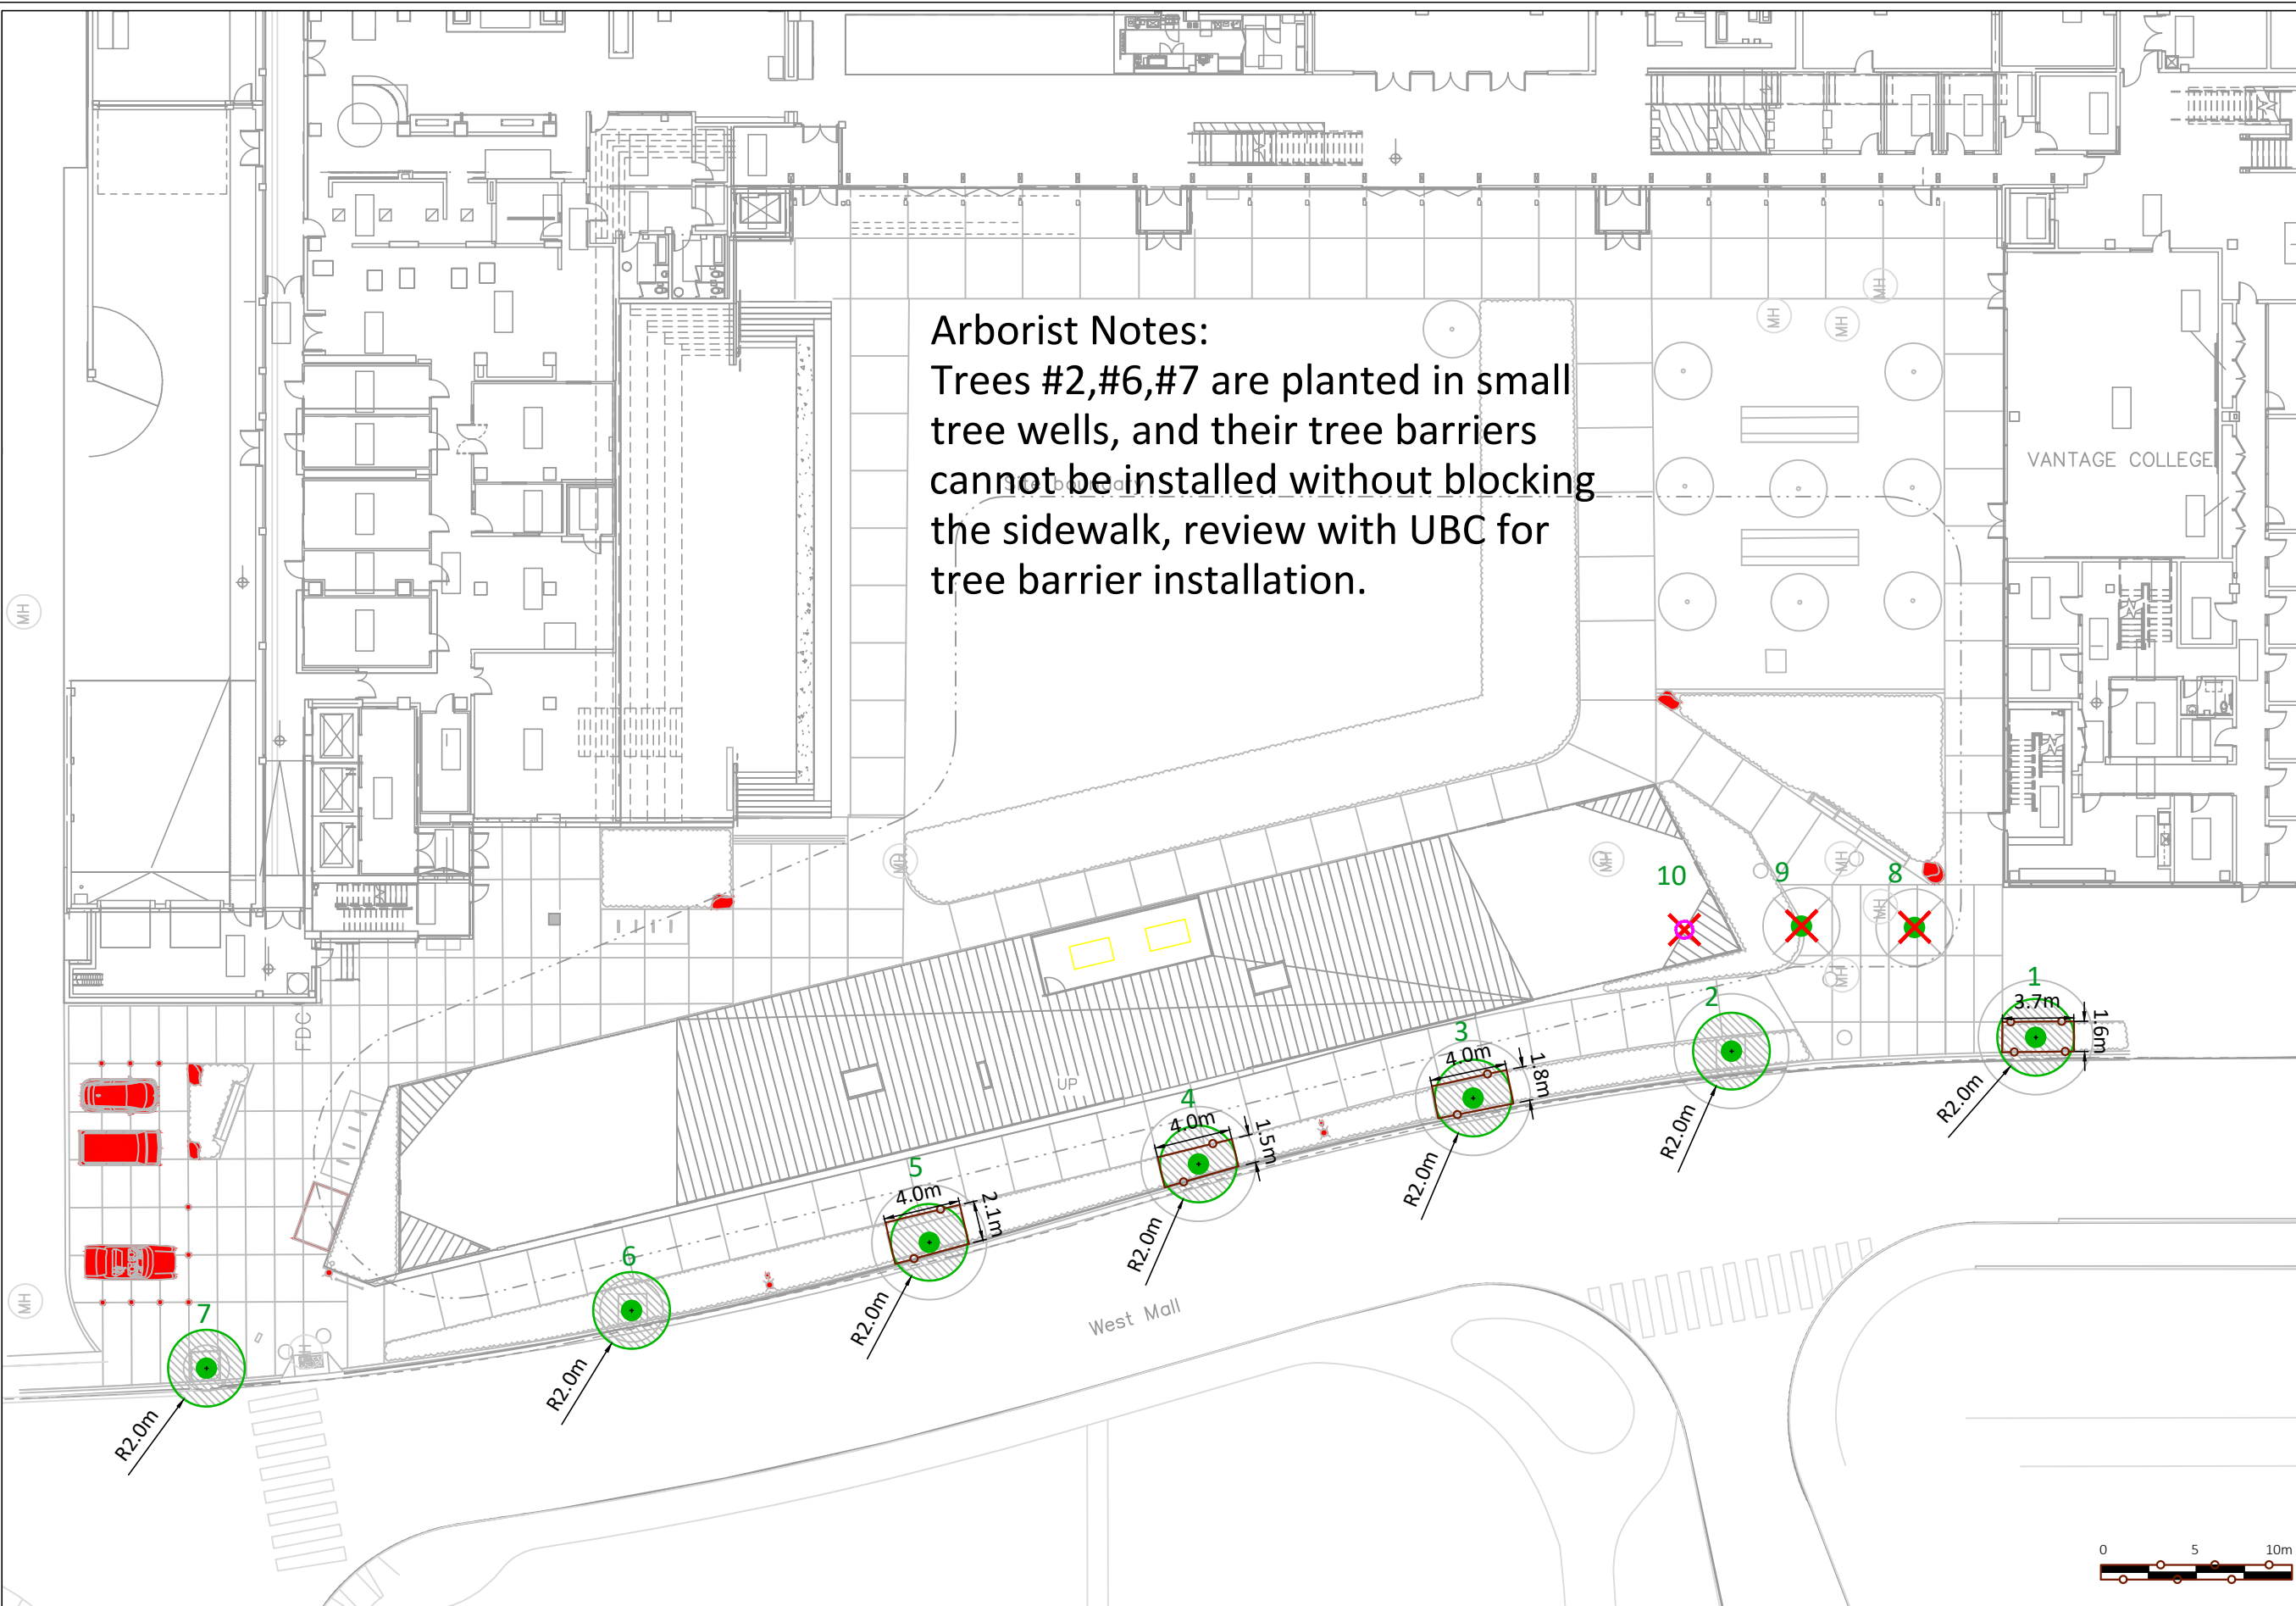
Drawing No: 01
 Date: 2024/03/05
 Drawn by: LH
 Page Size: TABLOID 11"x17"

Arborist Notes:
 Trees #2,#6,#7 are planted in small tree wells, and their tree barriers cannot be installed without blocking the sidewalk, review with UBC for tree barrier installation.

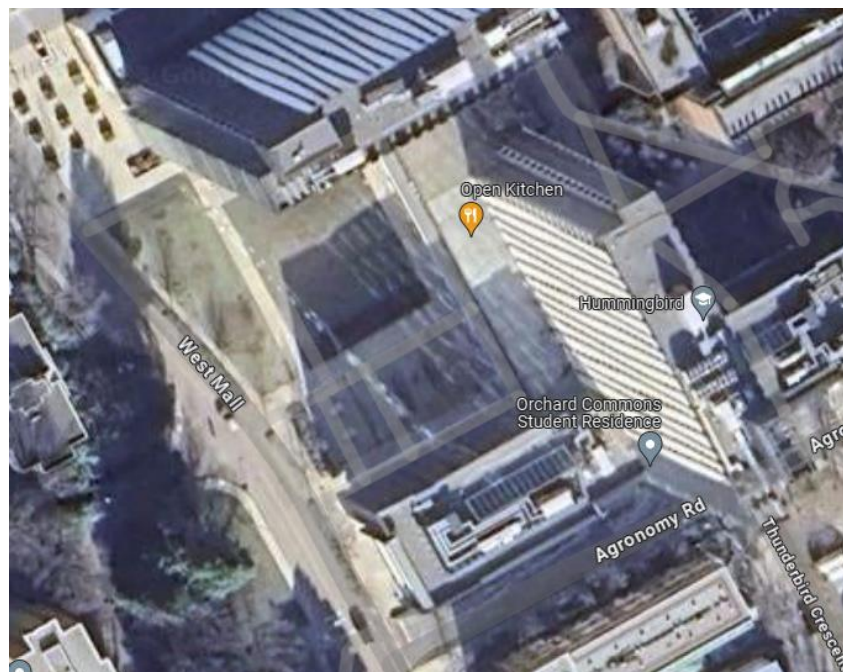
Figure 1. The grassed area beside West Mall in the photo from Google Maps is the proposed location for the daycare.

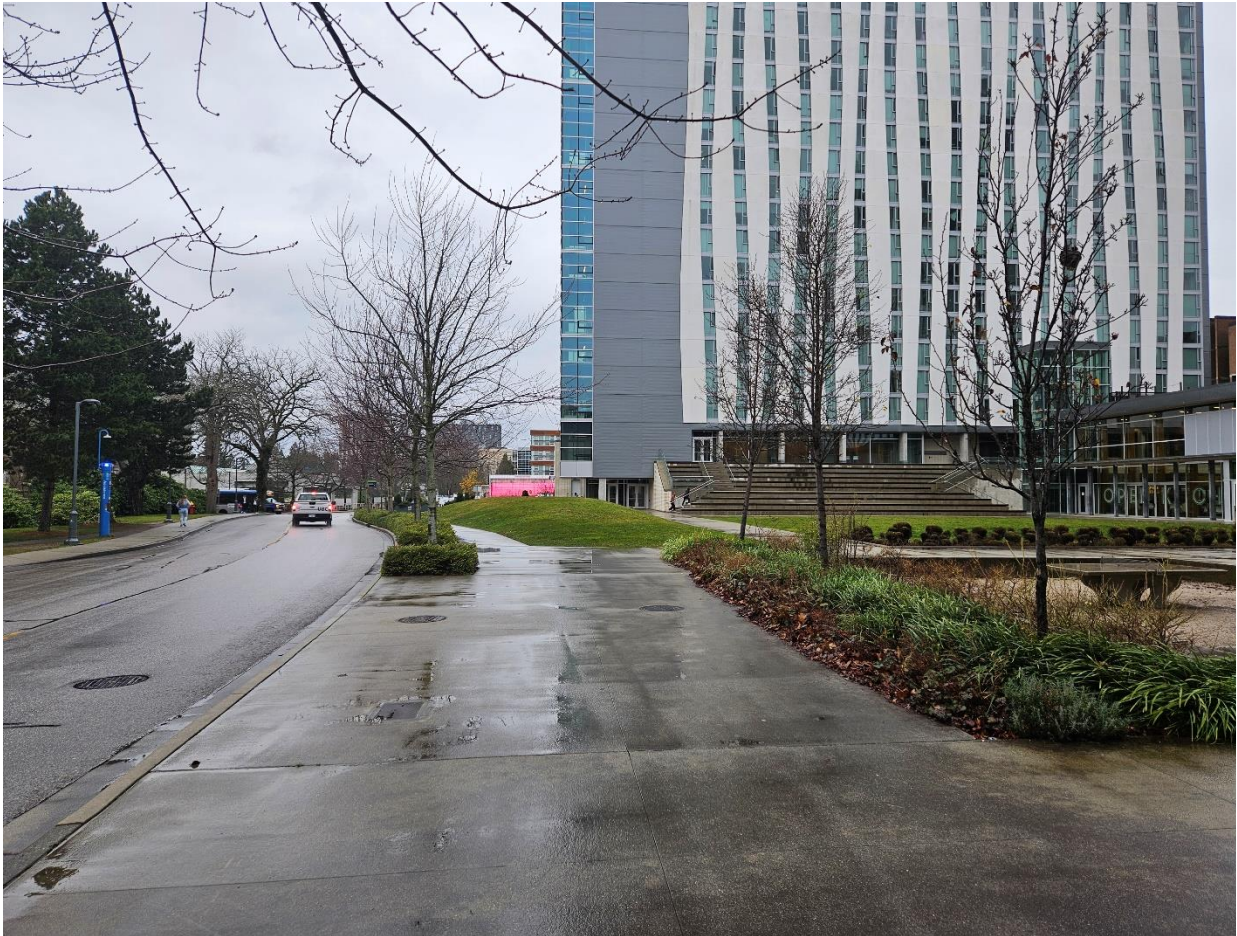
Photo 1. Looking north at the site and trees along the edge.

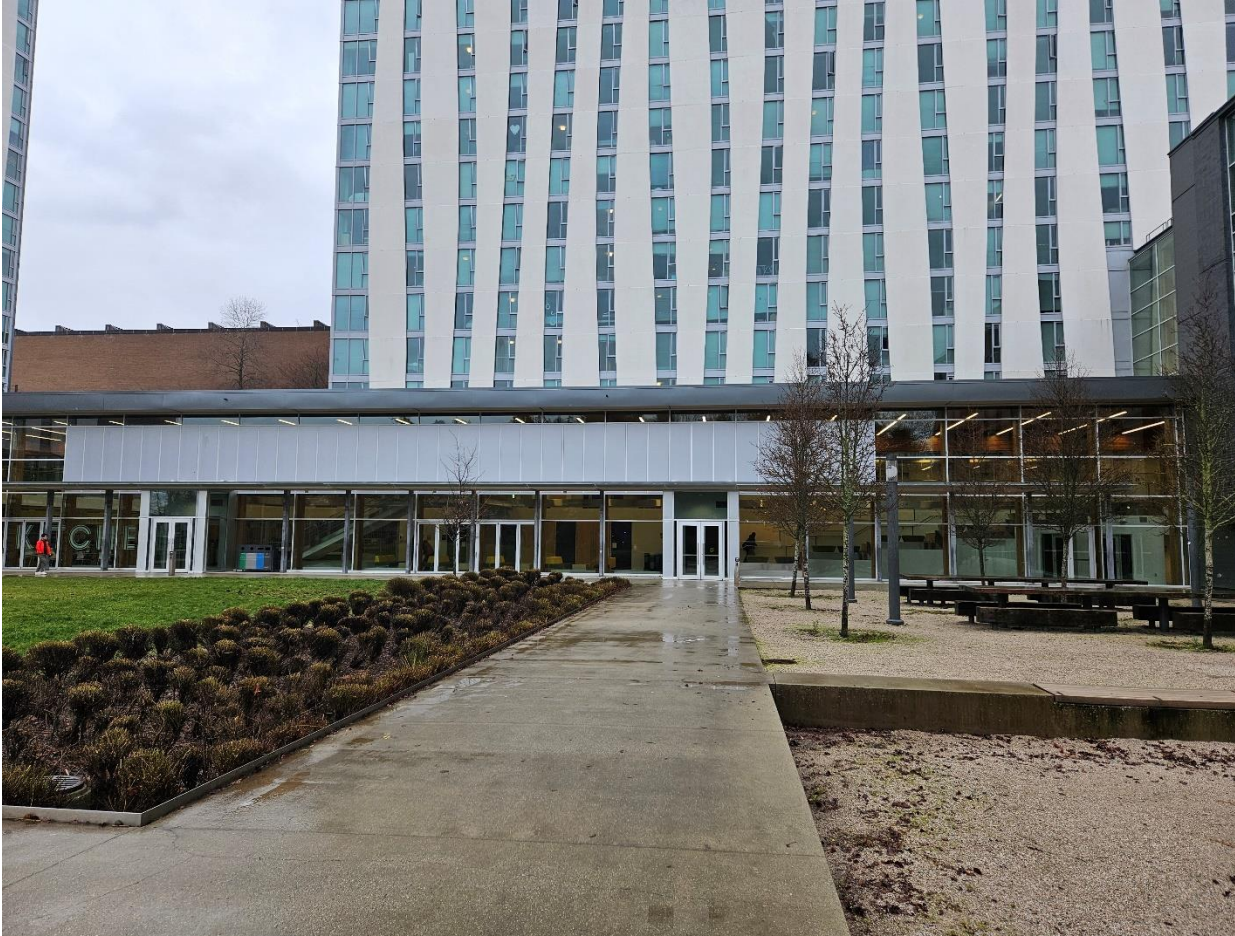
Photo 2. Looking east toward the residence and the south edge of what would be the proposed daycare.

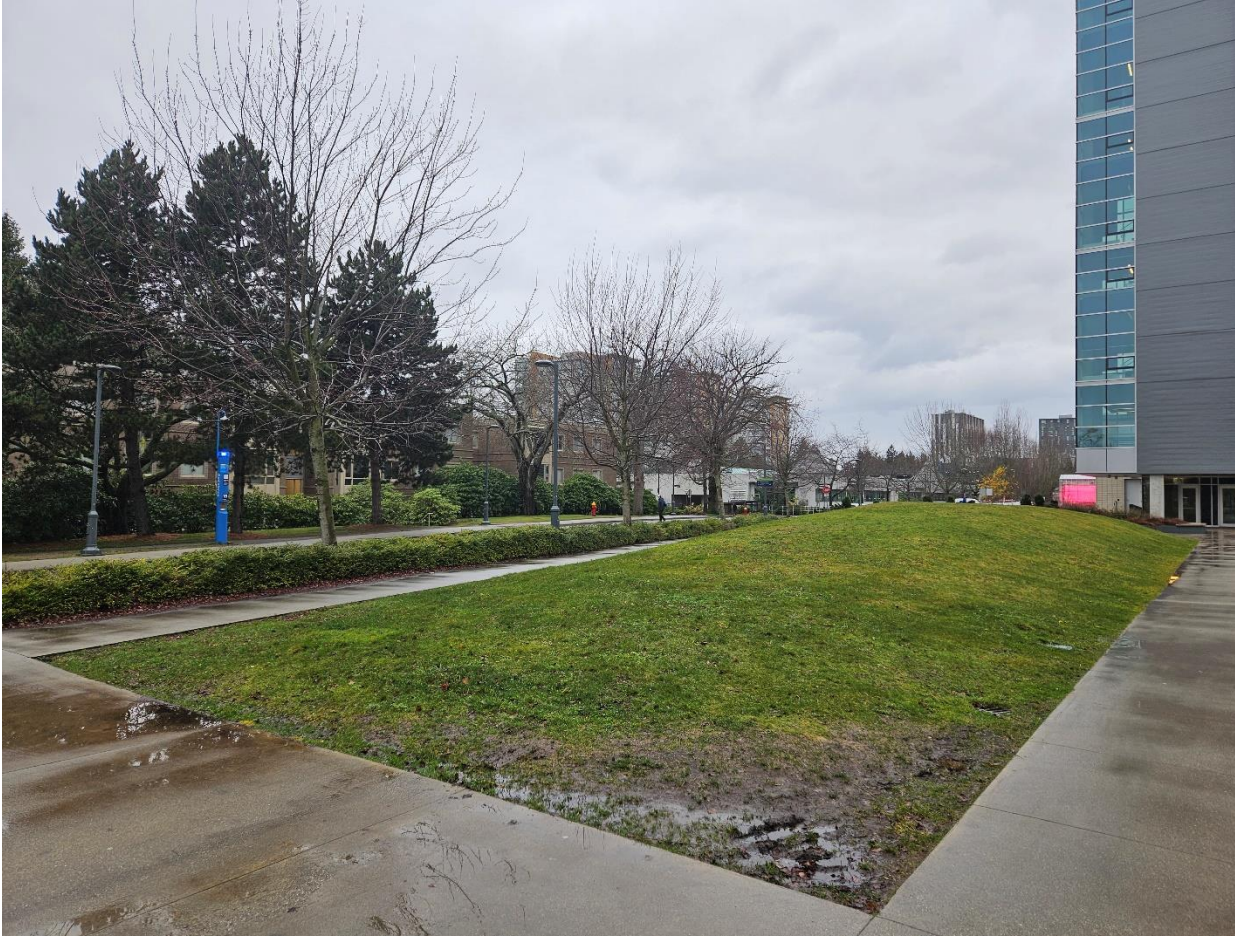
Photo 3. Looking northwest at the trees along West Mall.
