# Cumbria Relocation

University of British Columbia

Issued for DP - November 2, 2018

**Re: Geotechnical Report, Cumbria Sculpture – West Mall and University Boulevard, UBC**

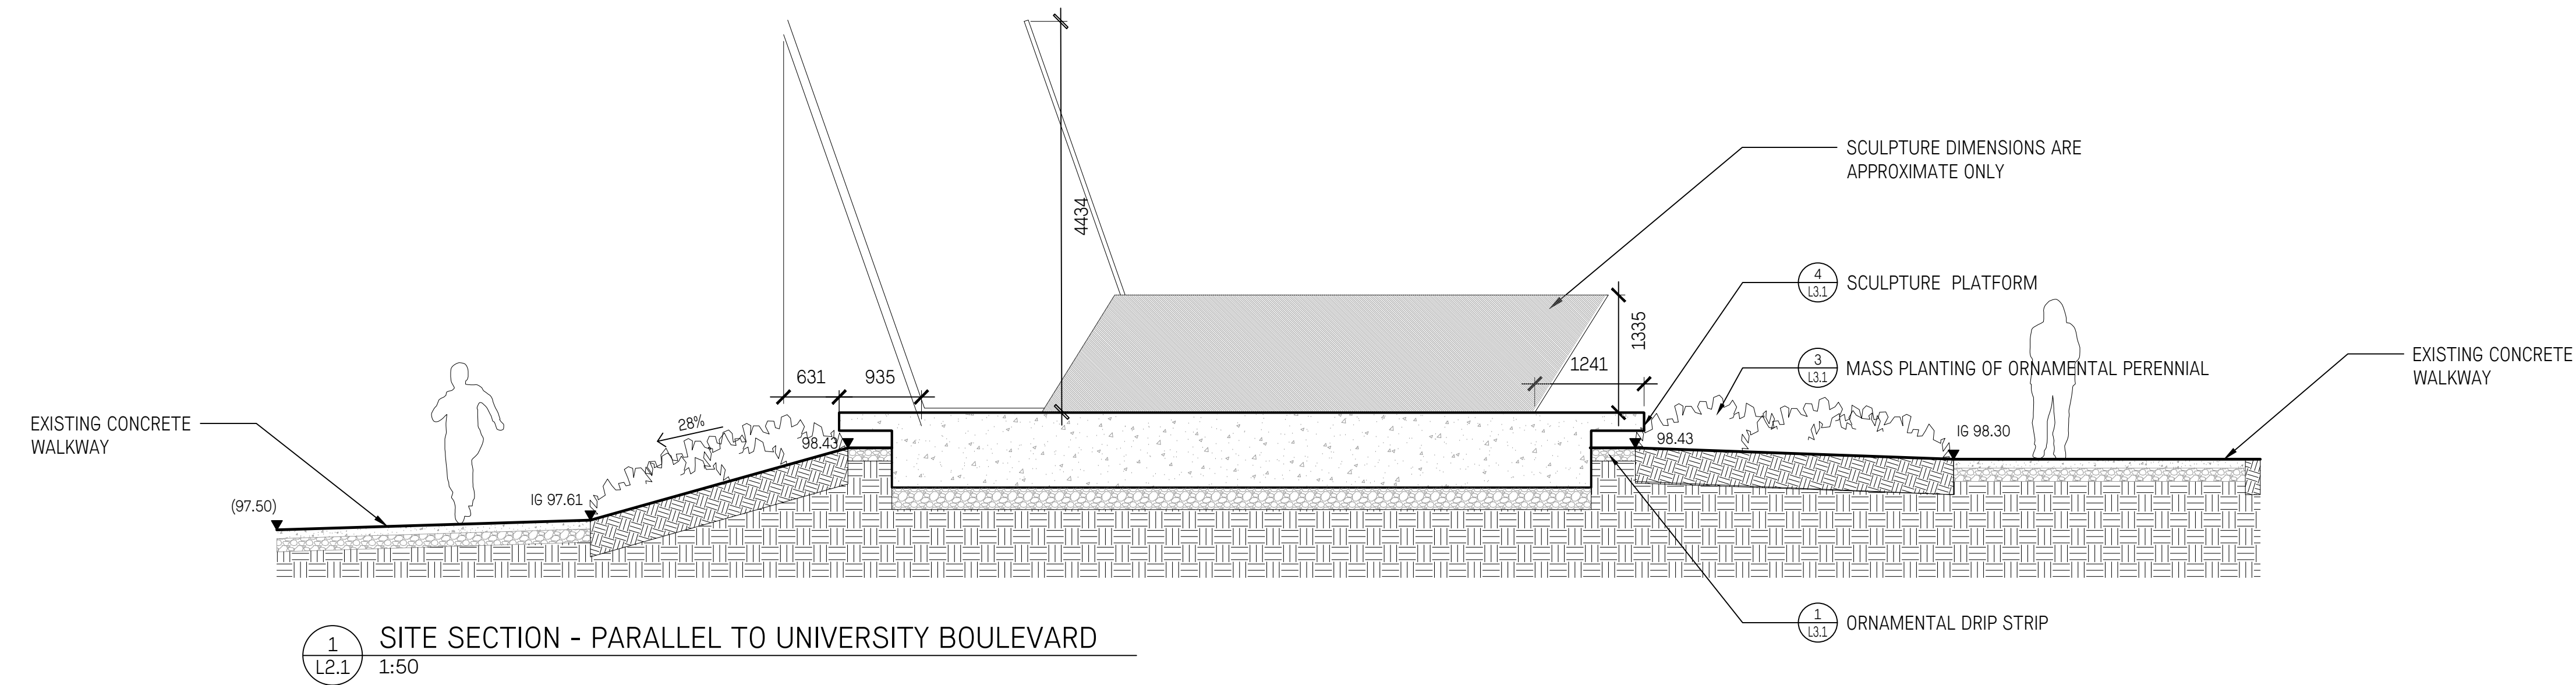
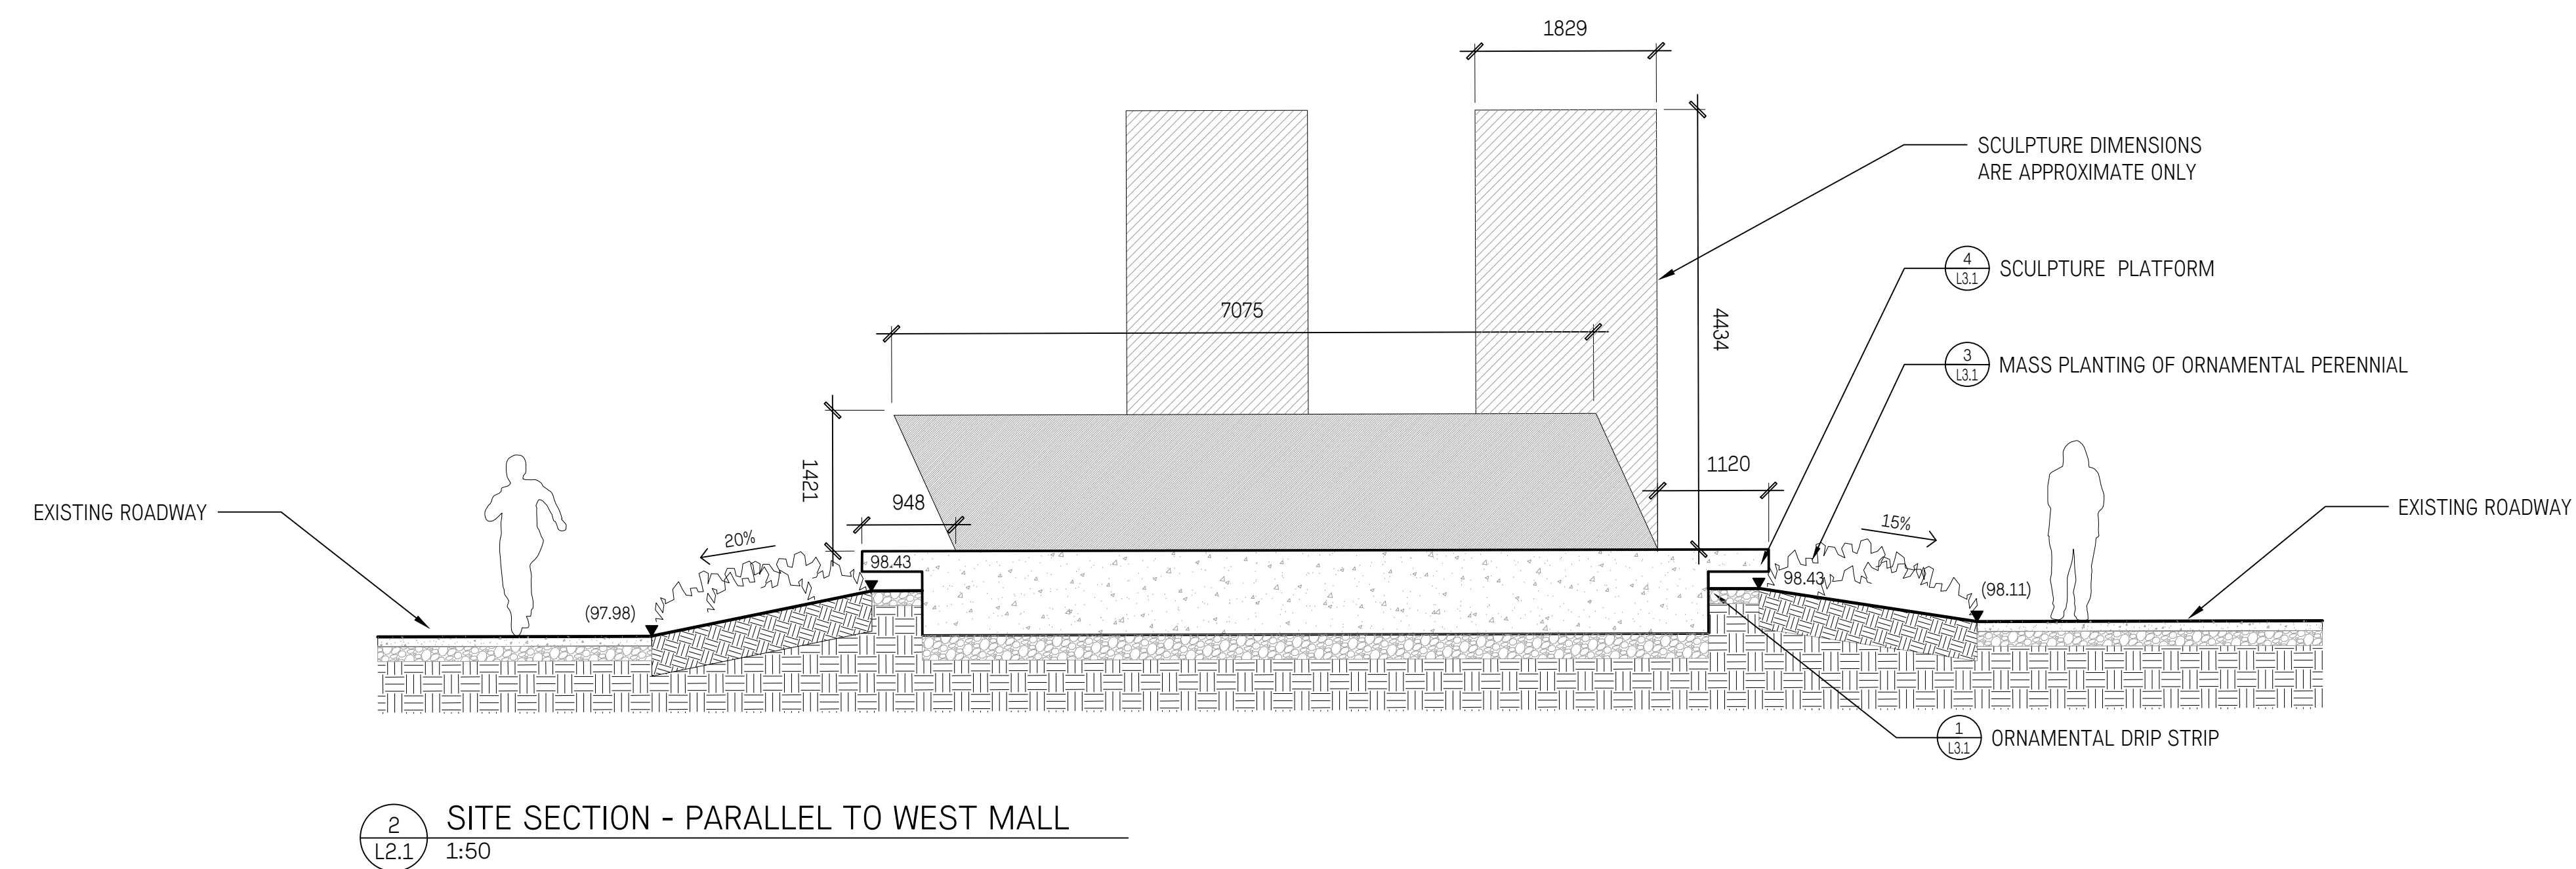
Date	Sept 25, 2018	Drawing Number
Project No.	1821	<b>L2.1</b>
Scale	1:100	
Drawn/Checked	Ih   JF

## Landscape Sections

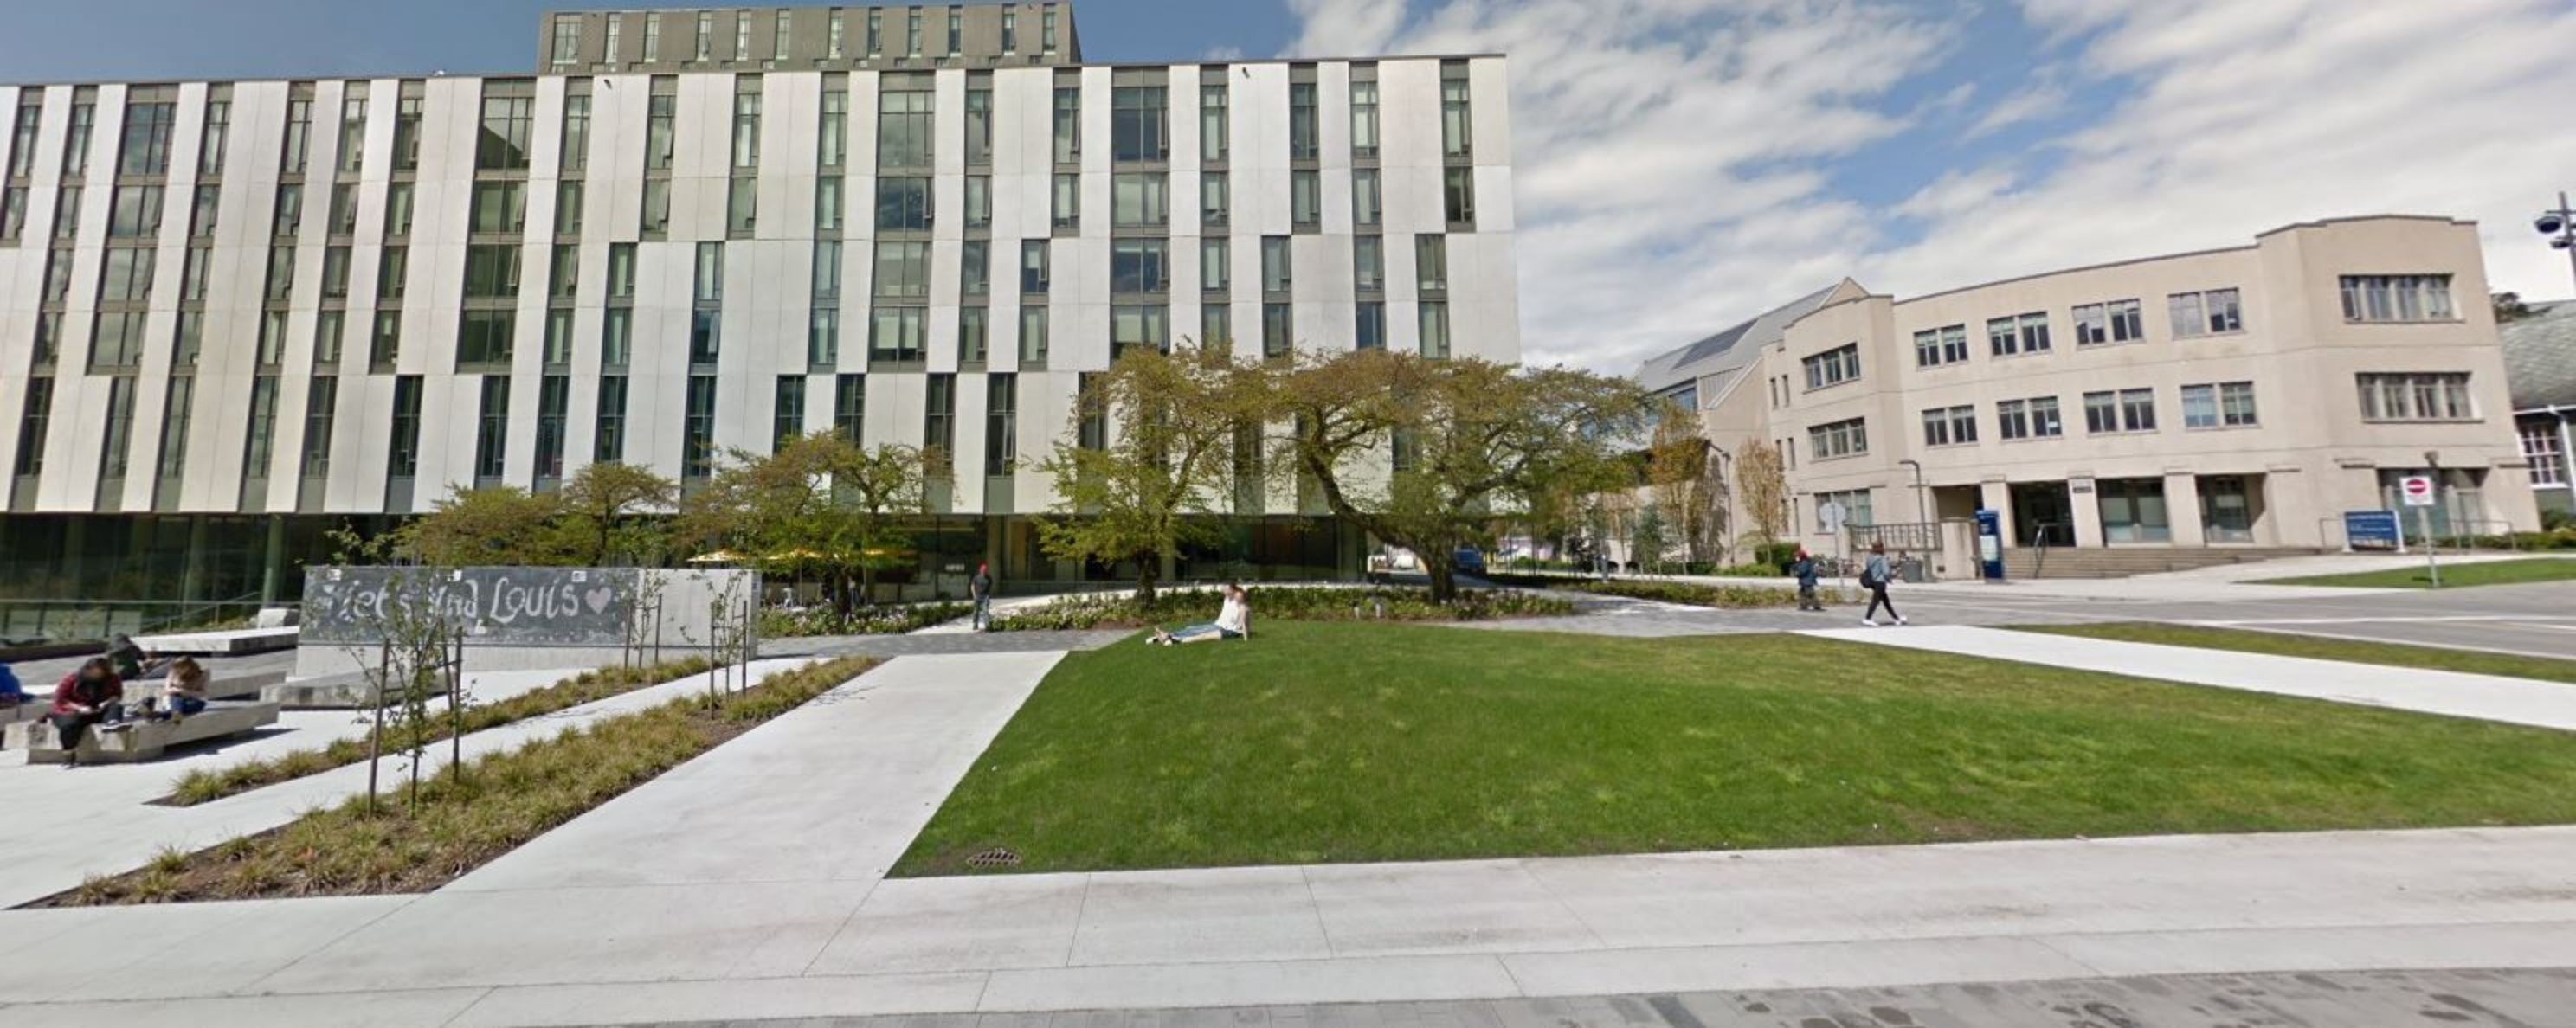
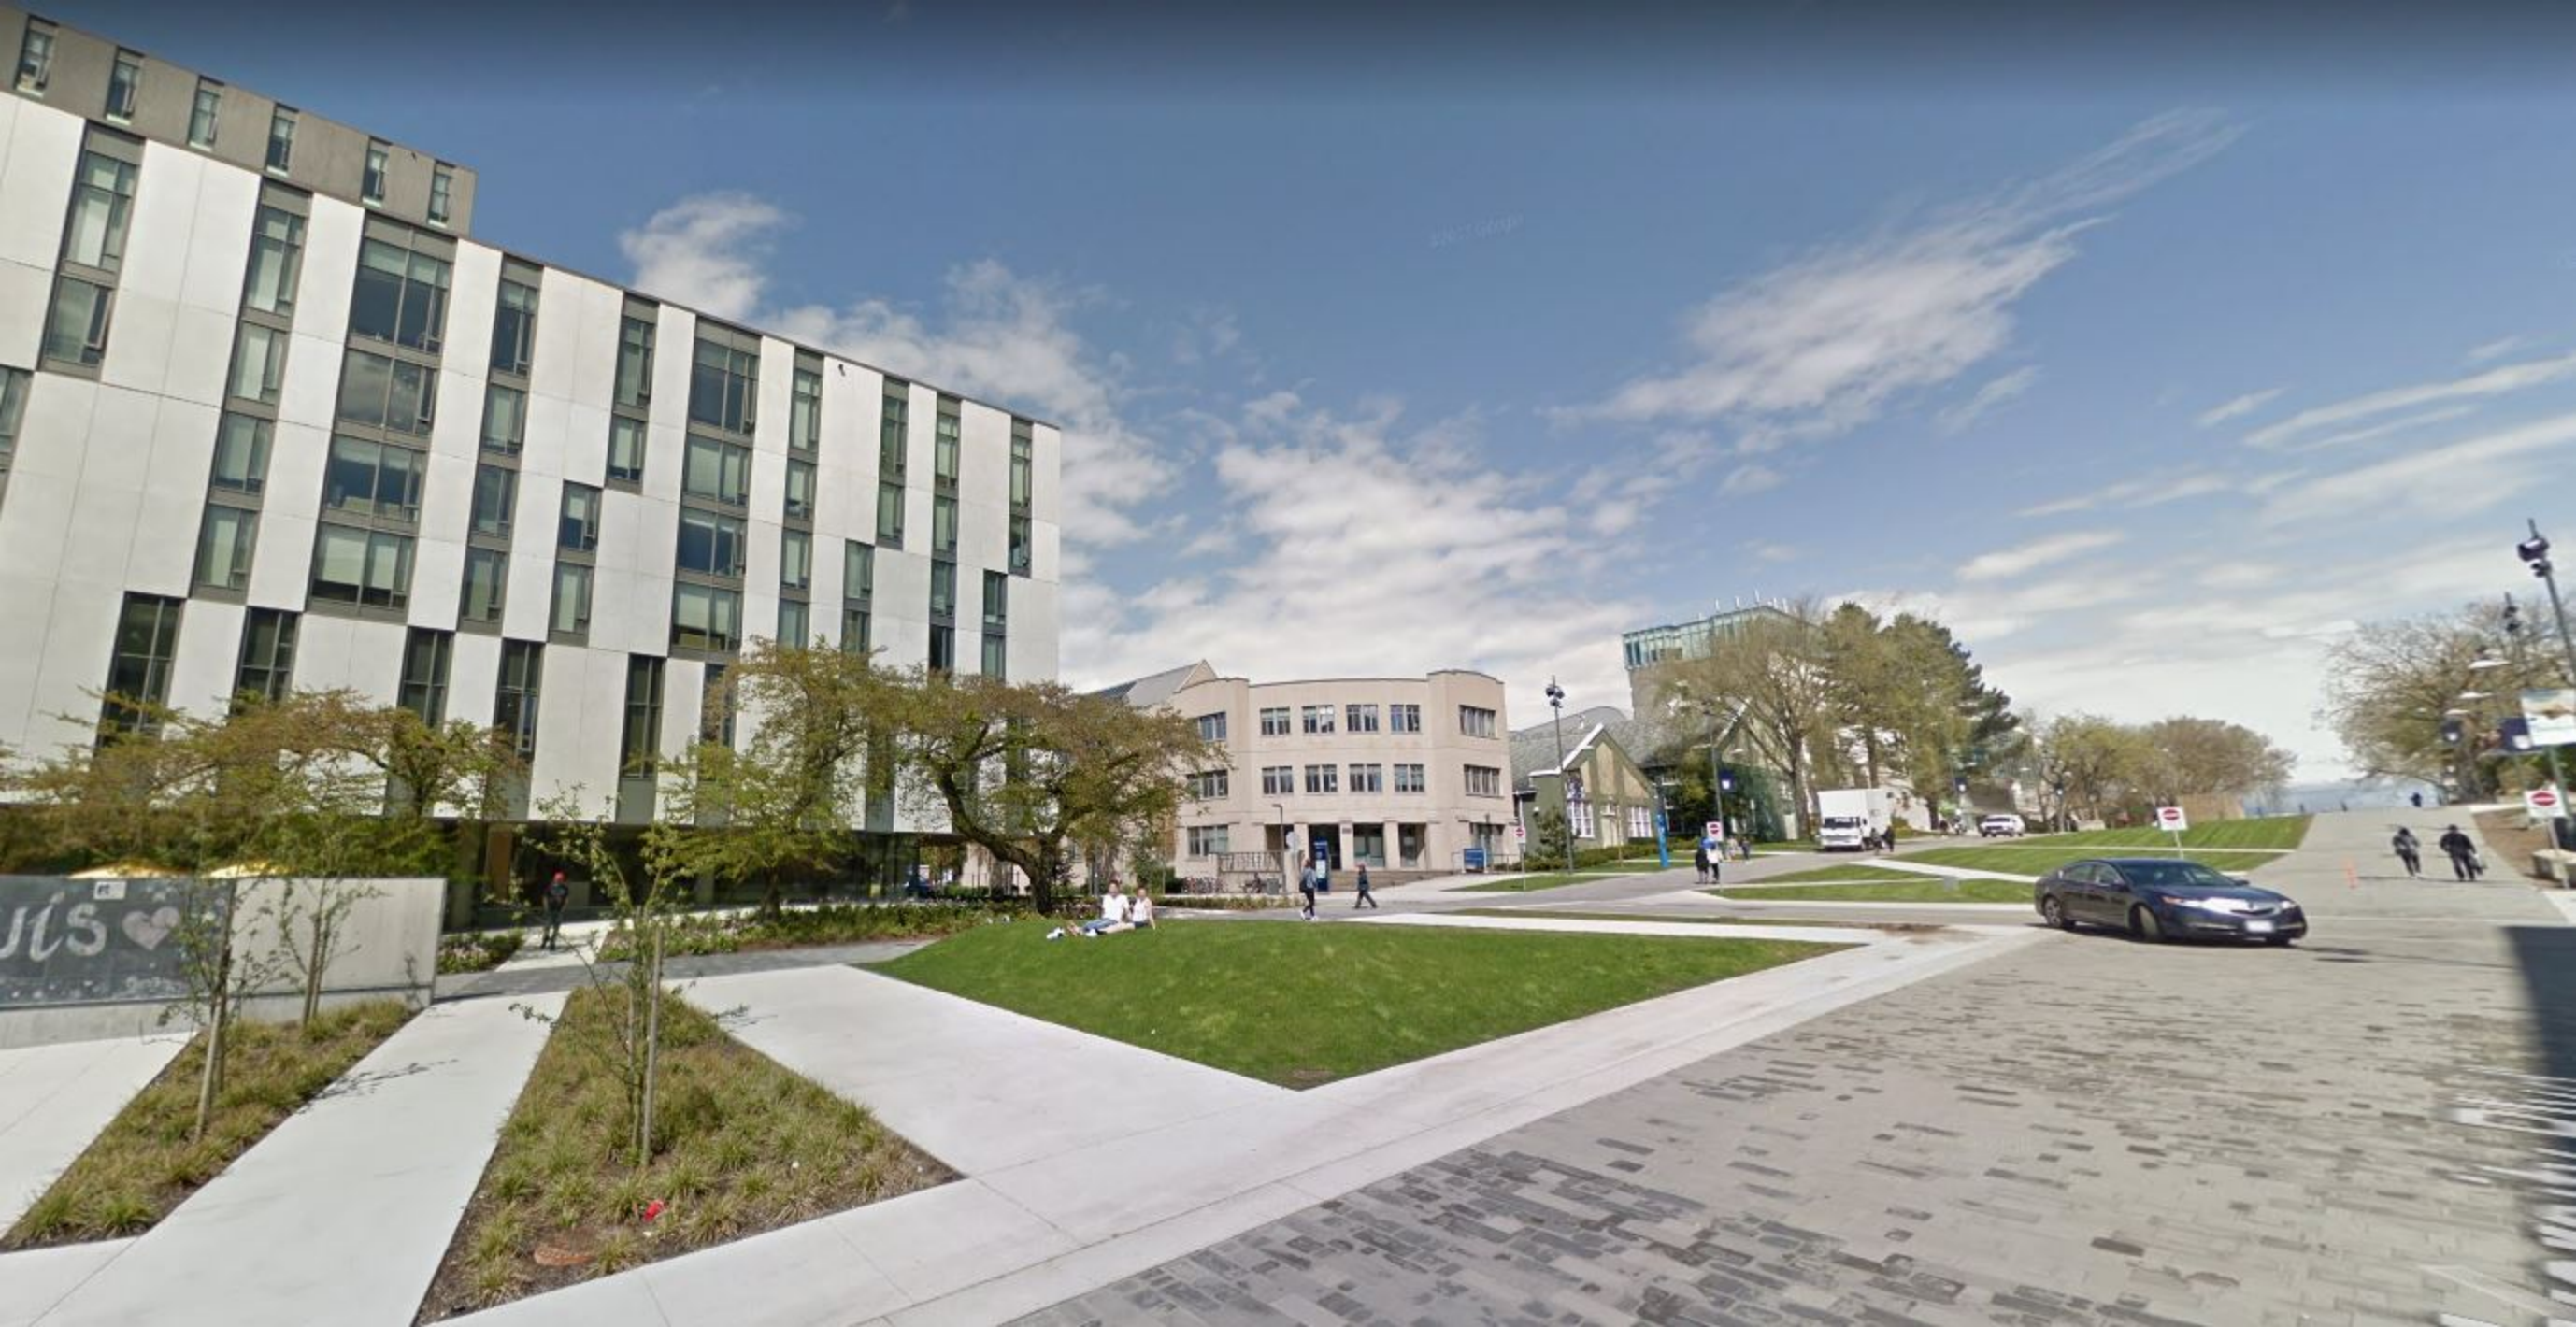
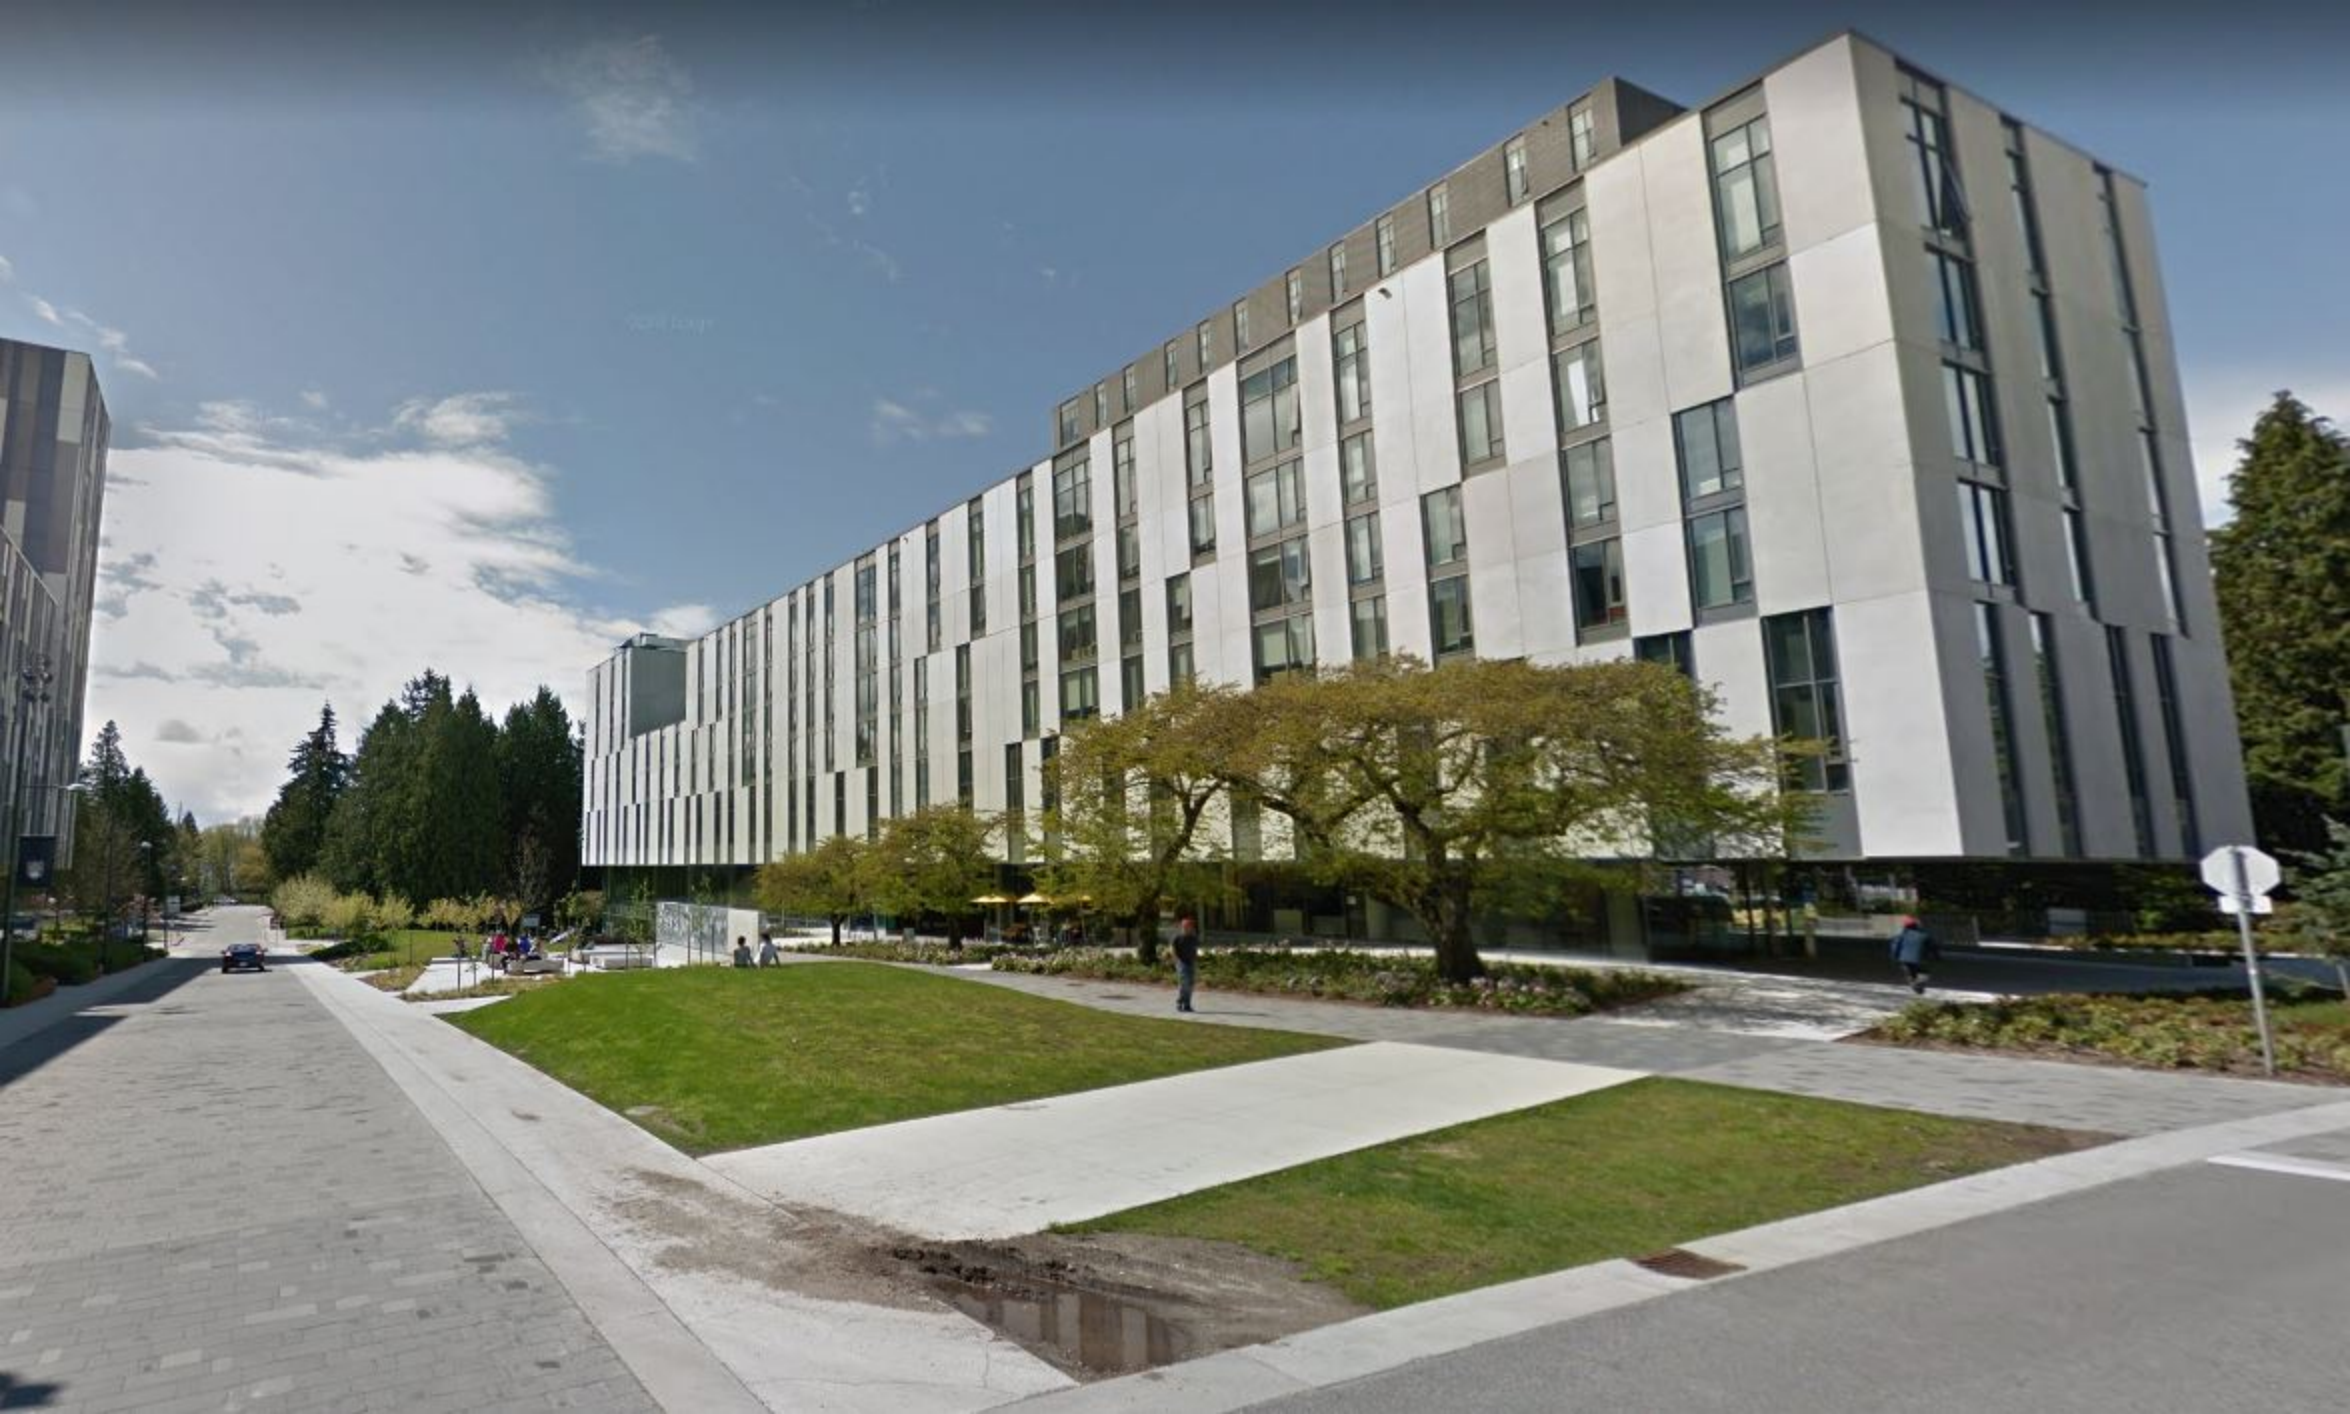
Date	Sept 25, 2018	Drawing Number
Project No.	1821	
Scale	AS SHOWN	<b>L3.1</b>
Drawn/Checked	Ih   JF

## Landscape Details

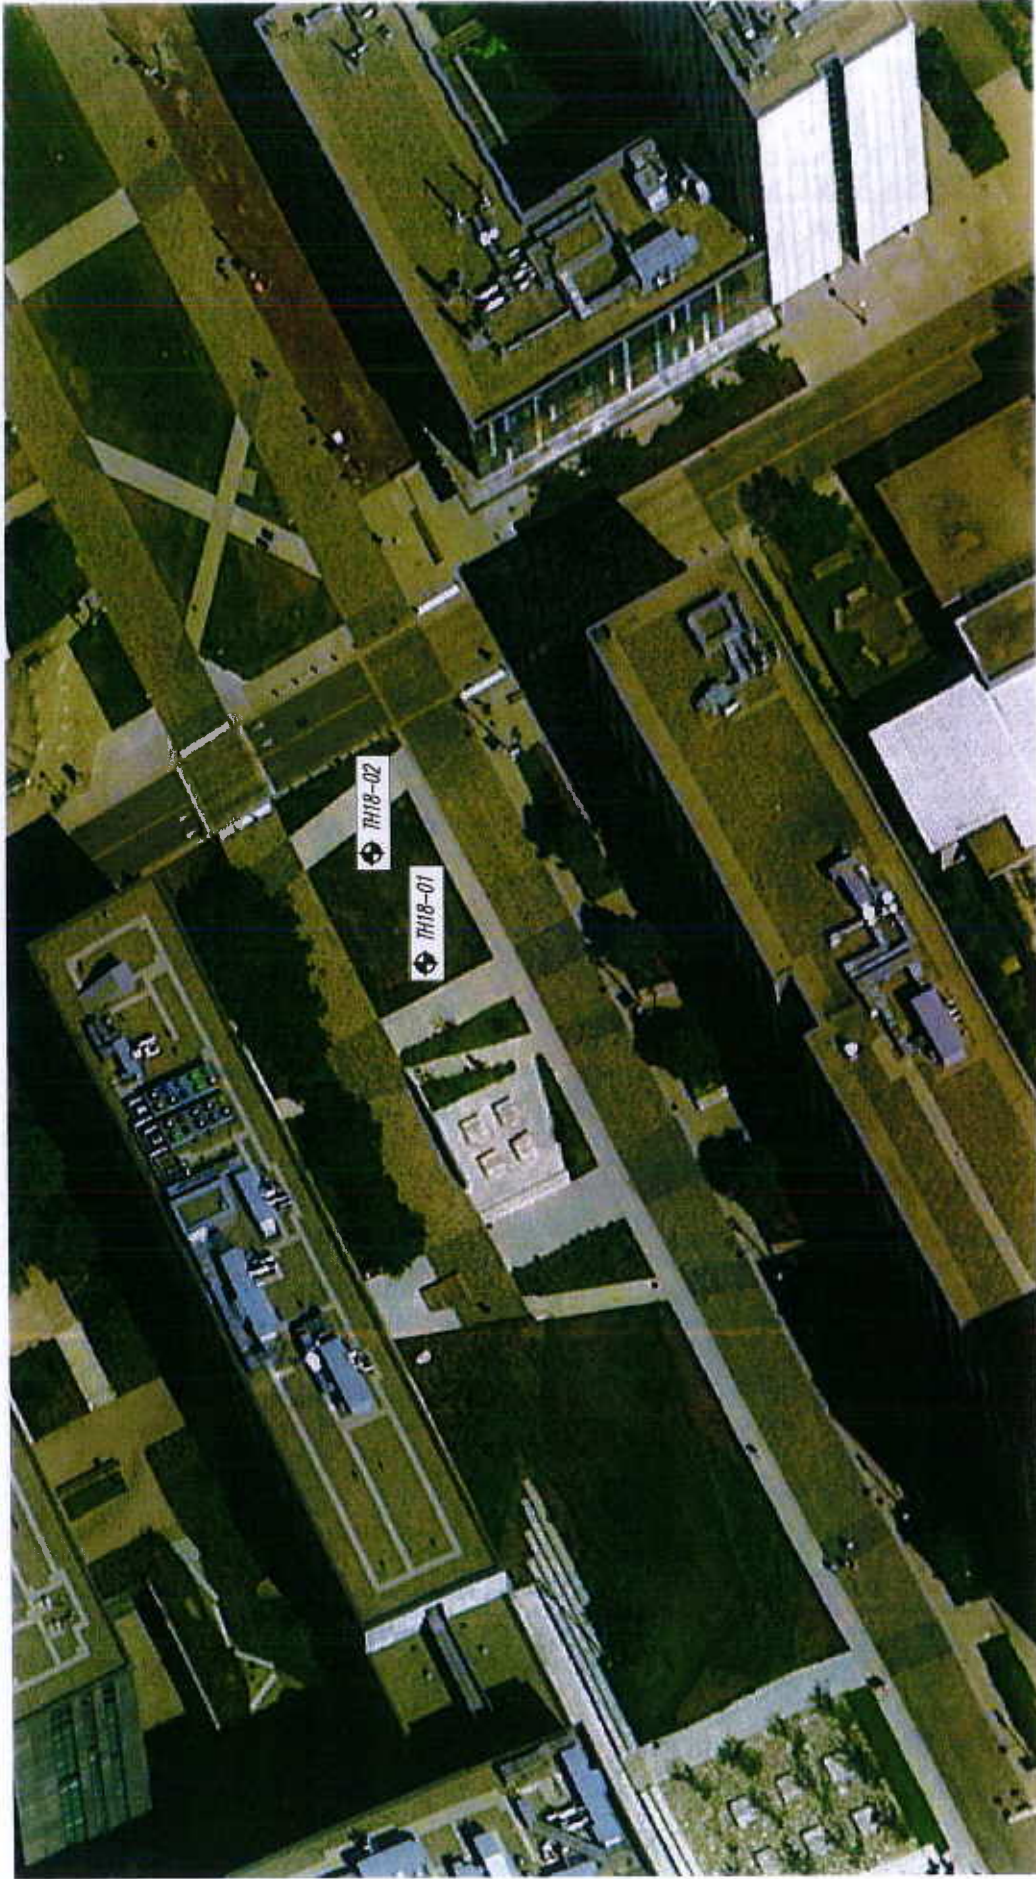
**SITE PLAN**

**Cumbria Sculpture**  
 West Mall and University Boulevard, UBC  
**TEST HOLE LOCATIONS**

The approximate test hole location is shown on our Drawing No. 16428-01 included with this report.
