# UNIVERSITY CENTRE CONSERVATION PLAN

SEPTEMBER, 2012

**SUBJECT PROPERTY:** University Centre  
**HISTORIC NAME:** Faculty Club  
**CONSTRUCTION DATE:** 1958-1959  
**ORIGINAL ARCHITECT:** Frederic Lasserre and Koyander & Wright, Associated Architects  
**MAJOR ADDITION:** 1968  
**ADDITION ARCHITECT:** Erickson Massey Architects

**Title:**  
Character-Defining Elements  
Materials, Site/Massing

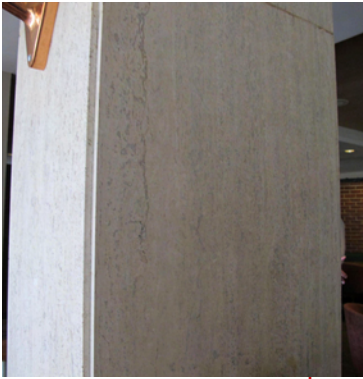
5.5.2 TRAVERTINE

Travertine is a calcium carbonate material, often light in colour, and is formed by rapid chemical precipitation from thermal springs or other mineral rich waters. It is a common material in modern construction, but due to its calcium-based composition, it is susceptible to damage by acid products. The travertine wall cladding of the University Centre is light pinkish in colour, and is laid in a repetitive pattern of large rectangular tiles. Travertine is delicate material and in order to preserve this character-defining element, it is suggested that the travertine remain in place, and not be disturbed during rehabilitation work. If damaged, it is unknown how difficult it would be to match the stone in colour and texture.

- Retain the travertine cladding, and protect during construction.
- If travertine is damaged during construction, perform Dutchmen repairs, consolidate, or otherwise reinforce the material, using recognized conservation methods.
- If travertine is cleaned, do not use acid-based cleaners, as they will dissolve the calcium-based material. Use only neutral detergents, and ensure adequate testing is undertaken of small sample areas before cleaning commences. Do not use any abrasive cleaners or cleaning methods.

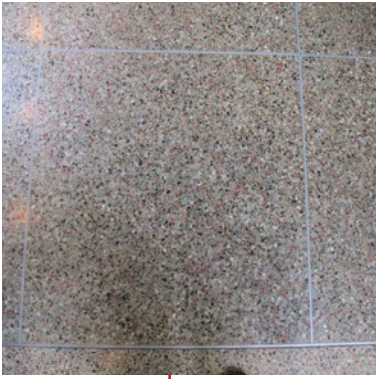
5.5.4 TERRAZZO FLOOR

The terrazzo flooring is original to the 1959 building, and is in good condition. Terrazzo is a composite material that can be poured in place, or can be pre-cast. The product originated in Venice as a way to recycle marble chips or other fine aggregates, and is often seen in floors, walkways, and patios throughout Europe and North America. The aggregate often consists of marble, quartz, granite, glass or other combination of materials. Terrazzo is cured, ground and polished to a smooth surface or otherwise finished to produce a uniformly textured surface. Metal strips are often laid in the wet cementitious base to separate aggregate colours and to control cracks due to shrinkage.

The terrazzo floors in the University Centre features multi-tonal aggregate, predominately grey, blue, and red, and is separated into rectangular tiles by metal strips. The cementitious base is tinted both grey and beige in varying locations on the floor. The grey base generally makes up the main floor area, and the beige is featured predominately in the surrounding trim tiles along the walls and slab edges. There are existing locations that demonstrate previous repair work, likely due to expansion and contraction of the flooring, or differential settlement. The material does not lend itself to removal and reinstallation, and if disturbed would need to be replaced.

- The original terrazzo flooring should be retained, and structural upgrading should not disturb the existing flooring.
- If any sections of terrazzo flooring need to be replaced, match colour and appearance.

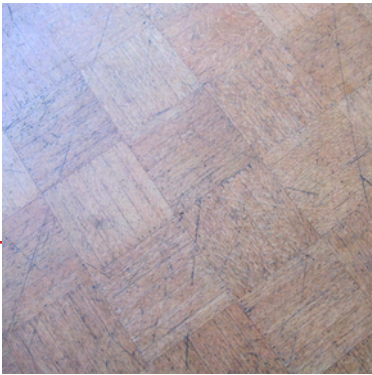
5.6.1 OAK PARQUET FLOORS

Due to the high-traffic nature of the dining hall, the floors demonstrate various degrees of damage. The passing of time creates a natural patina on historic wood flooring, which often contributes to the character of a historic place. In the case of the University Centre wood flooring, however, the damage should be repaired, and if not repairable, consideration should be given to replacement.

- Carefully examine condition of the existing flooring. If the parquet flooring can be retained in situ, repair work should consist of carefully sanding the flooring down to expose the natural wood, and coating with a high traffic surface treatment. Be mindful not to sand past the nails. Treatments such as a urethane resin product should be used, to ensure durability to future high traffic dining use. Possible products may include DuraSeal® DuraClear™ floor treatment, although a low or non-VOC product is encouraged.

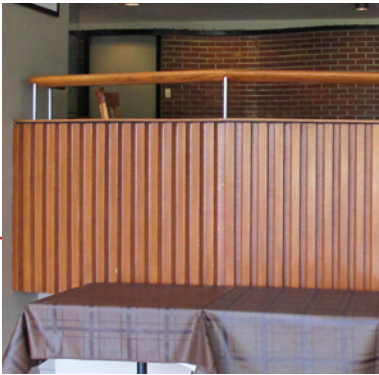
5.6.2 OAK BOARD AND BATTEN

The original board-and-batten feature walls and balustrade treatments still remain intact in most interior spaces. The wood treatment on feature walls and balustrades are of oak boards with trapezoidal oak battens, stained in a rich, medium tone. The oak board-and-batten wall and balustrade treatments are significant, as they were custom made for the 1959 design. An exterior feature wall at the entry introduces this motif, which wraps around to the interior, and then repeats in key locations, including feature walls and angled balustrades in the Dining Room.

- Due to functional requirements, the stairs between the mezzanines and the Dining Room may remain and the original balustrade design does not need to be reinstated in these locations. The stairs may be retained, or replaced with a contemporary design that is compatible with the style of the original interior.

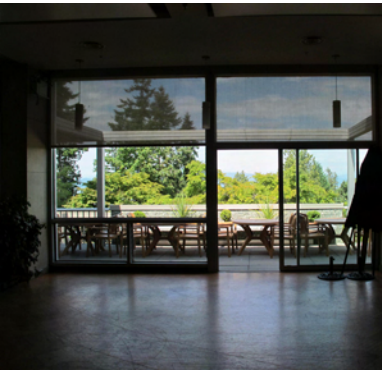
5.7 FENESTRATION

The current window systems along the exterior 1959 facades, particularly on the northern elevation, as well as the window bands along the west façade, are an integral part of the building's character. The floor-to-ceiling window-door systems on the north façade offer incomparable views from the restaurant; though the glazing has been replaced by modern double-glazed aluminum assemblies, the floor to ceiling window configuration remains significant to the building. Original character-defining fenestration elements include the aluminum window sash, and glazed aluminum doors with original wooden door handles.

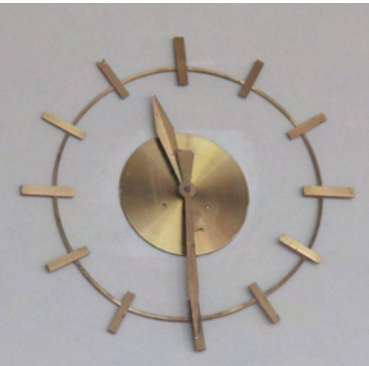
5.9.2 WALL CLOCKS

The wall clocks in the Dining Room are original character-defining elements, and should be retained. They are no longer in working condition, but are strong representations of the interior design style of the time.

- Preserve the original wall clocks in the Dining Room in their existing locations.
- Repair the clocks to working order.

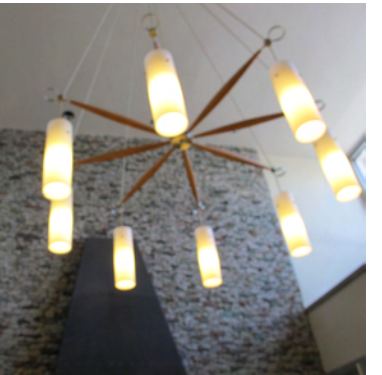
5.9.1 LIGHT FIXTURES

The original light fixtures are retained throughout the main public spaces of the building. The lighting fixtures feature both white and yellow-toned suspended conical and cylindrical shaped shades, seen both suspended individually, and as elements of a chandelier-type grouping. Over the years, the light shades on a number of fixtures have been replaced. These new light shades are replicas of the originals, and were installed as part of a maintenance routine. All light fixtures and hardware elements are original.

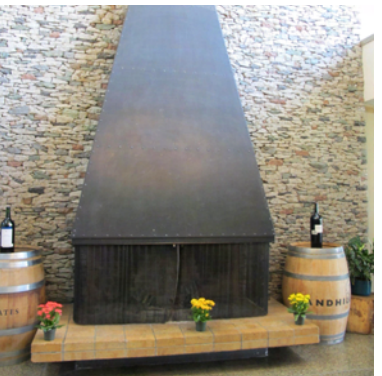
5.10 FIREPLACE

The fireplace with metal hood and suspended brick hearth in the Lobby is original, and is a character-defining element of the space. The fireplace is centrally located on the west chipped granite feature wall in the Lobby, and features a large metal hood that runs three quarters up the height of the two-storey Lobby walls. The hood and mesh protective curtain are black metal, and the surrounding brick hearth is comprised of rectangular buff bricks, and projects approximately three feet from the wall. The wood-burning fireplace is currently functional, and remains in use.

- In order to maintain the character-defining element, the existing elements of the fireplace that are visible in the Lobby should be preserved.
- If desired, the fireplace may be retrofitted as a gas-burning operation.

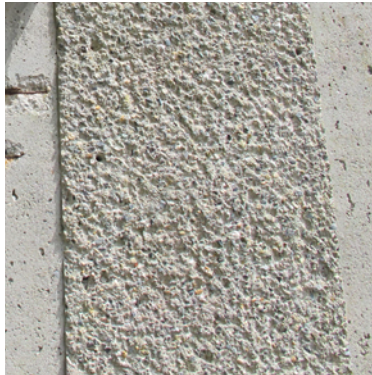
6.5 CONCRETE - TEXTURES

Erickson finished the exposed concrete of the addition in two distinct techniques, consisting of a traditional smooth surface, and a highly textured rough decorative surface. Both finishes are evident on interior and exterior concrete elements and are important heritage features that should be preserved. An initial visual review of the concrete reveals it to be in good condition, however there are instances of localized deterioration of the concrete, which is exposing corroded rebar. Checking has been found predominately on the main colonnade and the cantilevered stairs. On certain concrete roof elements to the exterior of the sliding glass doors, there is a high degree of organic growth from water retention.

- Preserve the original concrete structure.
- Protect and maintain concrete by preventing moisture penetration; maintaining proper drainage; improving water shedding; and by preventing damage due to the overuse of ice-clearing chemicals.
- Fill concrete checks and cracks with restoration mortar, to prevent future oxide jacking.
