## **STAGE 1 PRELIMINARY SITE INVESTIGATION**

**6049 NURSERIES ROAD  
University of British Columbia  
Vancouver, BC**

**UBC Properties Trust**  
Suite 200 - 3313 Shrum Lane  
Vancouver, BC  
V6S 0C8

December 6, 2024

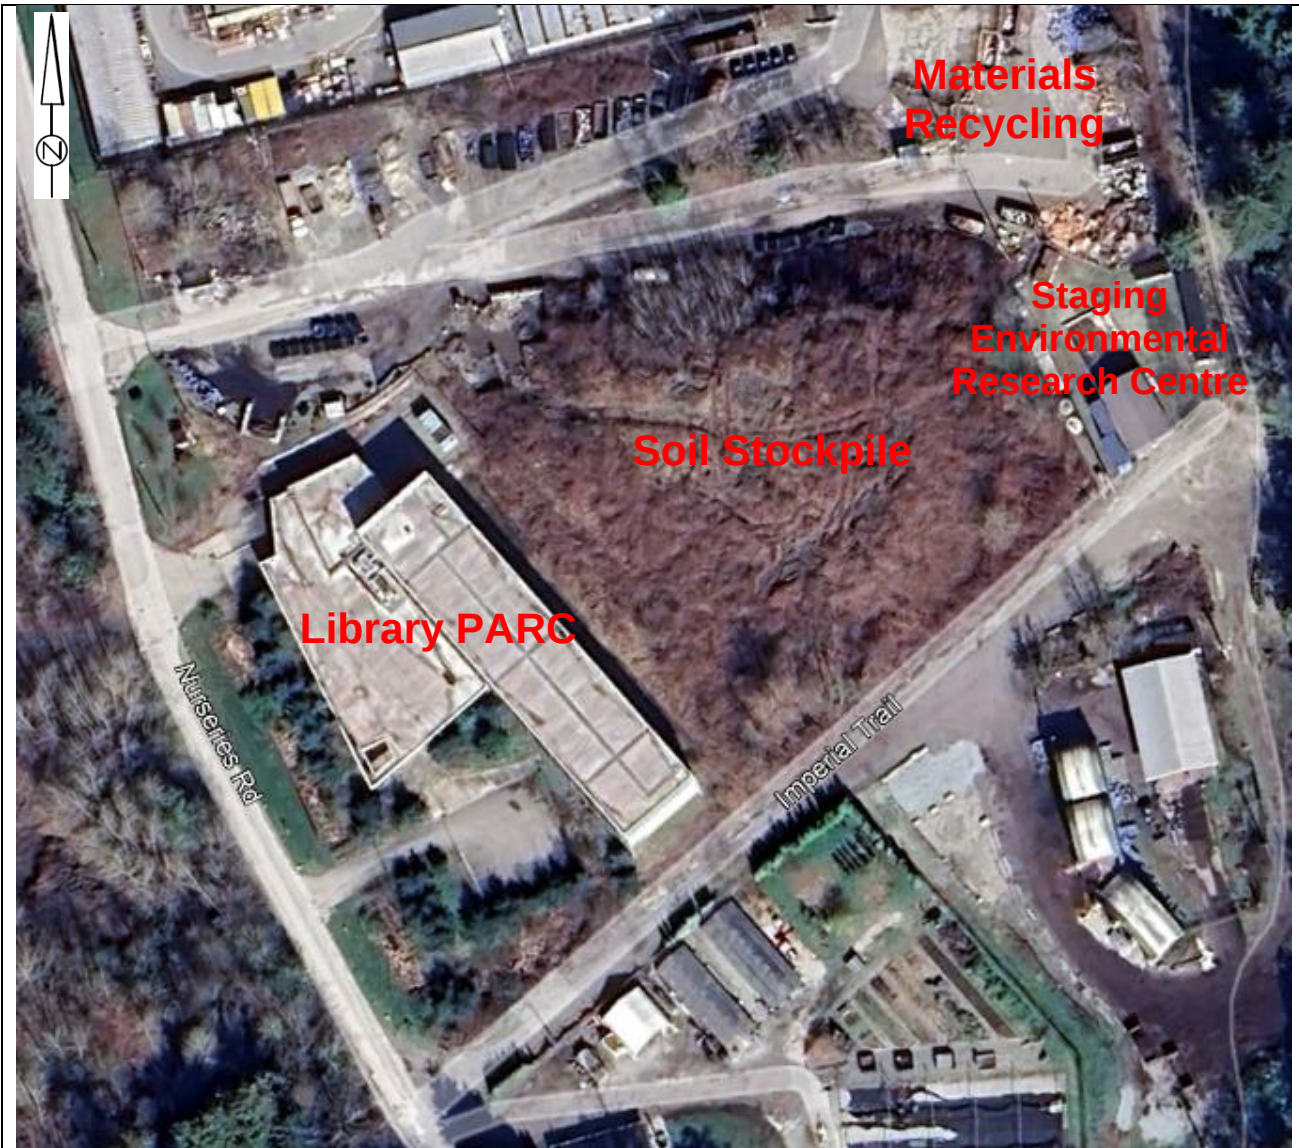
| | <b>Client:</b> UBC Properties Trust | <b>Figure 4:</b><br><b>Site Plan</b> |

An inspection of the Site was conducted by Jim Williams of Alliance on December 10, 2024. A site plan showing the current land use of the Site is presented in Figure 4. Photographs taken during the site inspection are presented in Appendix E.

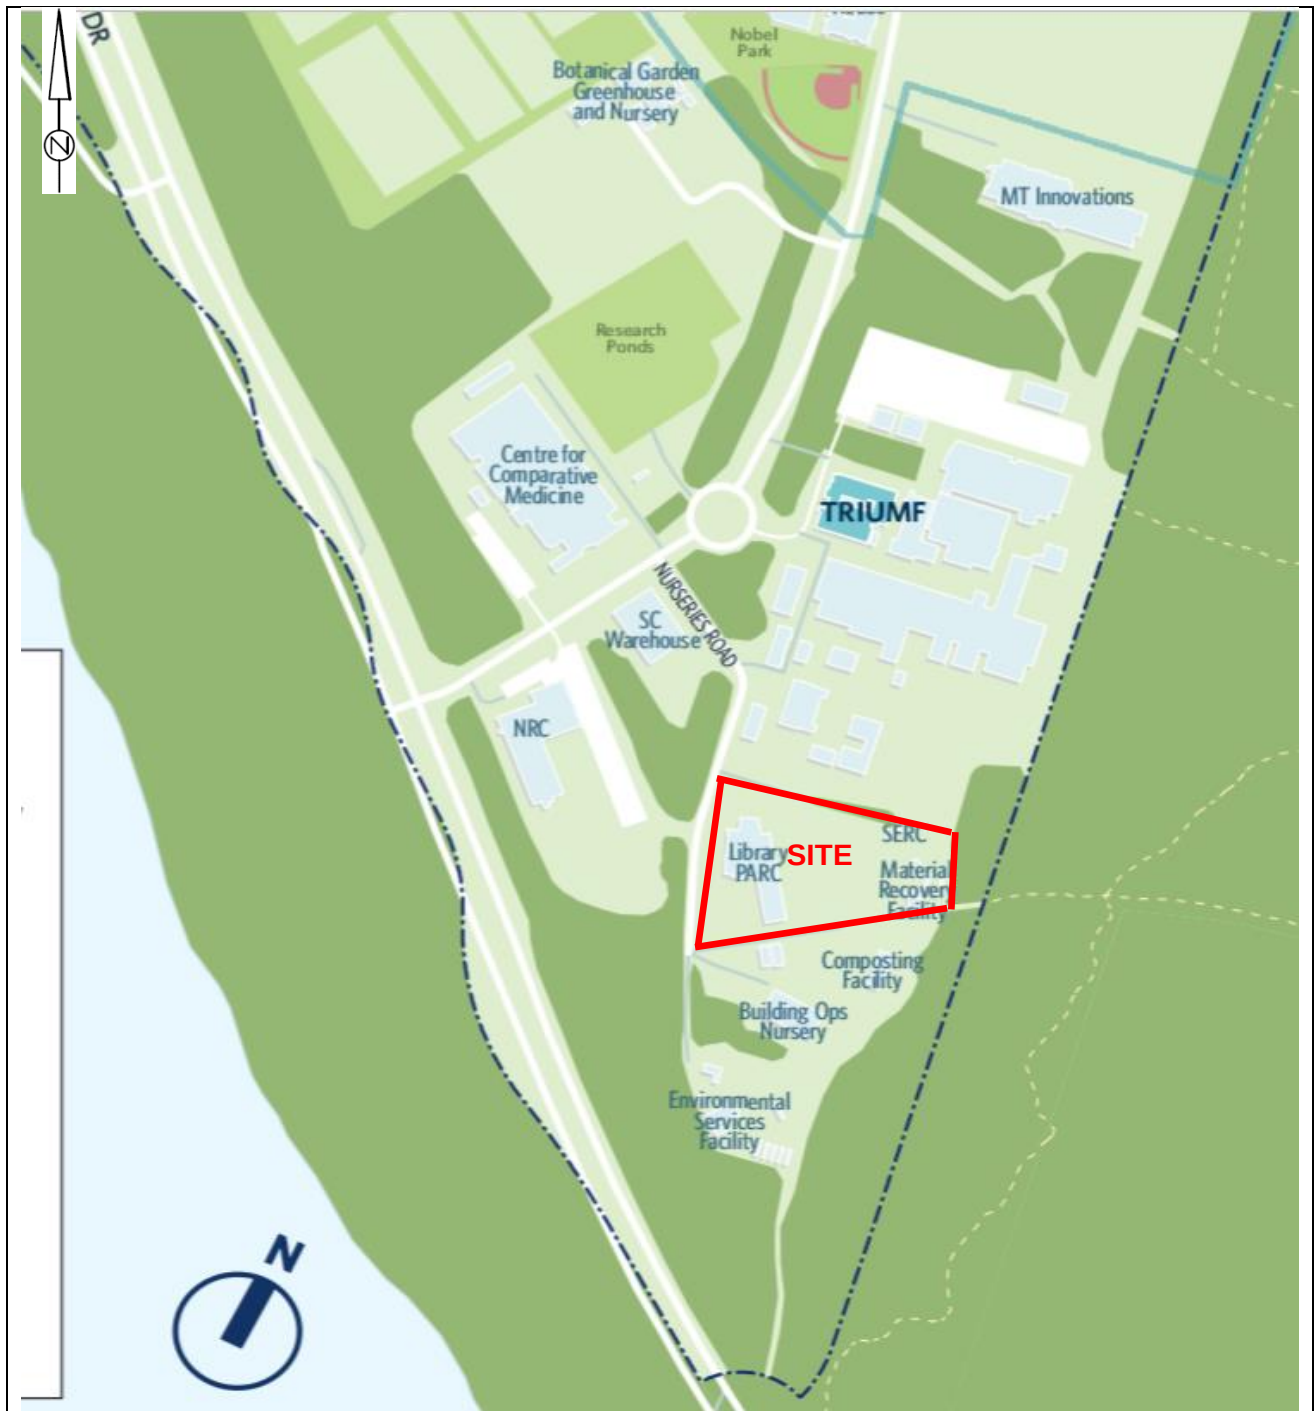
**Figure 5:**  
**Surrounding Land Use**

A visual assessment of the surrounding properties was also conducted during the site inspection to identify any potential offsite sources of contamination which may affect or adversely impact the Site. A surrounding land use map is presented in Figure 5.

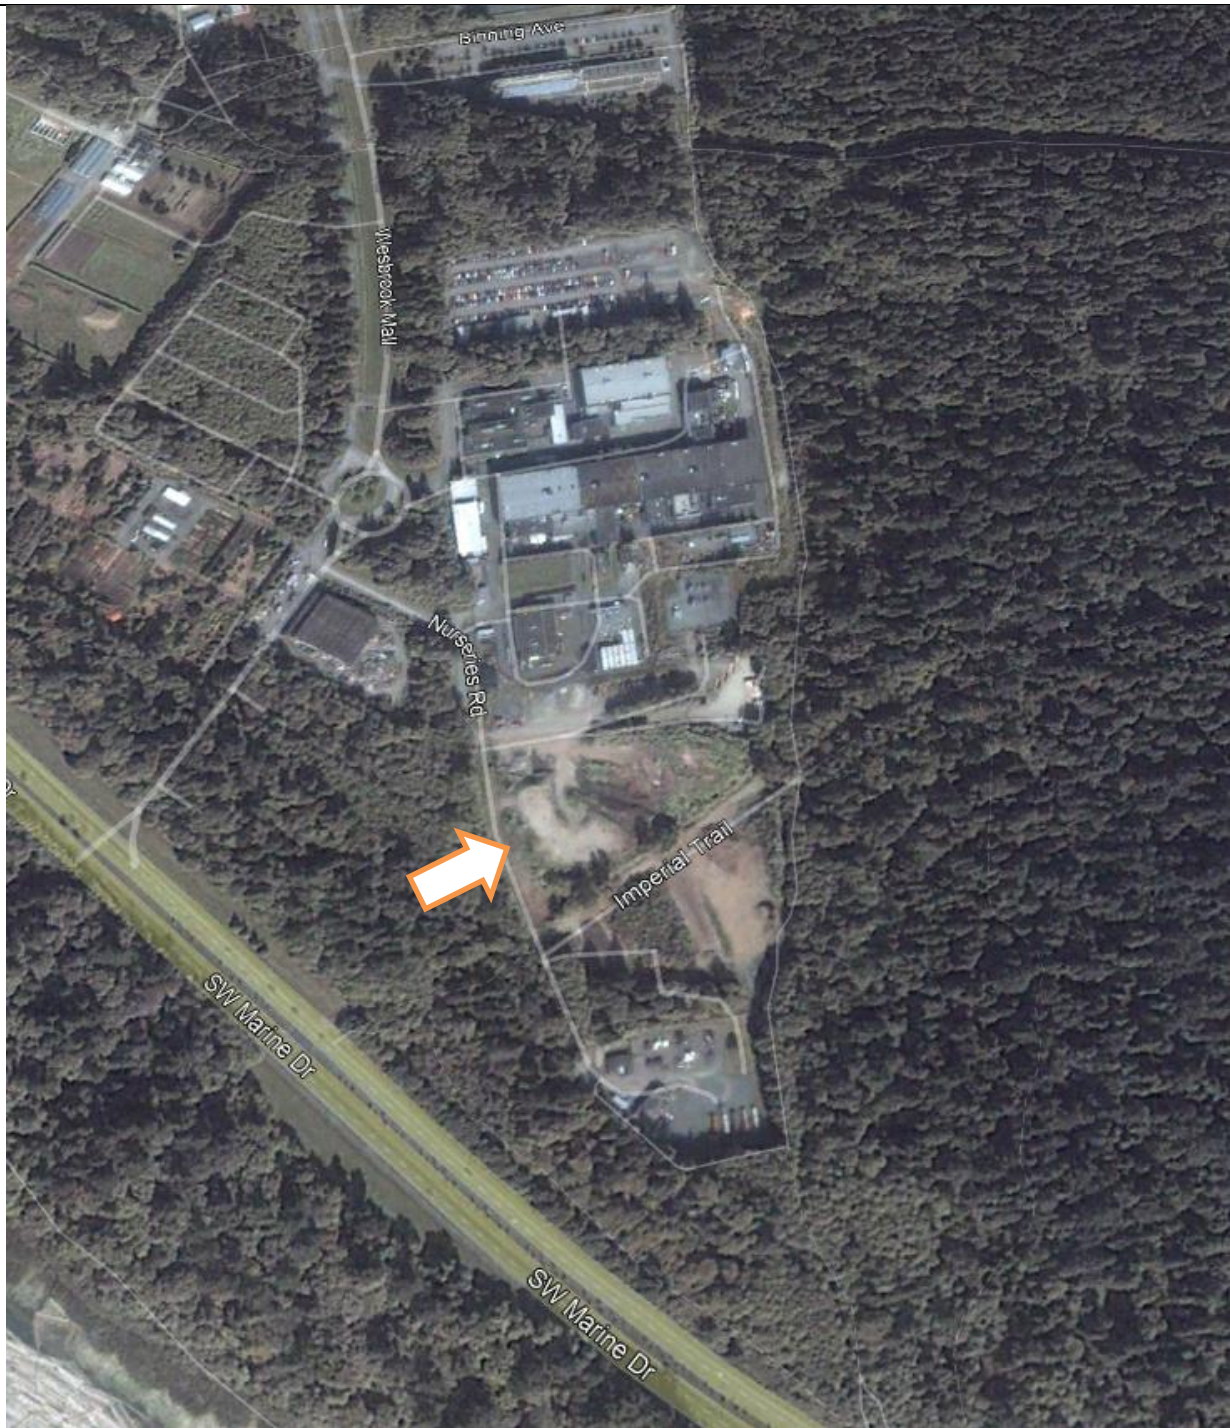
**2004 Air Photo**

| Date | Description |
|---|---|
| 2004 | The Site and surrounding area remain relatively unchanged, although some single family residences are now visible east of the Site. |

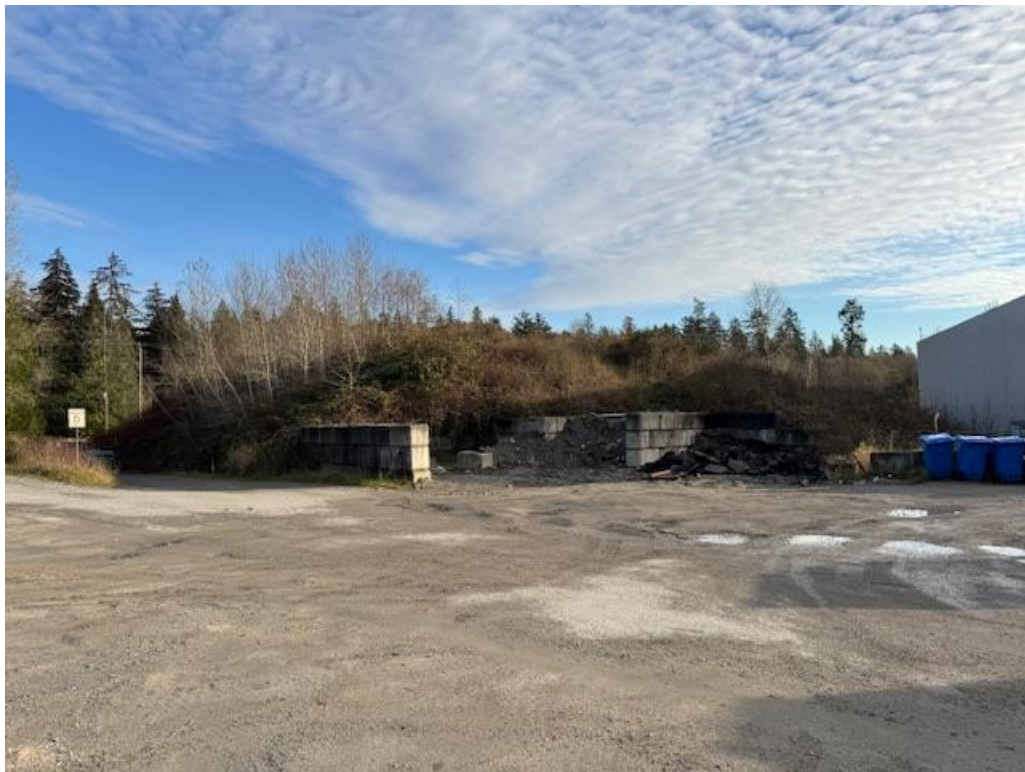
A soil investigation was conducted by Alliance EHS Consulting in February 2024. The investigation focused on the soil stockpile currently occupying the centre of the Site. Twelve sets of soil samples were collected from the stockpile and analyzed for light and heavy extractable petroleum hydrocarbons (LEPH/HEPH) corrected for polycyclic aromatic hydrocarbons (PAHs), Benzene, Toluene, Ethylbenzene, Xylenes (BTEX), Volatile Petroleum Hydrocarbons (VPH), Metals and Soil Salinity. Results of the investigation found that all parameters analysed within the stockpile contained concentrations less than the most stringent CSR generic and matrix soil standards for Urban Park, Residential, Commercial and Industrial land uses. However, concentrations of PAHs were found in excess of the CSR standards for Agricultural land use. Therefore, if the soil is to be transported offsite, it must go to a non-agricultural landfill site or waste treatment facility.

**Photo 2:** Mound of fill soil at centre of Site.

If the soil stockpile requires removal from the Site, the soil must go to a non-agricultural landfill site or a soil treatment facility for disposal.

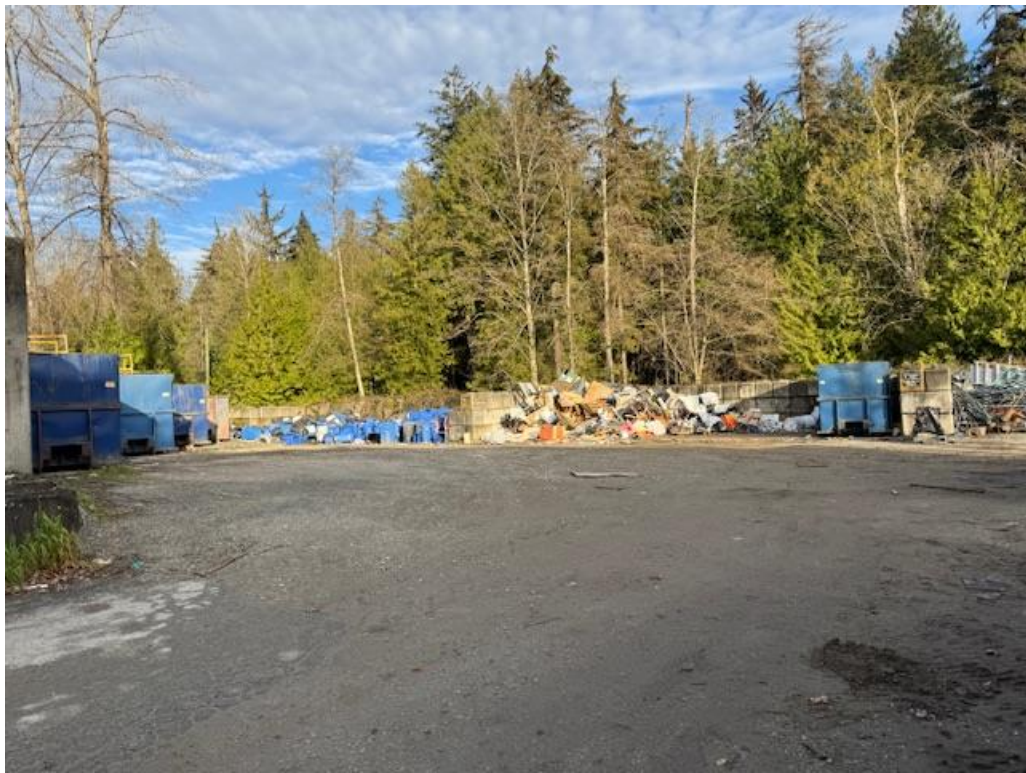
Solid non-hazardous wastes and recyclable materials are removed from the Site by UBC waste collection and management. The Site is also used for sorting of recycling materials such as plastics, metals, scrap wood, etc.

**Photo 4:** Sorting area for recycling at east end of Site.

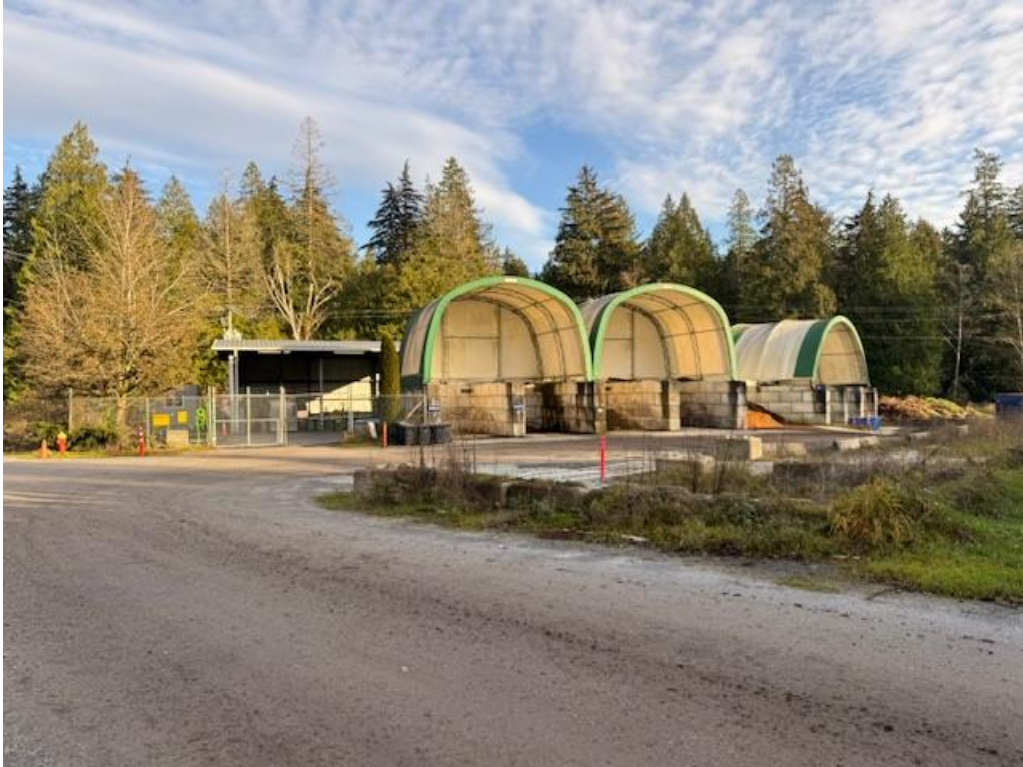
**Photo 7:** Onsite sorting area for recycling.

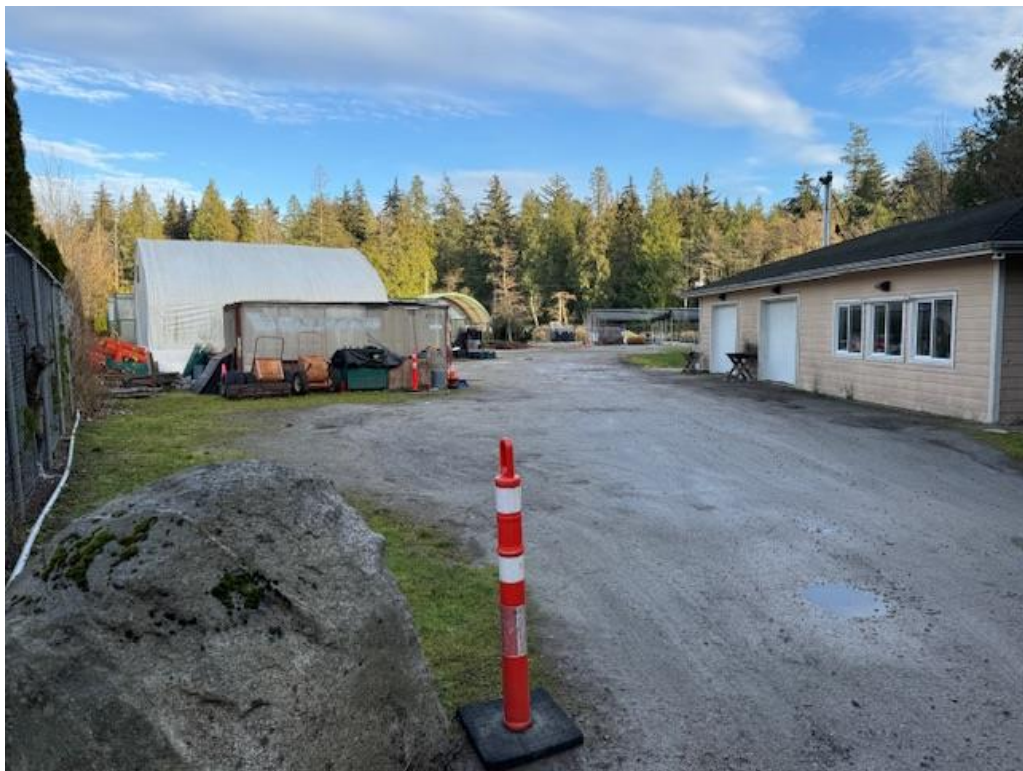
**Photo 8:** Onsite sorting area for recycling.
