# Diamond Head Consulting Ltd. Arborist Report

**Gage South Student Housing and Bus Loop  
Exchange**

**March 10, 2016**

**To be submitted with Tree Retention and Removal  
Plan Prepared by PFS Studio**

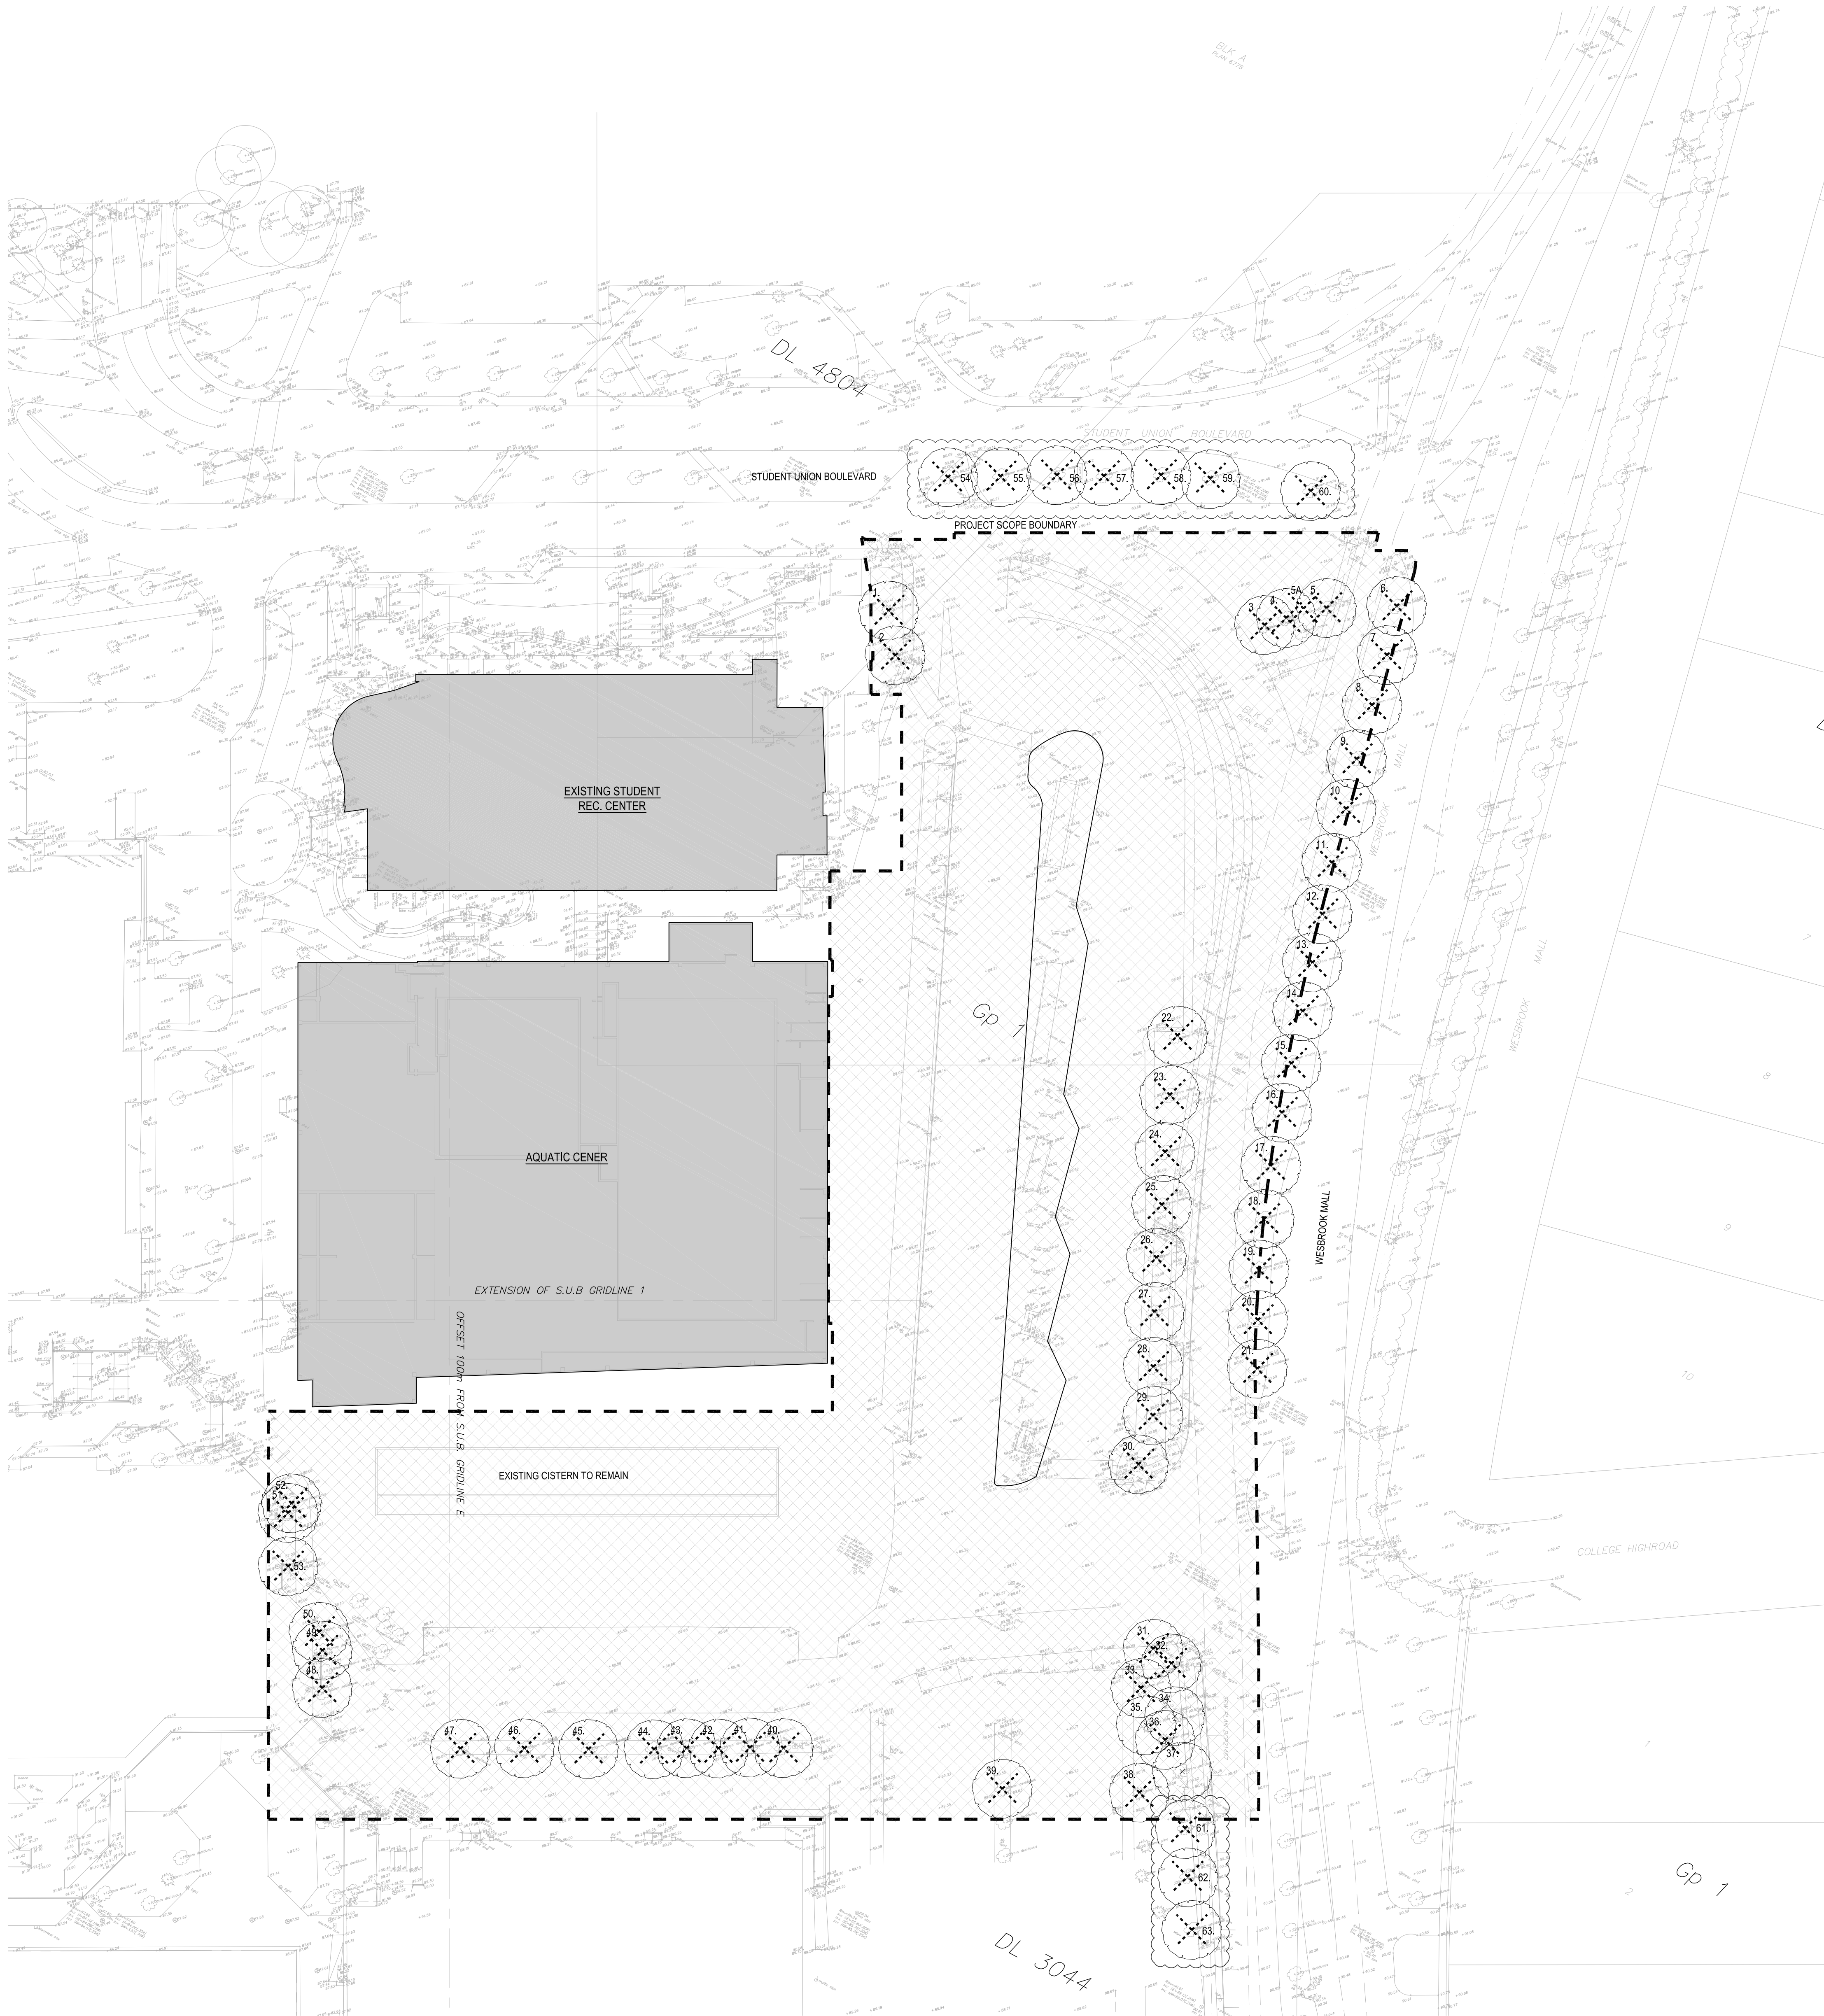
1 PLAN VIEW  
SCALE: 1:500

9. TREES IDENTIFIED TO BE RELOCATED (\*) REQUIRE ASSESSMENT AND COORDINATION WITH THE PROJECT ARBORIST AND CAMPUS LANDSCAPE ARCHITECT. RELOCATION TO BE DETERMINED BY CAMPUS LANDSCAPE ARCHITECT.
