DEVELOPMENT PERMIT APPLICATION SUBMISSION  
JANUARY 7th, 2016

# INDIAN RESIDENTIAL SCHOOLS HISTORY AND DIALOGUE CENTRE

UBC, VANCOUVER, B.C.

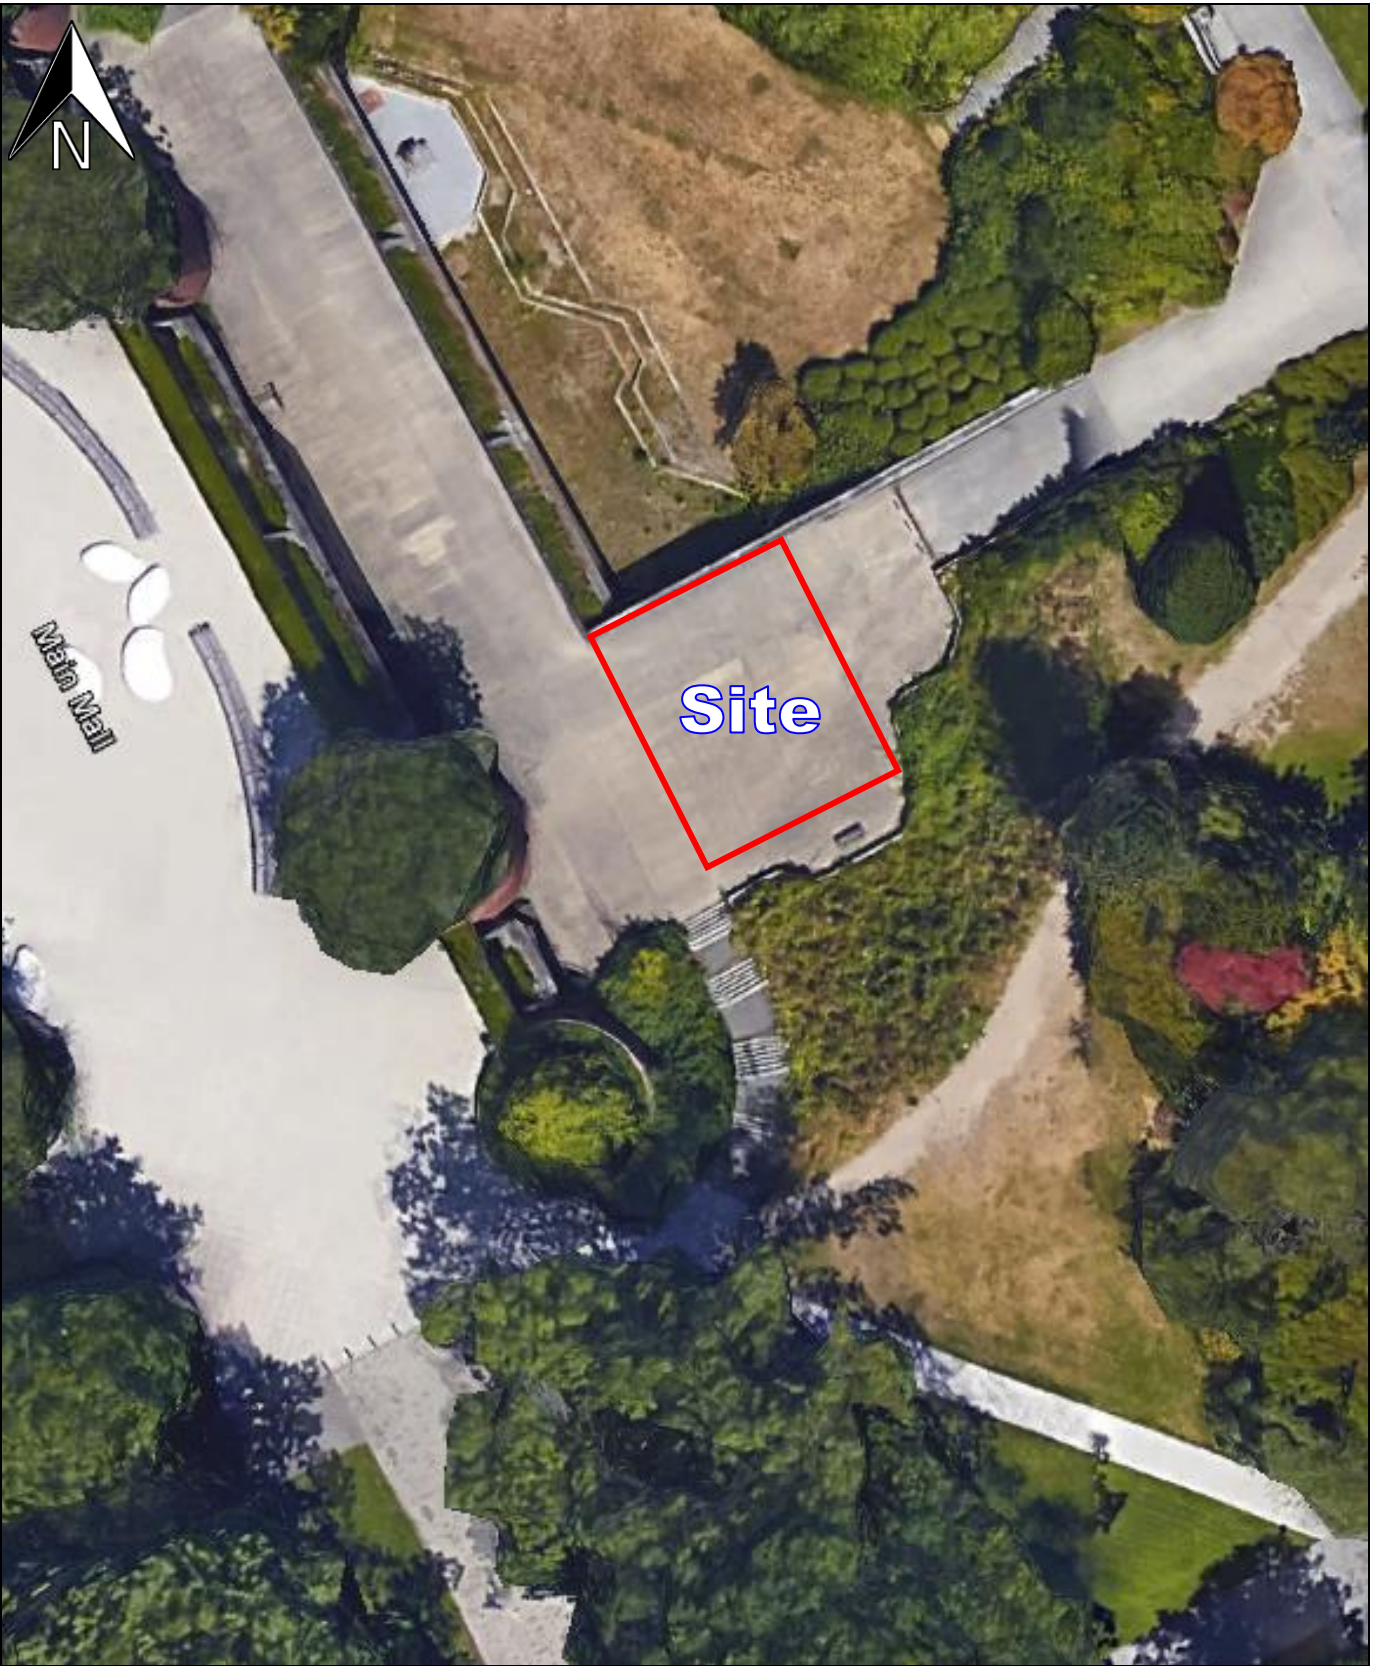
**Figure 2: Site Plan**

**Scale (approx.): 1:500**

The Site is made up of a single lot. The lot is square in shape with a gross parcel area of approximately 250 square metres. The Site is a section of a paved walkway and existing rooms located within the library garden and the library itself. The surrounding areas of the Site consist of paved roads/walkways and academic buildings: Memorial Road and the Buchanan (Arts) academic buildings to the north, the Irving K. Barber Learning Centre to the east, Agricultural Road and the Sciences academic buildings to the south, and Main Mall and the Walter C. Koerner Library to the west. A location map of the Site is presented in Figure 1. A site plan of the Site is presented in Figure 2.

The Site currently consists of several rooms of the Walter C. Koerner Library located below garden at the southeast corner of the library and a paved walkway above these rooms. Both areas are located below ground level with nearby stairways leading into the area from ground level. The paved area is an open area with a single seating bench. No access was available to the library rooms, though were observed to be used for storage. A location map of the Site is presented in Figure 1. A site plan of the Site is presented in Figure 2.

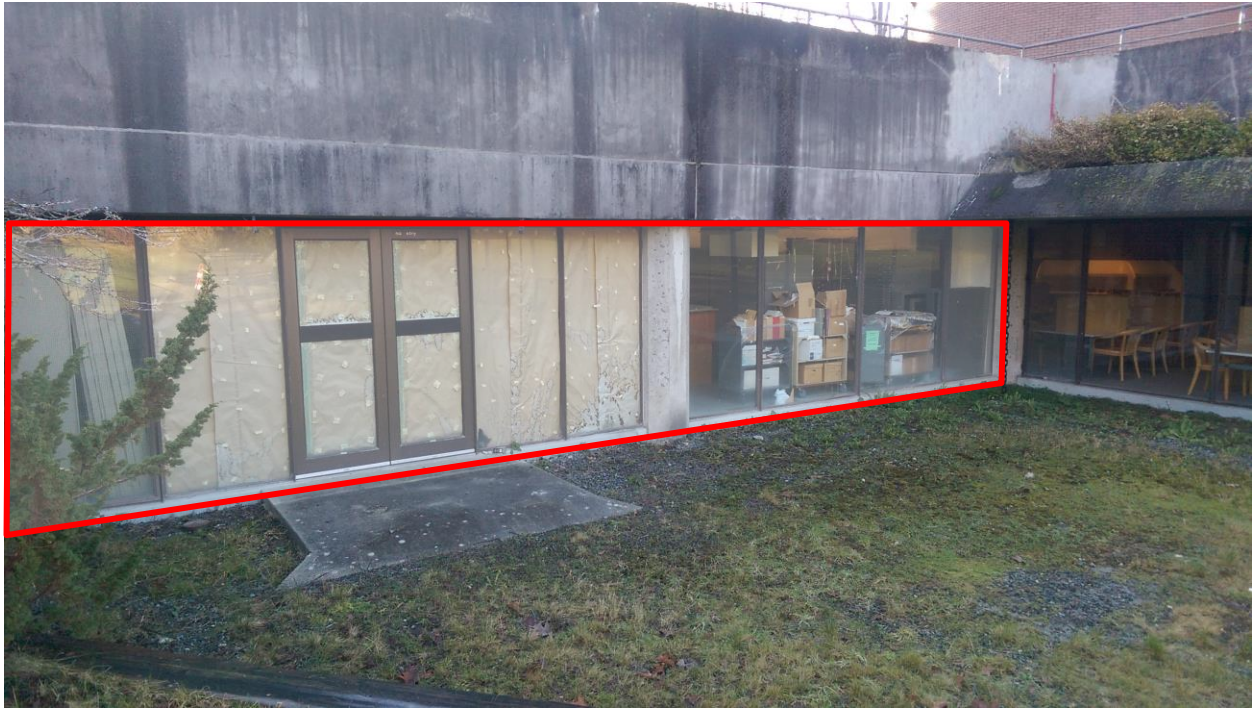
**Photo 5:** Below portion of the Site. The area consists of several rooms of the Walter C. Koerner Library.

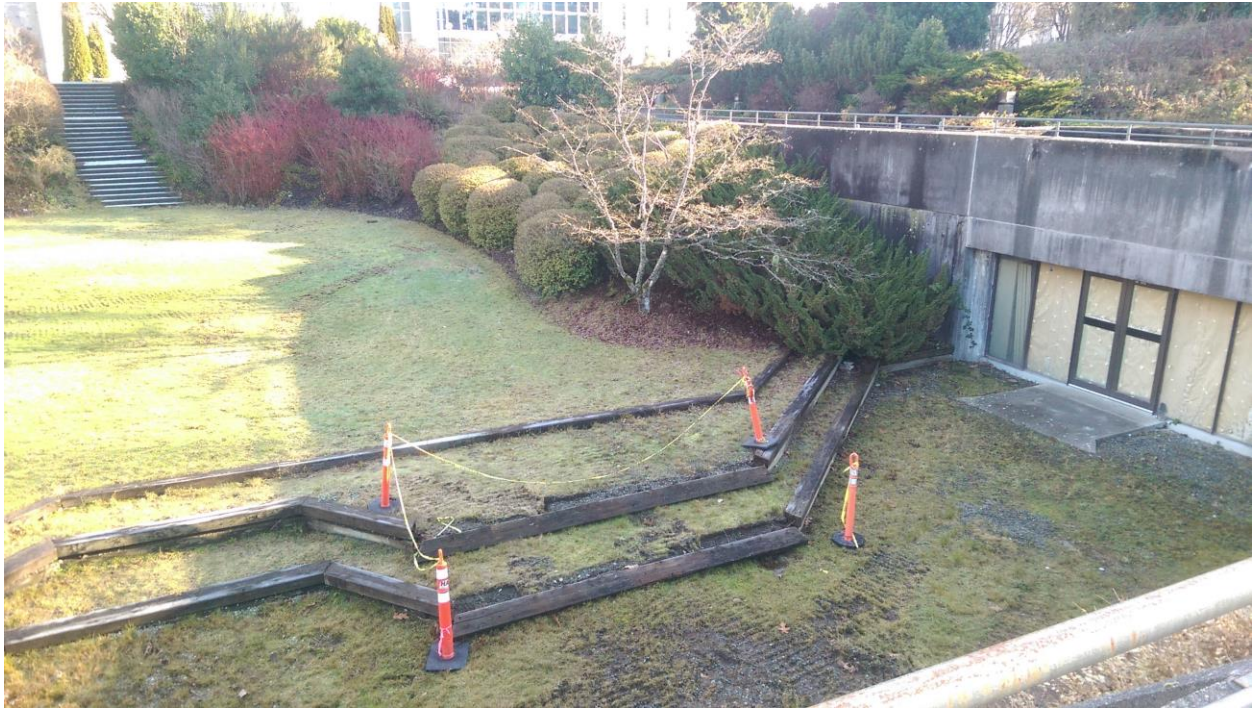
**Photo 7:** View of the below portion of the Site and the adjacent sunken garden from the above level.
